Office of the Chief Investigator
Transport and Marine Safety Investigations

**Rail Safety Investigation
Report No 2007 / 05**

Level Crossing Collision between
Yarra Valley Tourist Railway Trolley No PM16
and a Motor Vehicle at a Level Crossing
at TarraWarra Estate
12 April 2007

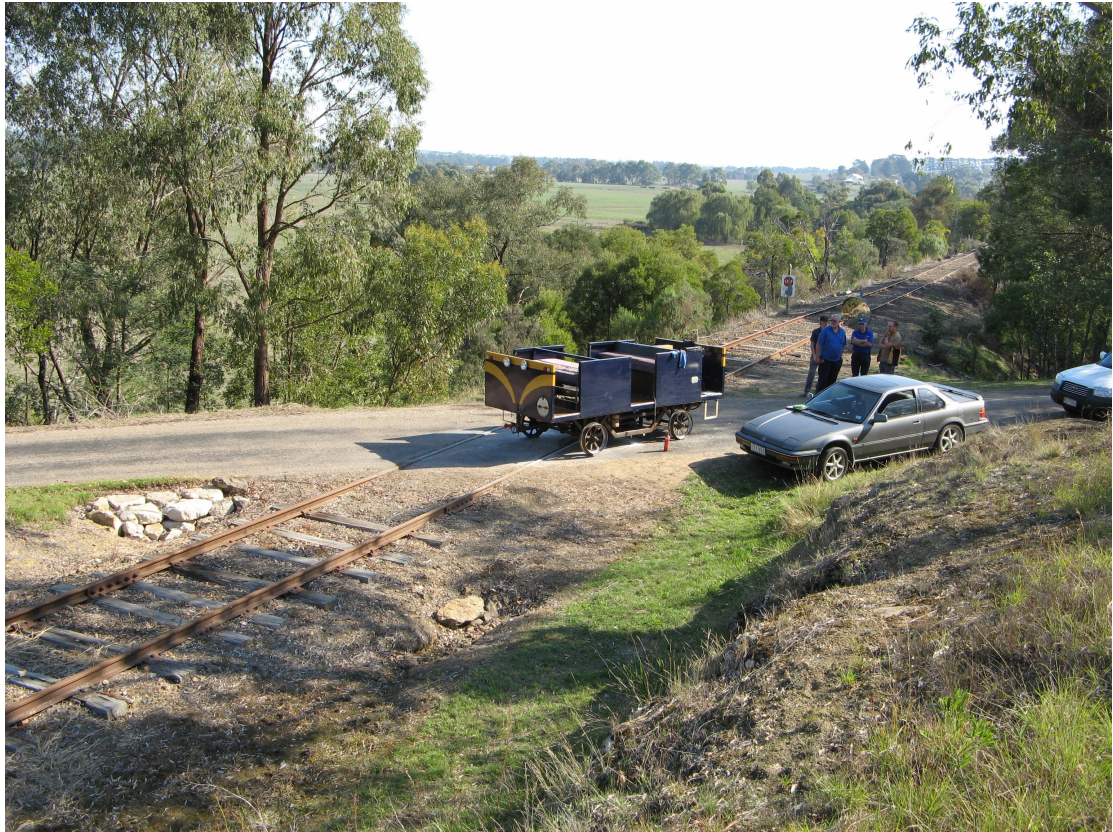
As a result of the collision the trolley was derailed but remained upright. When the motor vehicle collided with the motor trolley the impact caused an electrical fire on the trolley which was quickly extinguished by the trolley driver.

collision. He said that he felt the trolley being lifted in the air and carried sideways by the car until the trolley came to rest in a derailed state at an angle to the track. As a result of the collision a small fire broke out under the front of the trolley which he extinguished.

Figure 1 - View of post collision location of PM16

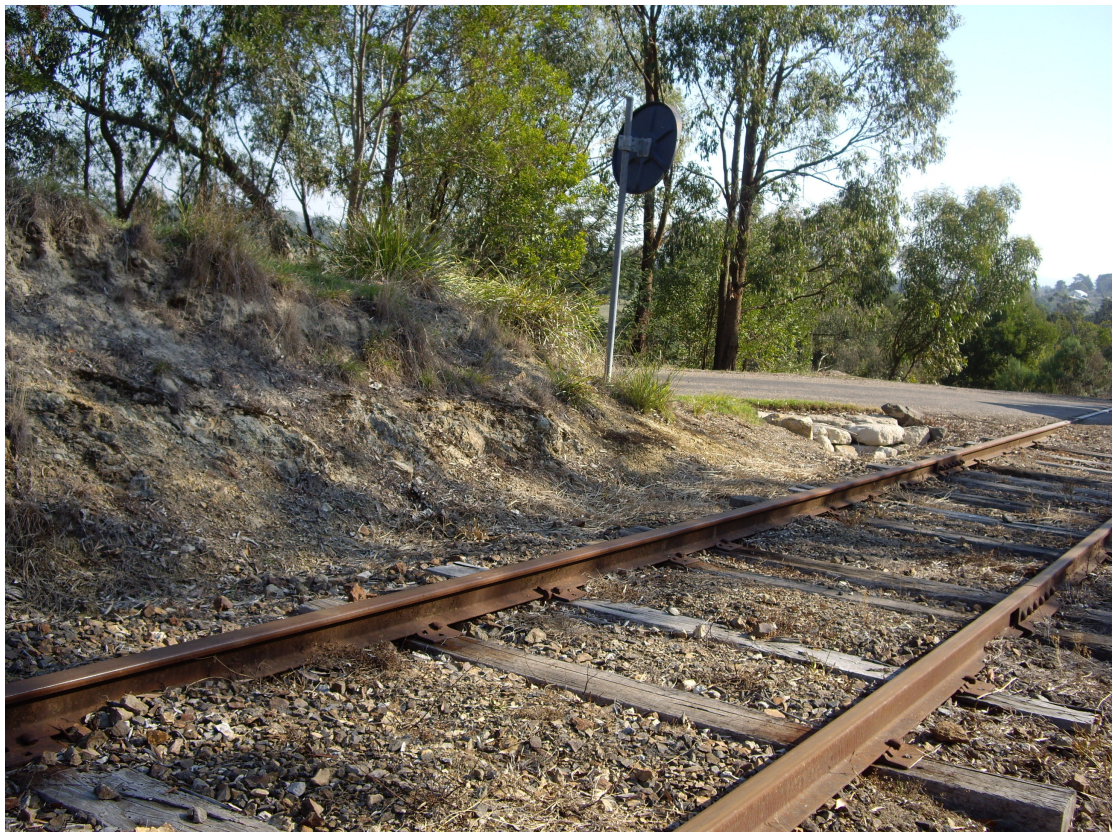
For rail vehicles approaching the crossing from Healesville, a whistle board was located 221 metres prior to the crossing and a five mile per hour (eight km/h) speed restriction sign was located 85 metres before the crossing.

Rail traffic from Healesville approaches the crossing through a cutting on a descending gradient of 1:40 with visibility restricted by embankments and vegetation.

Figure 2 - Rail approach view of level crossing
