Office of the Chief Investigator
Transport and Marine Safety Investigations

**Rail Safety Investigation
Report No 2008/12**

**Derailment
Ballast Train**

Longwood

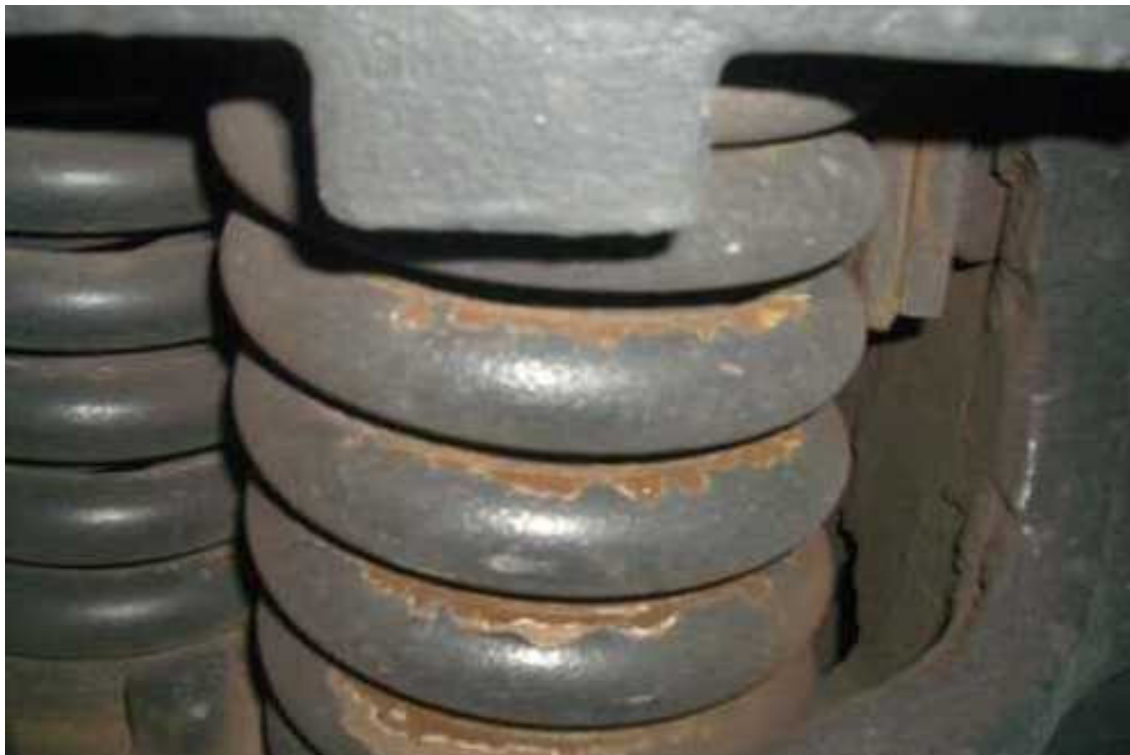
The ballast wagons were observed to be fully laden and in some cases the load uneven. There was evidence of bogie spring coil binding³ having occurred on the ballast wagons, indicating that the suspension of the bogies had been, at times, worked to their limits of compressibility. The ballast plough/equipment van and the ballast plough wagon were observed to have their ploughs raised clear, secured and padlocked.

Figure 4 – Typical ballast wagon bogie suspension spring showing evidence of spring coil binding

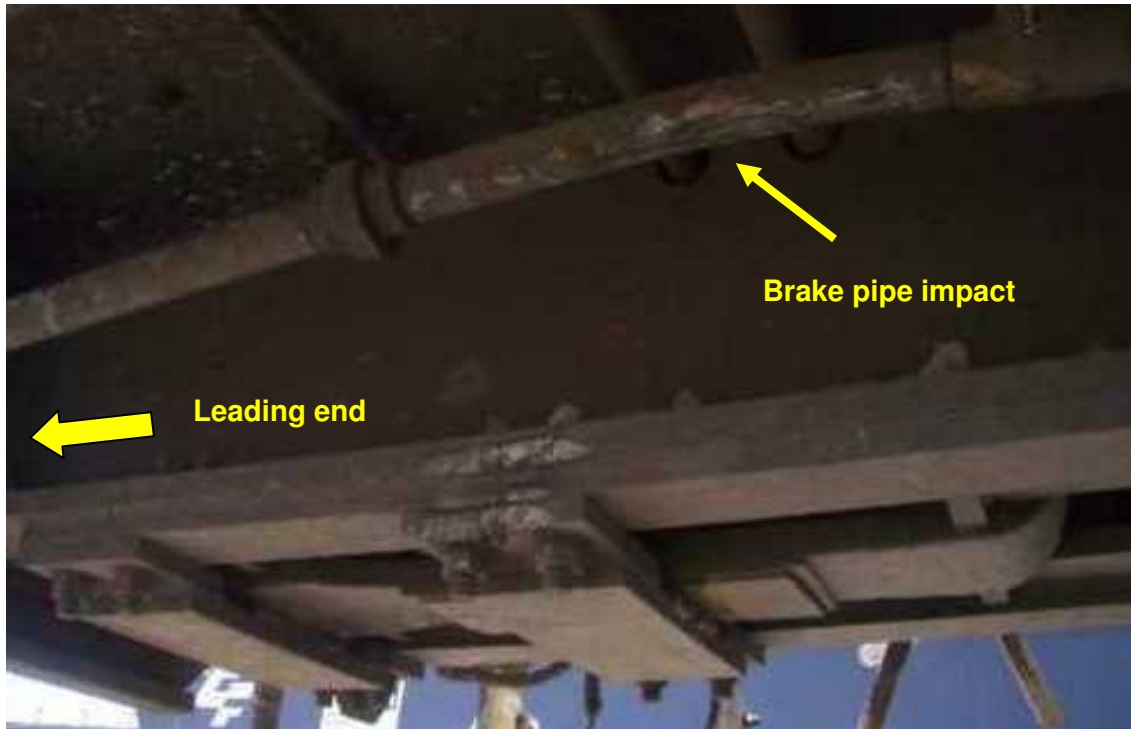
The body and under-frame of the ballast wagon had suffered localised damage during the incident. The brake pipe beneath the hopper had suffered impact damage from the leading bogie resulting in the separation of a brake pipe fitting at the triple valve pipe bracket on the left-hand side of the leading end of the wagon. Other damage included a puncture of the hopper slope sheet caused by the frame of the leading bogie.

Figure 5 – Impact to the brake pipe under the body of the ballast wagon

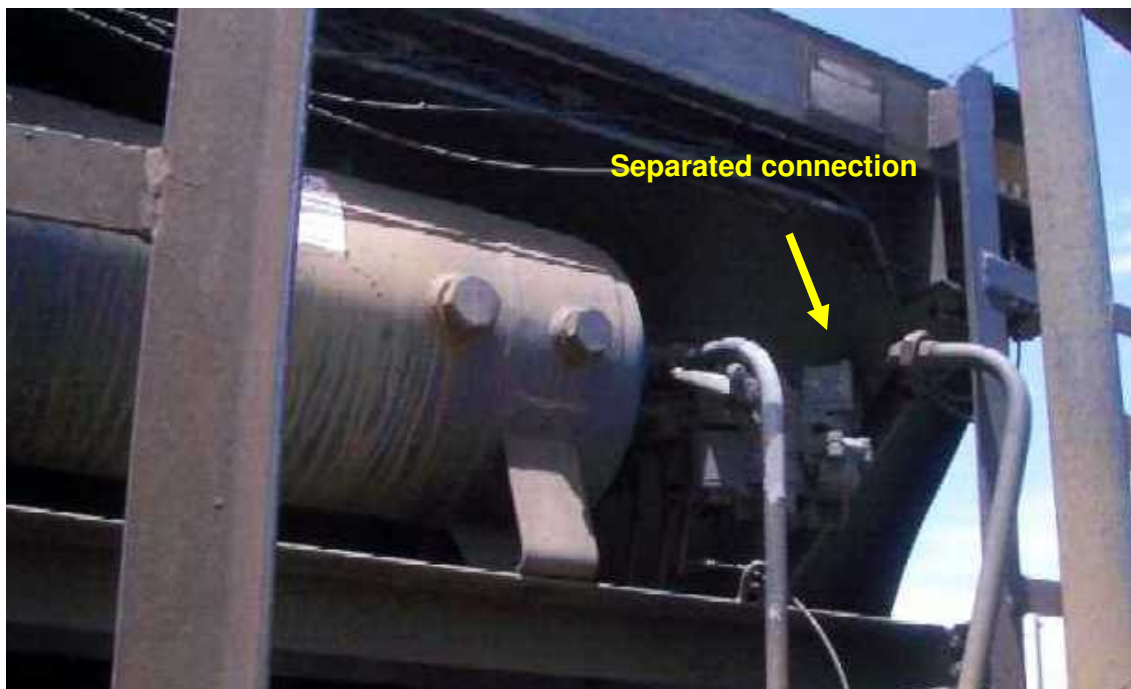
Figure 6 – Separation of brake pipe fitting, leading end of ballast wagon NDF2223S

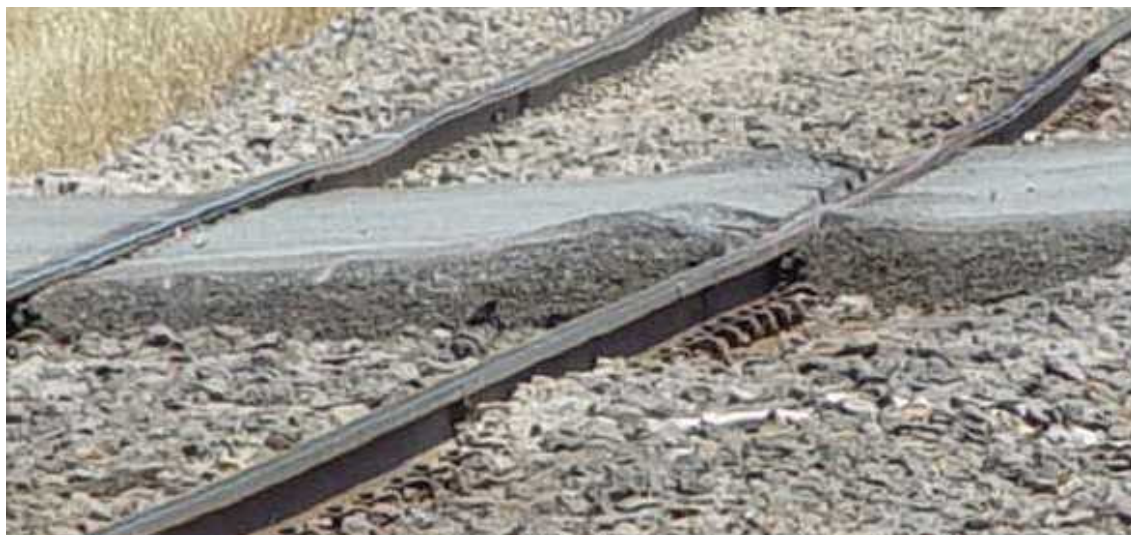
There were no significant or obvious geometric defects visually identified in the track approaching the Down Street level crossing. At the level crossing and beyond, there were indications of geometric irregularity.

Figure 7 – Track through the Down Street level crossing (photograph enlarged to show detail and may exaggerate track irregularities)

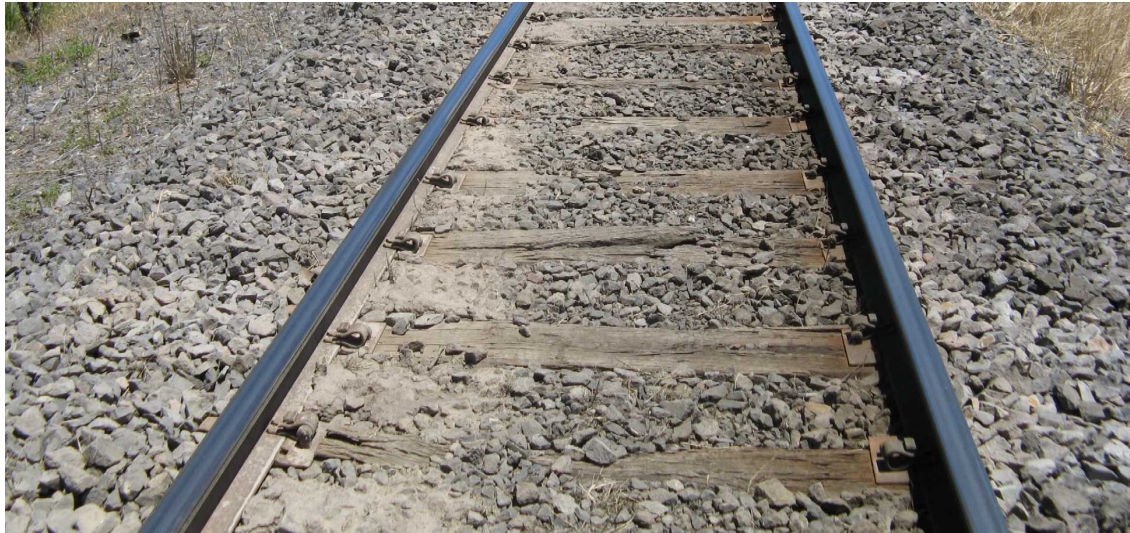
The ballast on the Melbourne side of the Down Street level crossing was fouled with mud, particularly around the left-hand (Up) rail. This fouling was particularly evident between the crossing and the point of flange-climb.

Figure 8 – Ballast condition on Melbourne side of Down Street level crossing, looking south

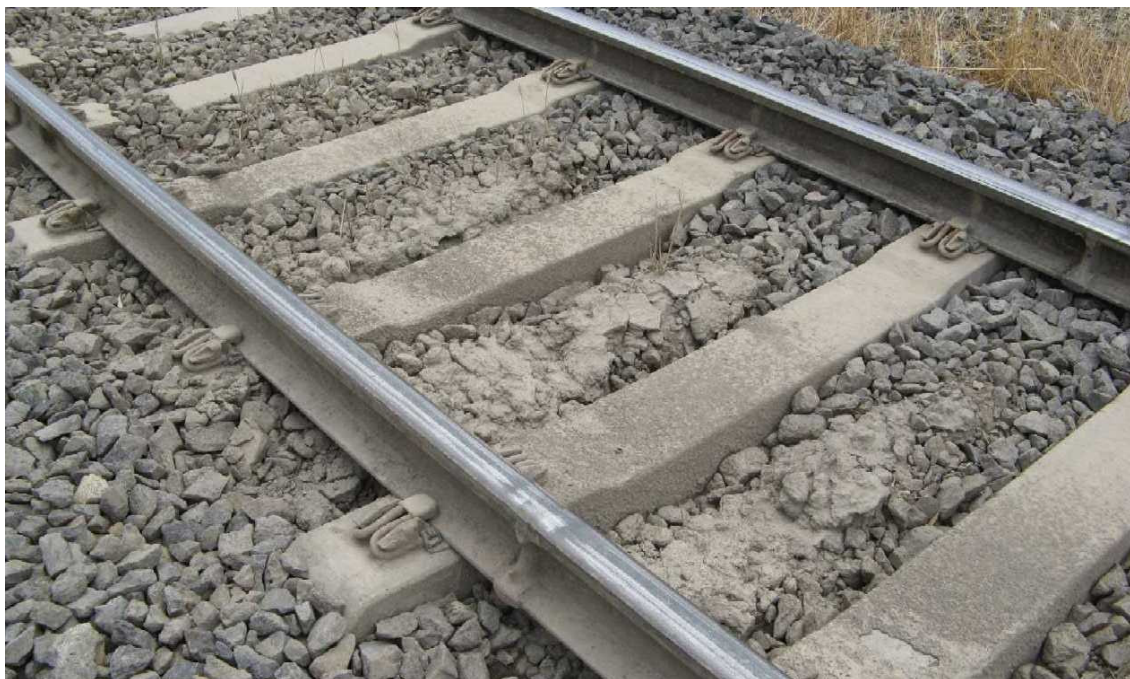
The location was re-inspected in November 2009 after its restoration. The ballast was found to be fouled with mud in a similar location to that previously identified at the incident site. There was also evidence of mud pumping⁷ resulting in mud and moisture in the formation rising to the surface and indicating poor drainage.

Figure 9 – Repaired track 10-15 metres south of the level crossing (photograph November 2009)

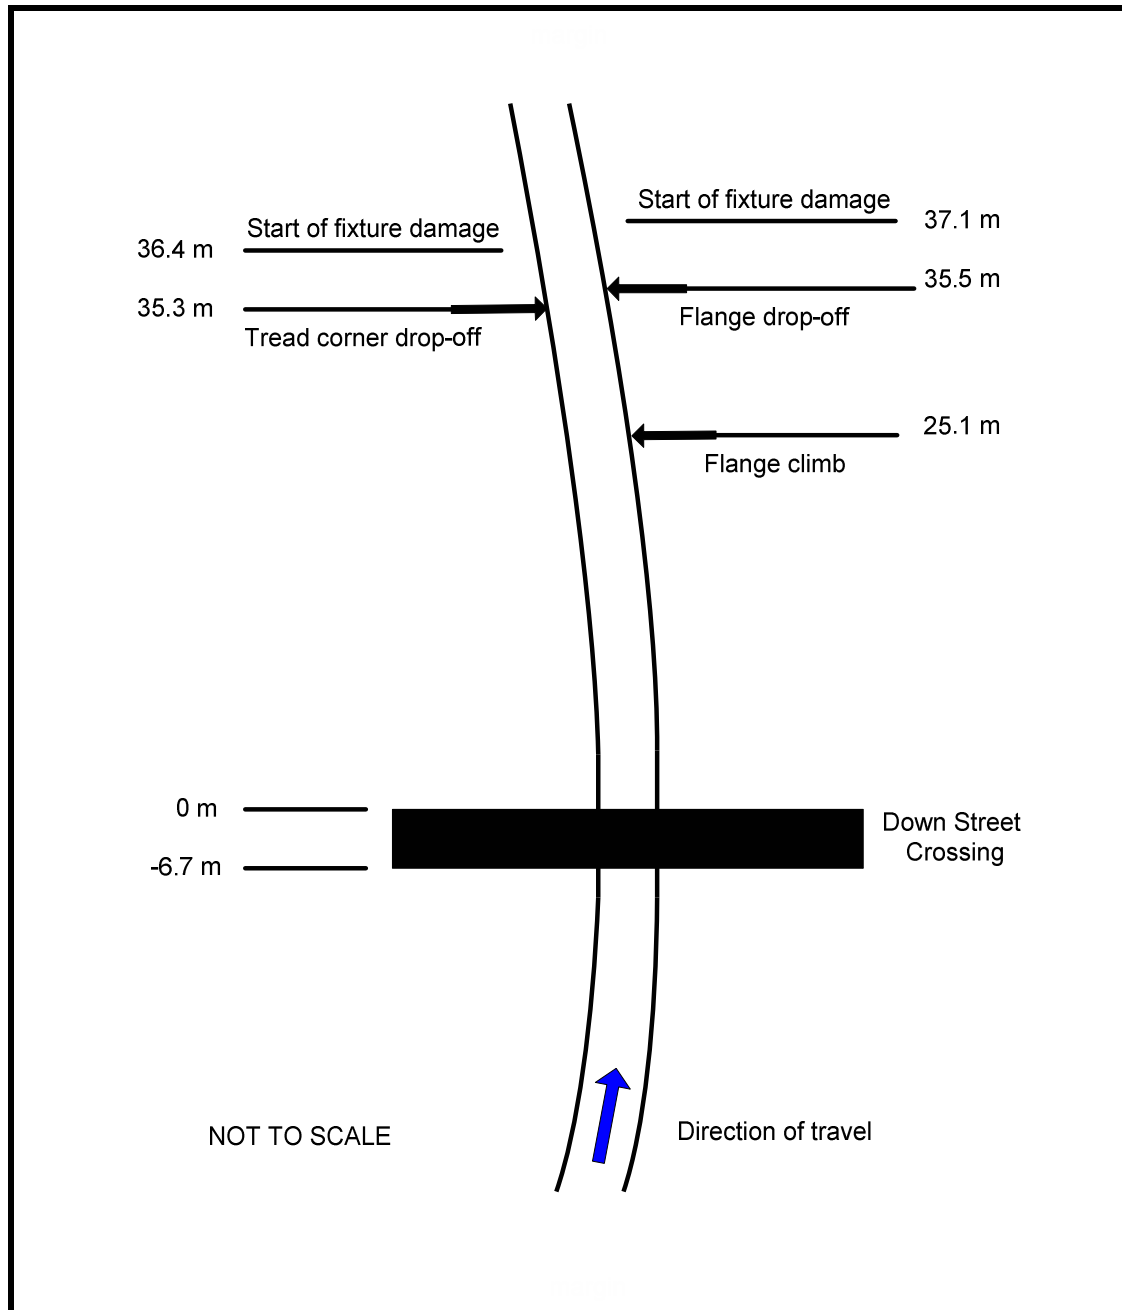
There was clear evidence of flange-climb on the right-hand-side rail when viewed in the direction of travel, commencing about 25 metres after the southern edge of the sealed level crossing. The flange drop-off point and the corresponding tread corner drop-off on the left-hand rail were also clearly evident.

Figure 10 – Critical points of the first derailment

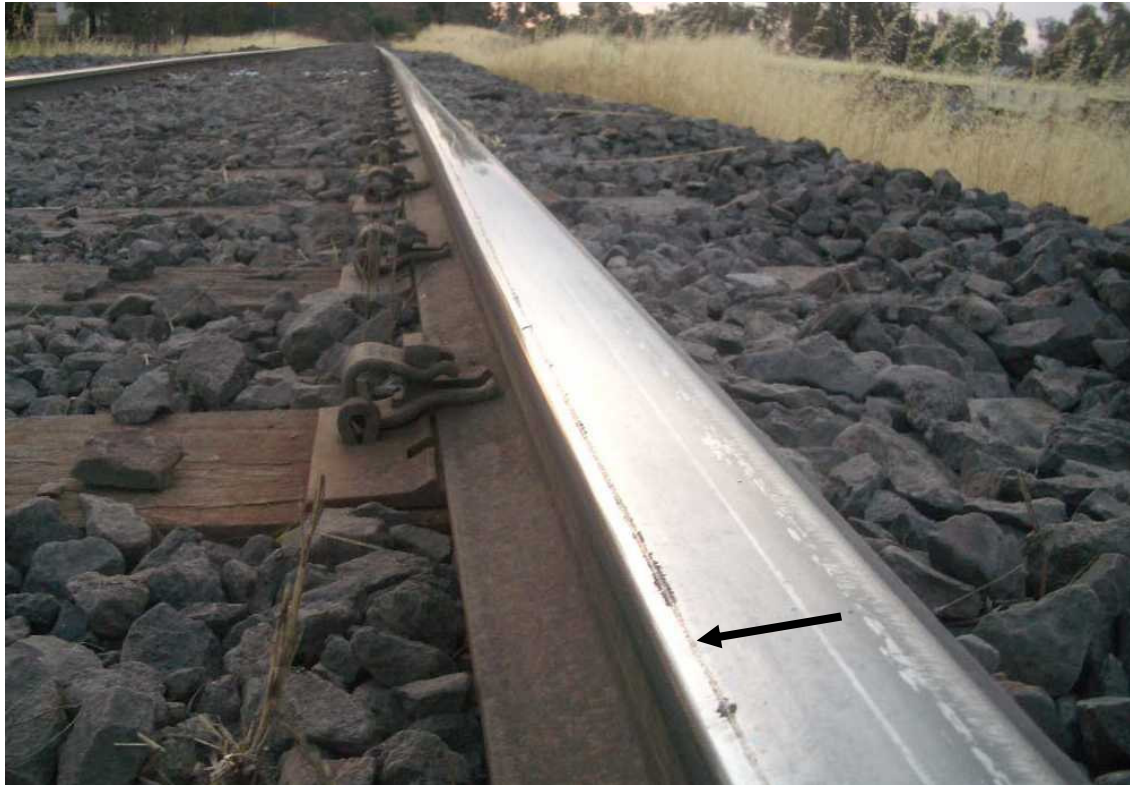
Figure 11 – Flange mark on right-hand rail head extending about 10 metres to the point of drop-off

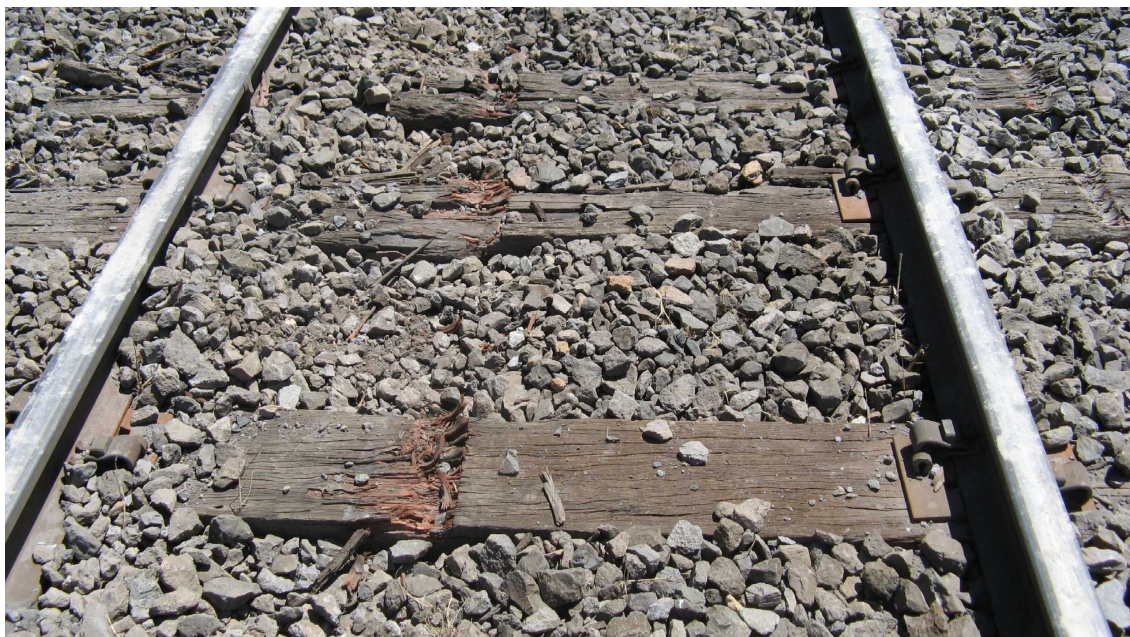
Initial damage to sleepers and track fastenings was light. Track damage commenced about a metre after both wheels of the first wheel-set had derailed. There was also evidence of crushed sleeper and ballast material on the railheads indicating on-rail wheels trailing the derailed wheels.

Figure 12 – Typical wheel marks after initial derailment and prior to the first rail fracture

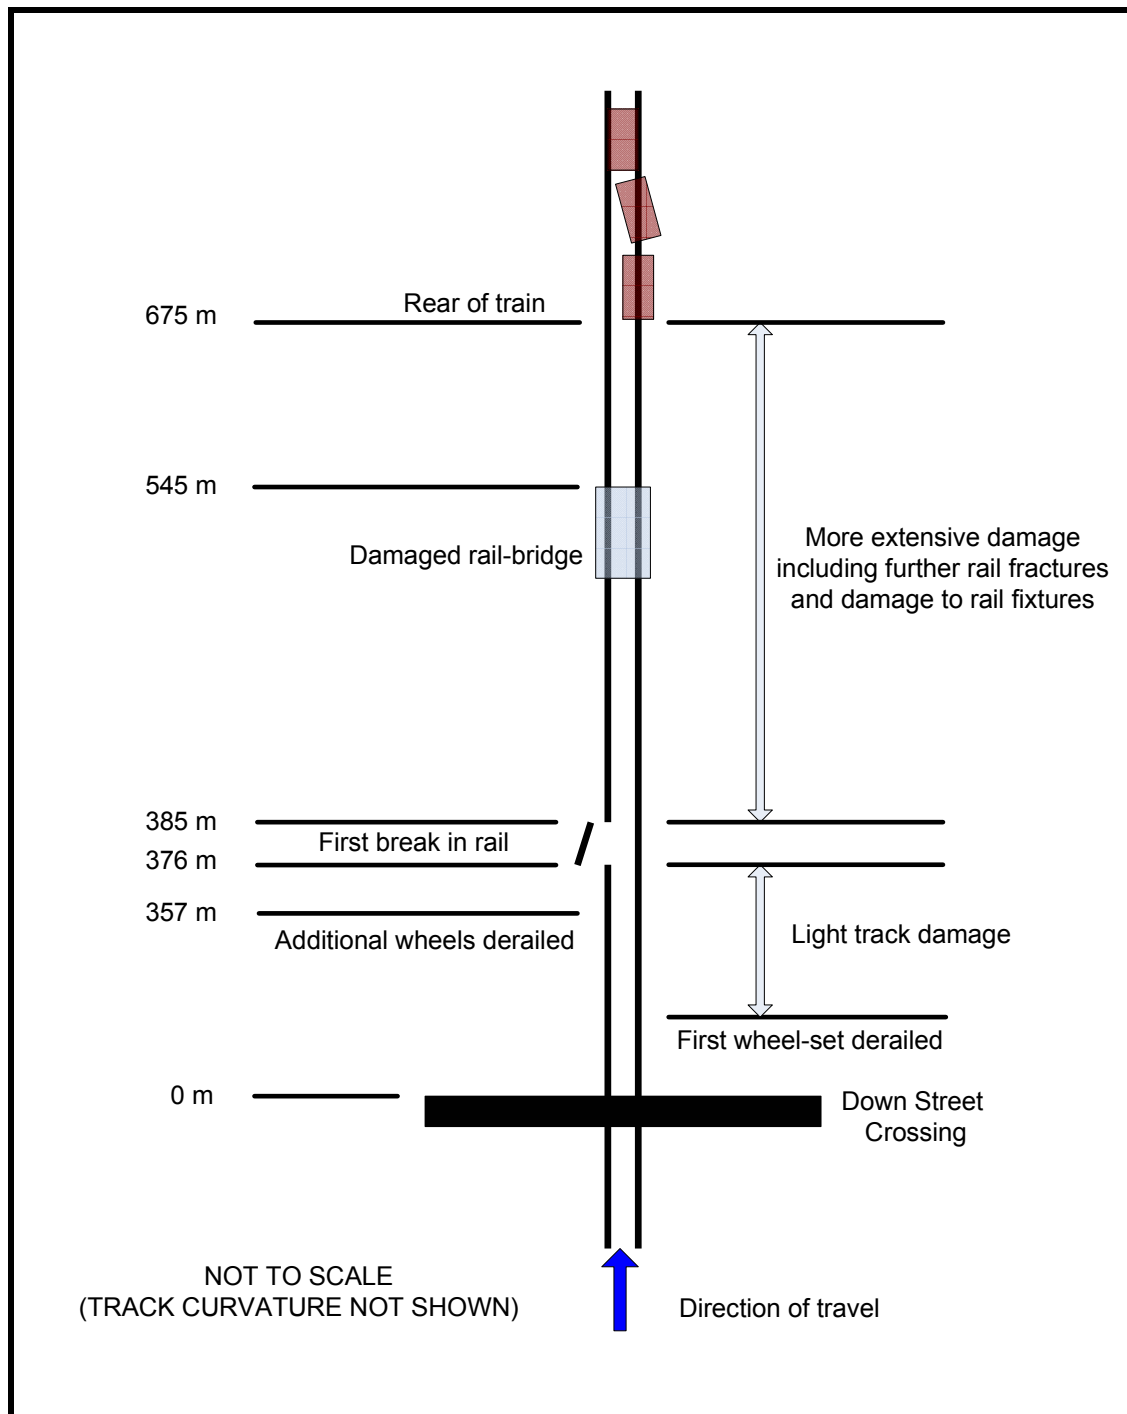
Figure 13 – Location of key features following the derailment of the first wheel-set

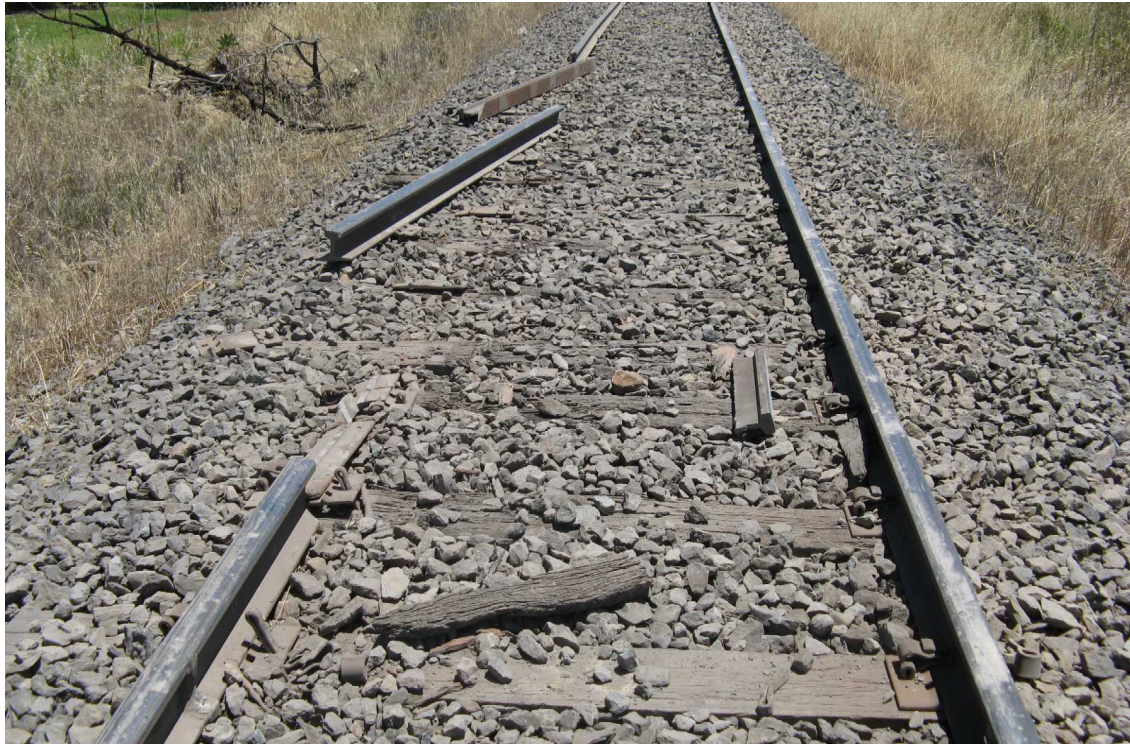
About 357 metres from the southern edge of the Down Street level crossing, there was evidence of additional wheels having derailed. A further 19 metres along, the left-hand rail was fractured resulting in a gap in the rail of about nine metres in length.

Figure 14 – First rail fracture, about 376 metres after the Down Street level crossing

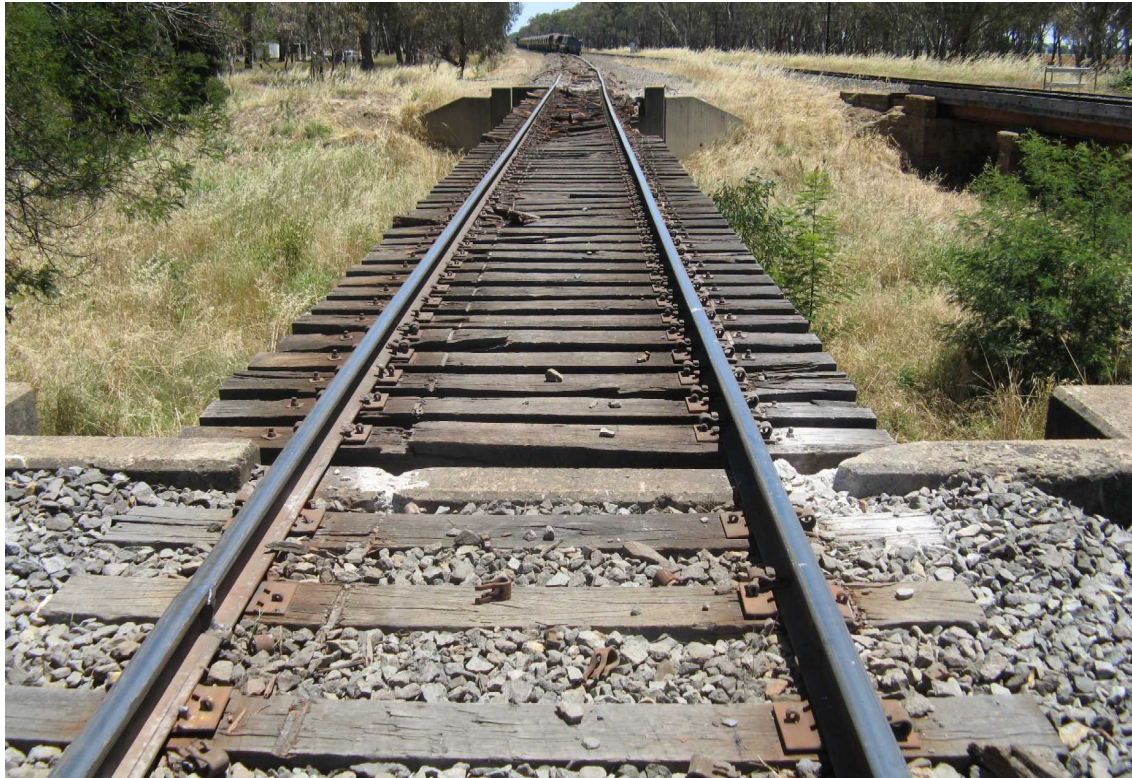
The railway bridge passing over Pranjip Creek had suffered significant damage. The damage on the northern, approach-end of the bridge was relatively light, apart from impact damage on the right-hand-side concrete abutment. There was also impact damage to the inner fixtures of the left-hand rail, although further onto the bridge the track was within gauge. The southern end of the railway bridge suffered severe damage to the sleepers and impact damage to the right-hand-side concrete abutment.

Figure 15 – Damage to the approach end of the railway bridge

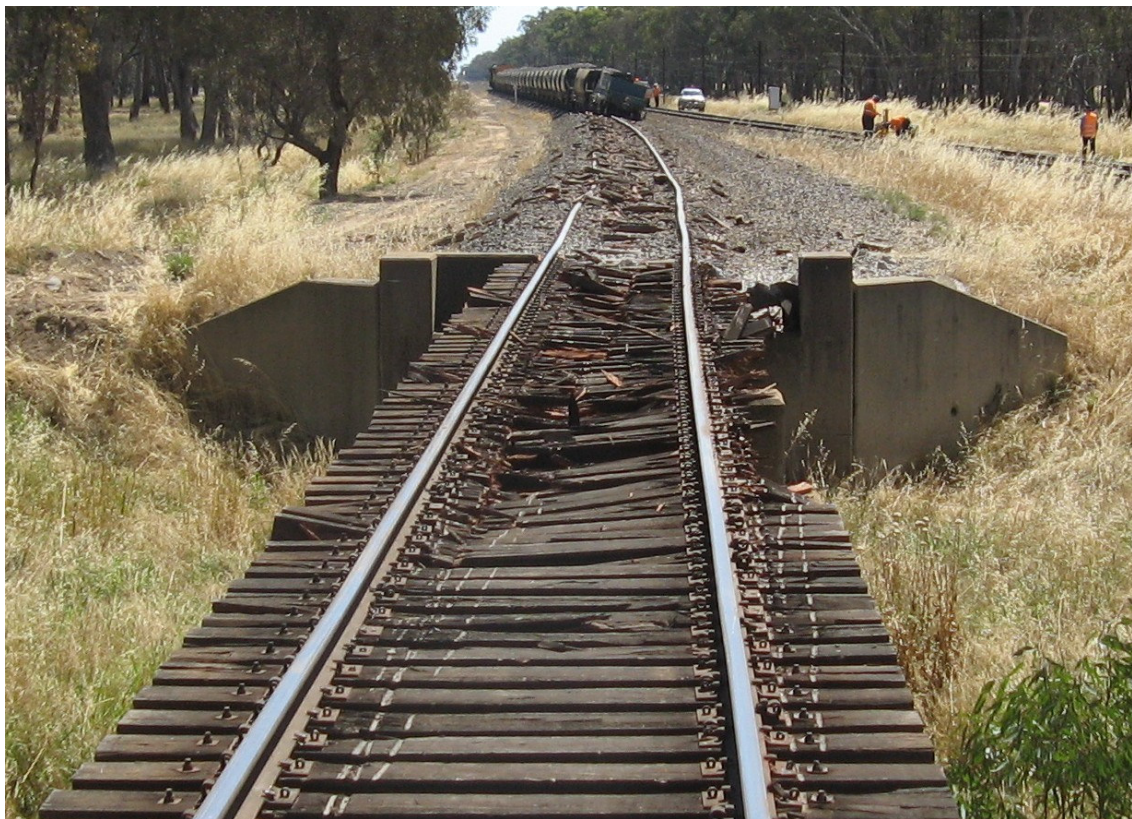
Figure 16 – Damage to the departure end of the railway bridge

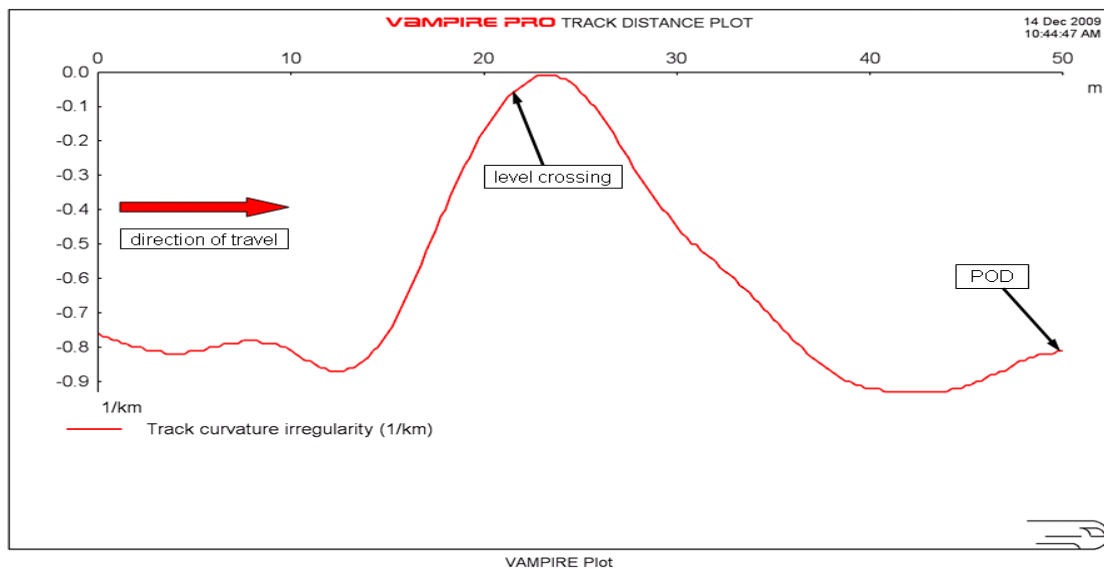
The straightening of the track through and shortly after the level crossing, as indicated by the versine¹³ data, is a deviation from the design curvature and is also effectively a track irregularity. The track had a left-hand curve of around 1200 metres radius prior to the crossing, straightened, then returned to a left-hand curve after the crossing.

Figure 17 – Track curvature irregularity in the approach to the point of flange climb (marked POD)
