Office of the Chief Investigator
Transport Safety

**Rail Safety Investigation
Report No 2009/14**

**Passenger Fatality
Connex Melbourne Ltd
Melbourne Central Station
(Melbourne Underground Rail Loop)
20 October 2009**

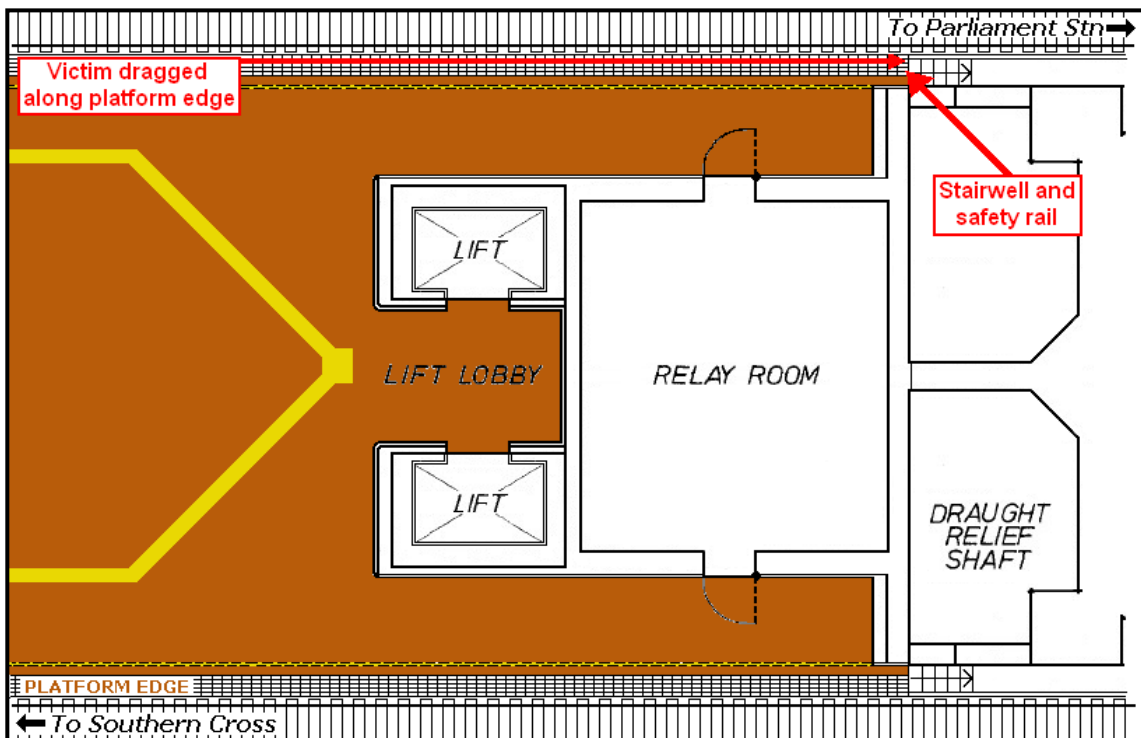
Two seconds after the train commenced to move, the male passenger was observed to force open the leading right-hand (in direction of travel) passenger saloon doors of the last car and attempt to alight. His companion followed and fell over him and onto the platform, but the man's left leg dropped between the platform and the train and was trapped as the train gathered speed. The door closed and the man was left in a seated position on the platform edge (coping strip) with his body against the side of the car. He was dragged along the platform edge with his right leg extended in front, and holding a bottle in his right hand. He slid on his buttocks in this position for the remaining length of the platform until striking a safety-handrail post at the top of the access stairway at the platform extremity, then to the ground (the track structure) and beneath the train. The speed of the train at this point would have been in excess of 50 km/h.

Figure 1 – Plan of Melbourne Central Station platform incident location.

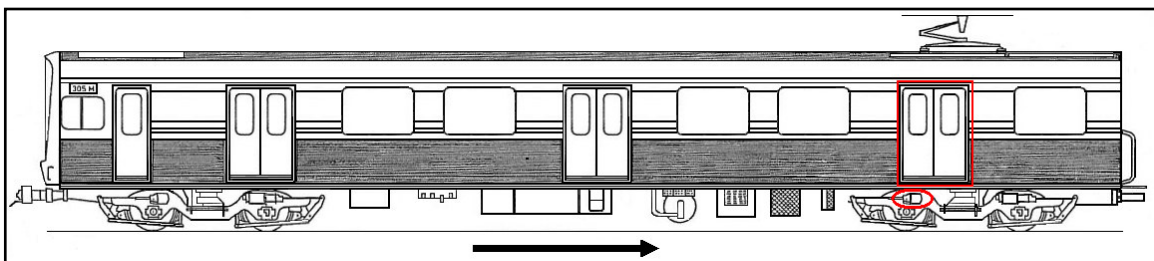
A bogie-mounted brake cylinder and piston assembly is located immediately below the door tread of this passenger saloon access door and below platform surface-level. This apparatus is part of the train's braking system. The brake cylinder casting includes — at its free end — alternative attachment points for the air-line connection. One of these is utilised with a flexible hose attachment and the other is plugged (refer to photo at Figure 4). Images of the brake cylinder display fresh scuff marks.

Figure 3 – Comeng motor car, showing door used by victim and proximate car brake cylinder (see photo below).

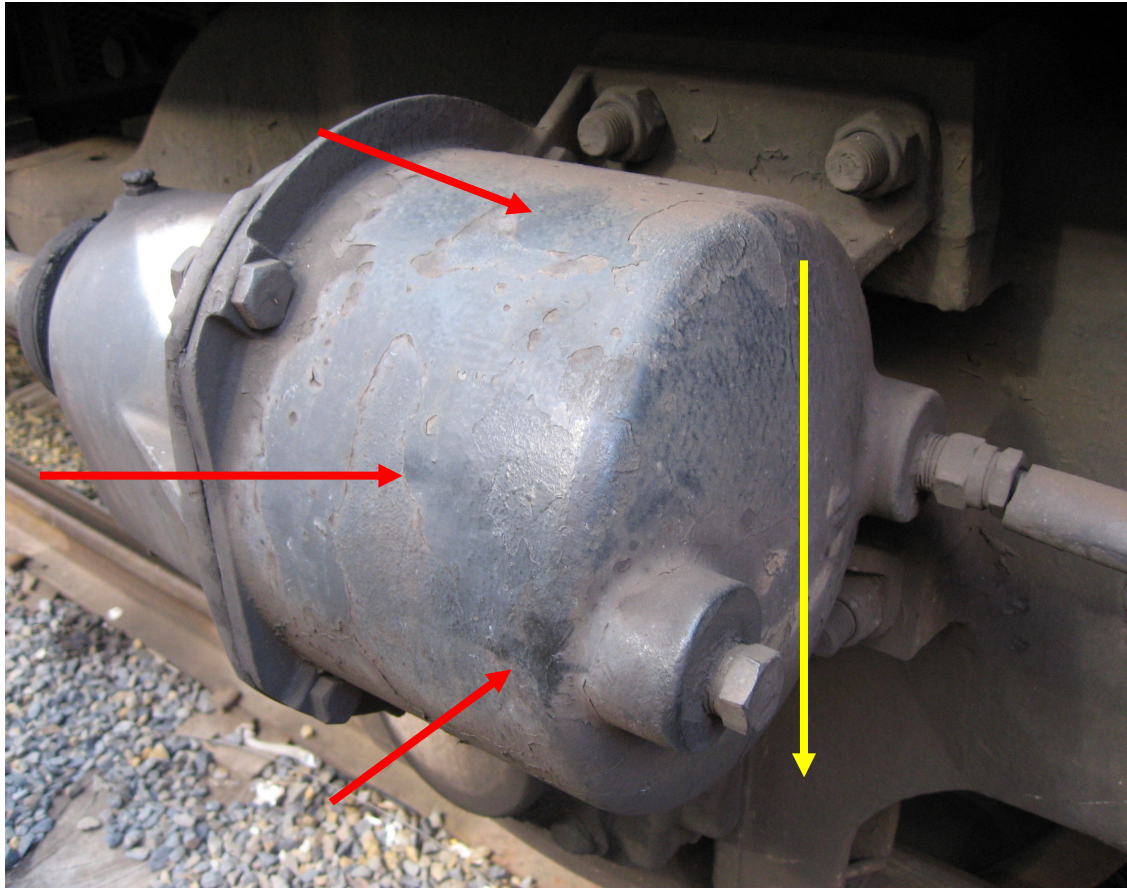
Figure 4 – Bogie-mounted brake cylinder photographed post-incident. Red arrows show fresh scuff marks on the cylinder casing. Yellow arrow between air hose attachment points shows relative position believed assumed by victim’s leg.

When the victim's leg slipped into the gap between the platform edge and the train, it would likely have been against the free end of the brake cylinder located below the doorway and laterally between this cylinder's air supply hose and the matching plugged attachment point. Scuff marks expected to have been made by footwear and/or clothing have 'polished' the brake cylinder surface in places consistent with the likely movements of the victim's foot and leg relative to the position of the brake cylinder.

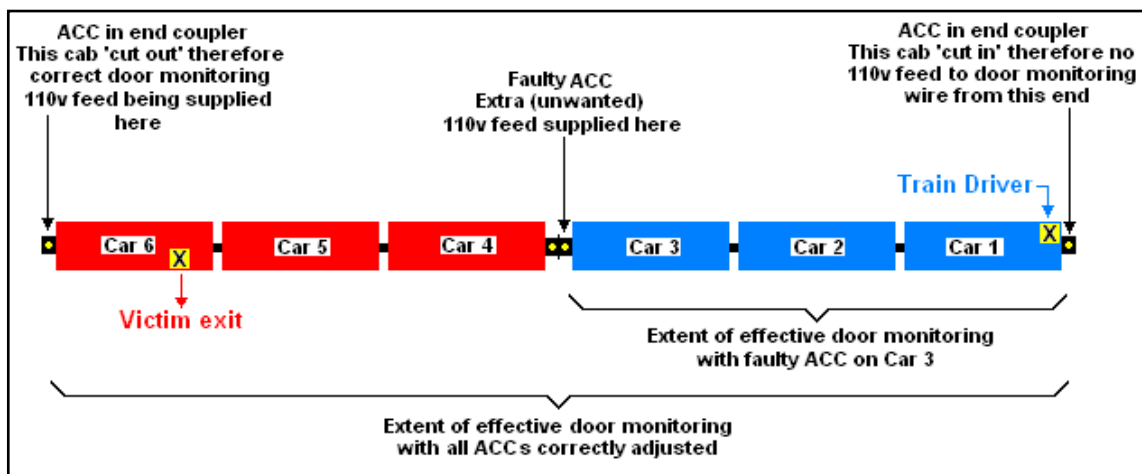
Figure 5 – Depiction of trainlined door monitoring circuit.

In this incident, the Coupler Plunger Striker Arm in the ACC in the end-coupler of the third car (refer to Figure 5) had been incorrectly adjusted such that although the coupler was in its *coupled* state, the ACC remained closed providing an intermediate feed onto the door monitoring wire. Since the location of this intermediate feed was *ahead* of the point on the door monitoring wire at which the interruption had been caused by the open door (at car 6), its presence acted to maintain the voltage on the wire. The result was that the system — monitored at the active driver's cab — did not detect a voltage drop and therefore did not provide a warning indication to the driver.

In this incident, the faulty ACC permitted a second (undesirable) 110 VDC feed to the door monitoring wire. Since this feed was between the disruption to the wire caused by the opened door and the point of detection at the front of the train, it acted to maintain the voltage on the wire — in effect masking the fact that a door had been opened.
