**Rail Safety Investigation  
Report No 2010/06**

**Train-to-Train Collision**  
**Metro Trains Melbourne Train 5863**  
**Pacific National Train 9319**  
**Between Roxburgh Park and Craigieburn**  
**4 May 2010**

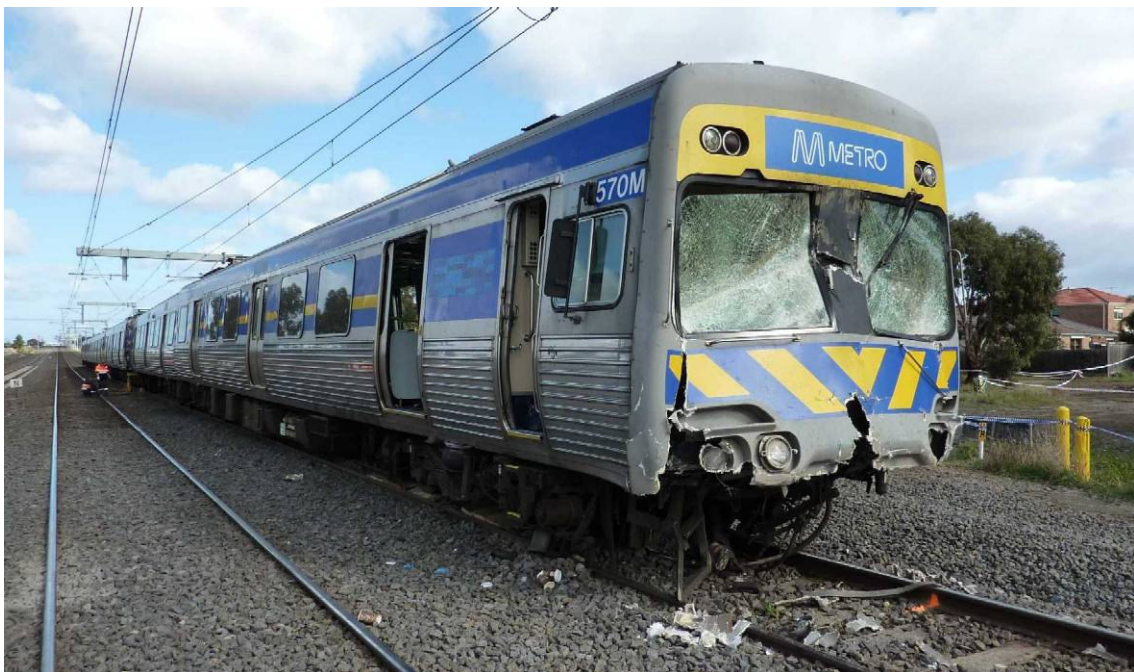
Figure 7 – The suburban train in its final position following the collision.

The damaged condition and location of both trains was consistent with the suburban train having impacted the rear of the freight train and shunted the freight train forward. The front of the suburban train had come to a stand about 20 metres past the 24 kilometre marker post with the rear wagon of the freight train about 15 metres ahead. The freight train's ETM had been destroyed and was located between the rails of the Down track about 5 metres ahead of the suburban train.

Damage to the suburban train had occurred predominantly to the leading car-set. The front face of 570M was damaged as a result of direct impact with the trailing wagon of the freight train, including extensive damage to the coupler, headstock and underframe indicating significant load transfer occurred through these structures.

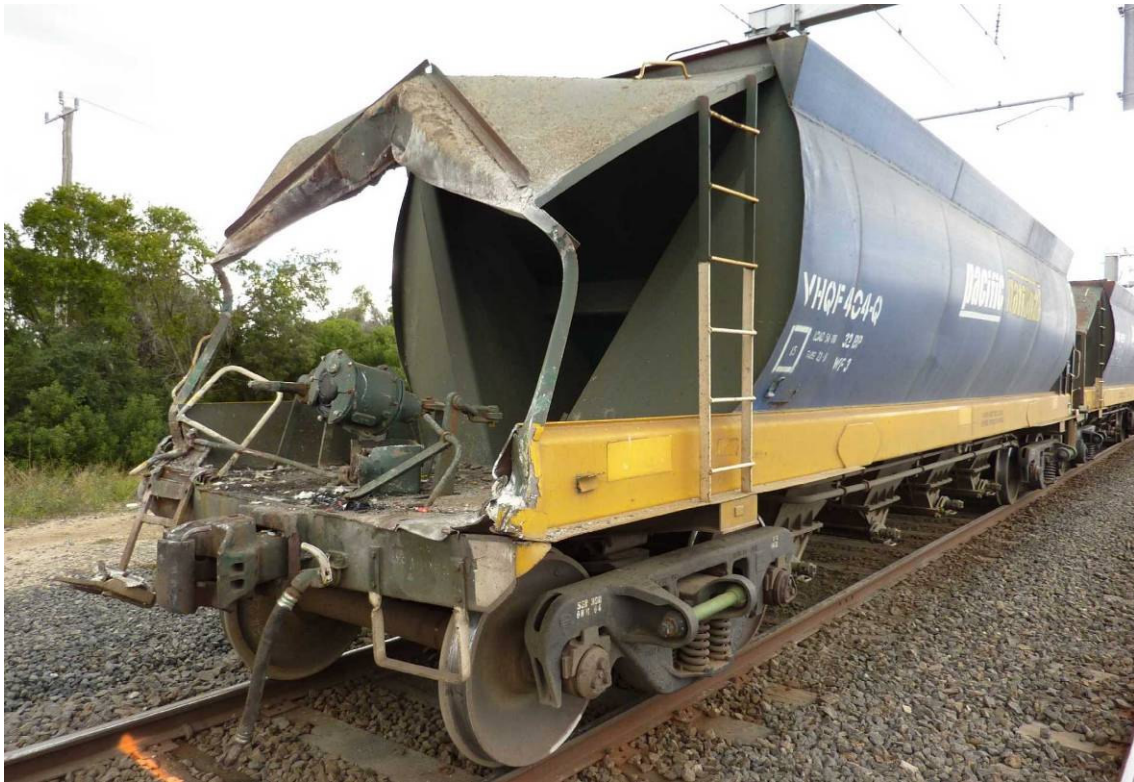
Figure 8 – Trailing freight wagon damage.

The trailing wagon of the freight train also suffered significant direct impact damage including damage to the brake equipment canopy and brake equipment located beneath it.

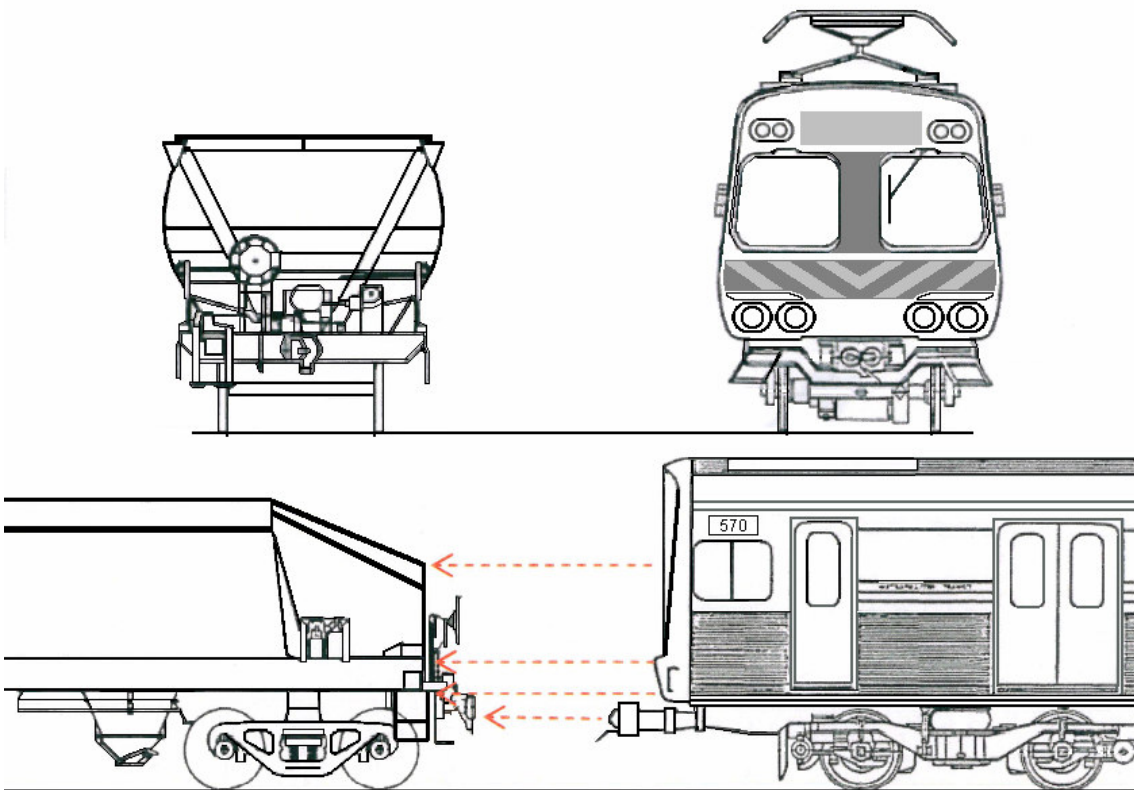
Figure 9 – Alignment of impact points.

The damage marks on the front of 570M and the rear of the freight wagon, suggested that there was not significant relative override during the impact. Loads would have been predominantly transferred through couplers and stiff in-line underframe structures. A small amount of lifting of the leading end of the suburban train is likely to have occurred during the collision and would account for the derailment of the leading bogie.

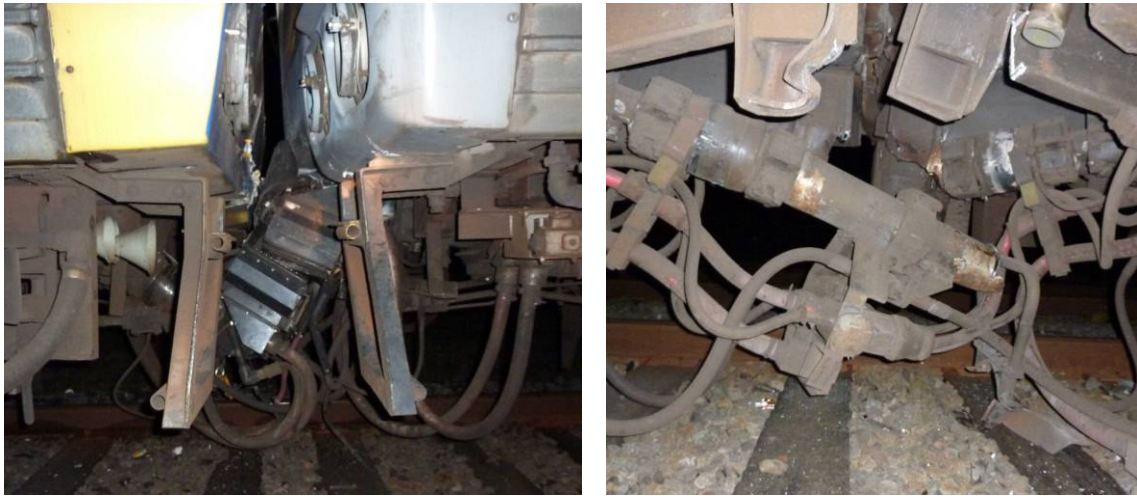
The semi-permanent couplings between the cars of the leading set had collapsed and the car ends were together. The multi-function coupler between the two car-sets had also collapsed. Other than minor damage to the leading face of 310M, there was no observable damage to the trailing car-set structures.

Figure 10 – Multi-Function coupler between 661M and 310M (left) and Semi-Permanent between 570M and 1135T (right).

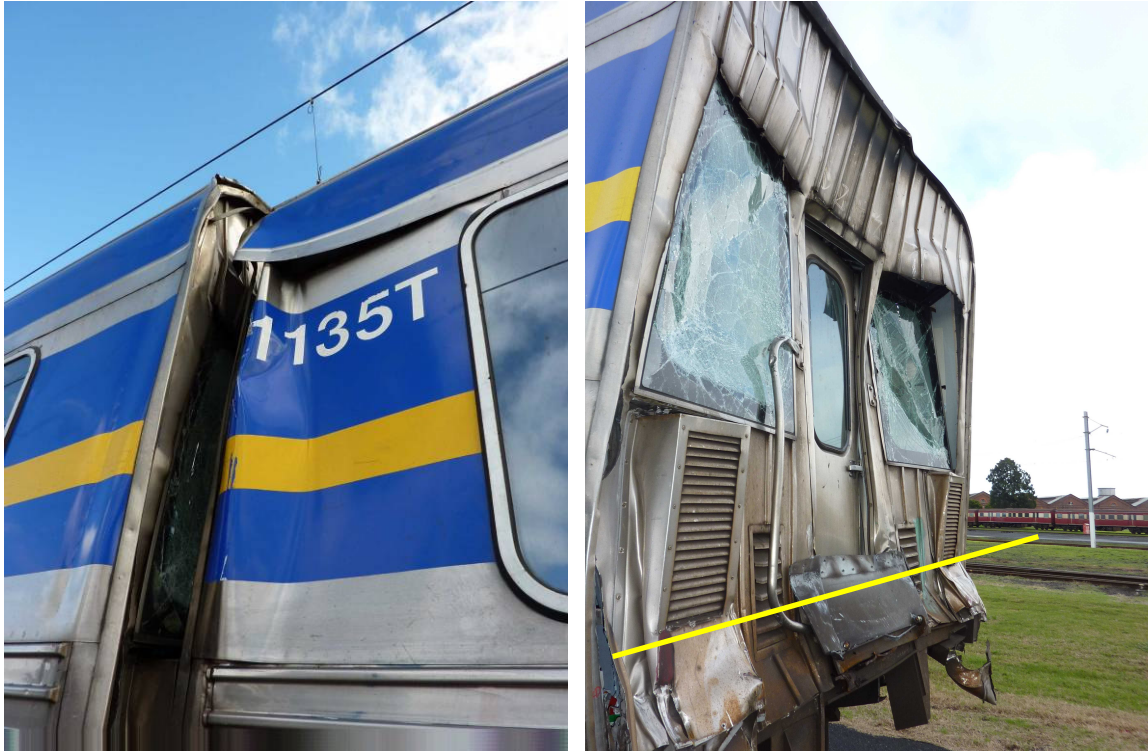
Whereas the relative climb between the lead car, 570M, and the second car, 1135T, was not significant, 1135T was found to have climbed around 400 mm above the third car, 661M. The consequence of the override by car 1135T was significant structural damage to the leading end of car 661M. The collision posts had been rotated backwards with the top connections detached. The rear-facing seats adjacent to the leading bulkhead had also been pushed backward, ceiling panels had cracked and were dislodged and the Passenger Information Display System (PIDS) Internal Display Unit (IDU) was detached and hanging by electrical cables.

Figure 11 – Car 1135T impact on 661M and evidence of override crease in 661M (right).

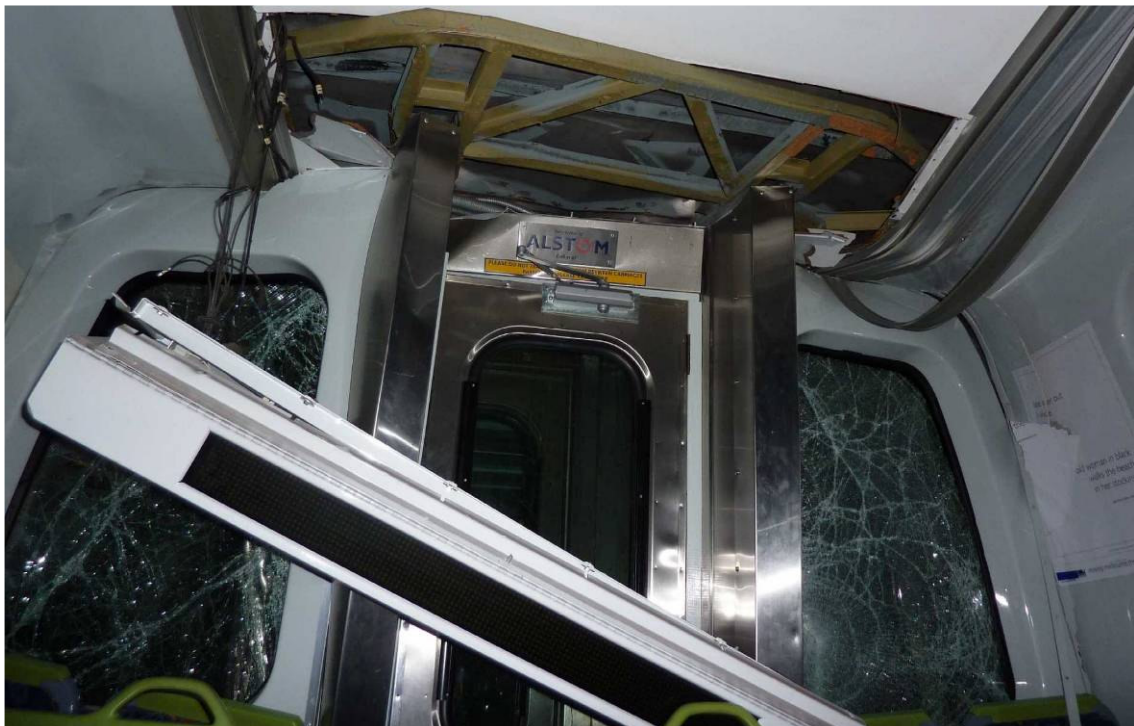
Figure 12 – Leading end of 661M showing structural distortion and dislodged PIDS Unit.

Car 661M received some of the more severe internal damage, particularly its leading end which suffered significant structural deformation, with the collision posts being pushed back as a result of the override by car 1135T. The glass of shattered windows had remained in place. In addition to the detachment of the PIDS unit from the overhead, a light fitting had detached with evidence of poorly located rivet holes on the mating surface.

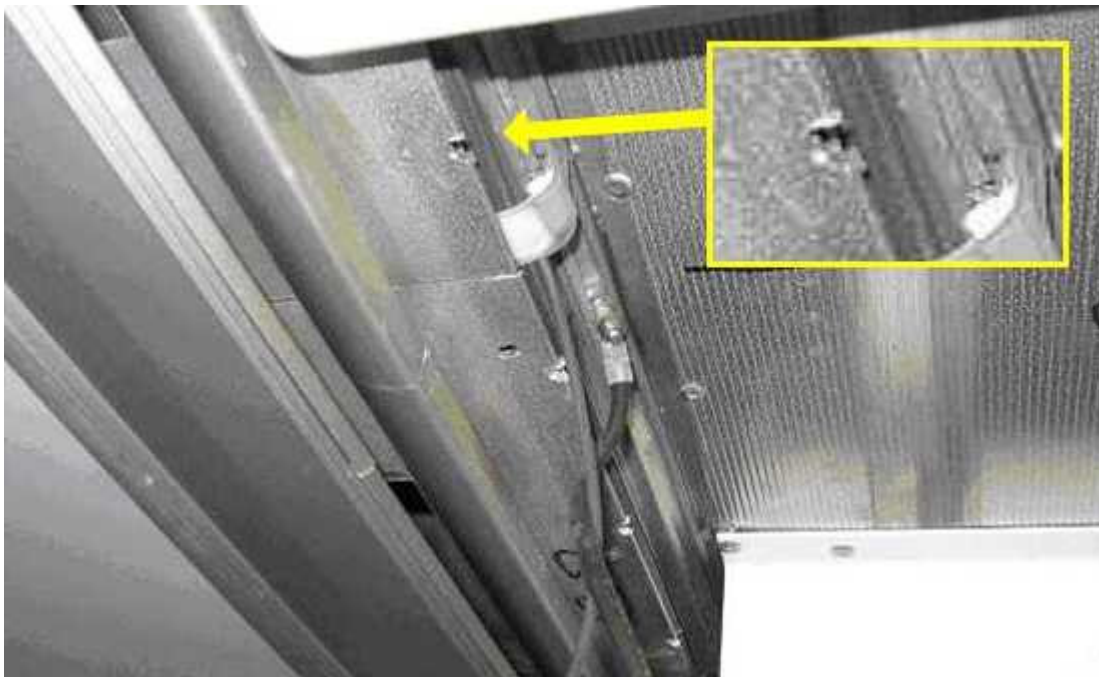
**Figure 13 – Poorly located rivet holes on mating surface associated with some detached light fittings.**

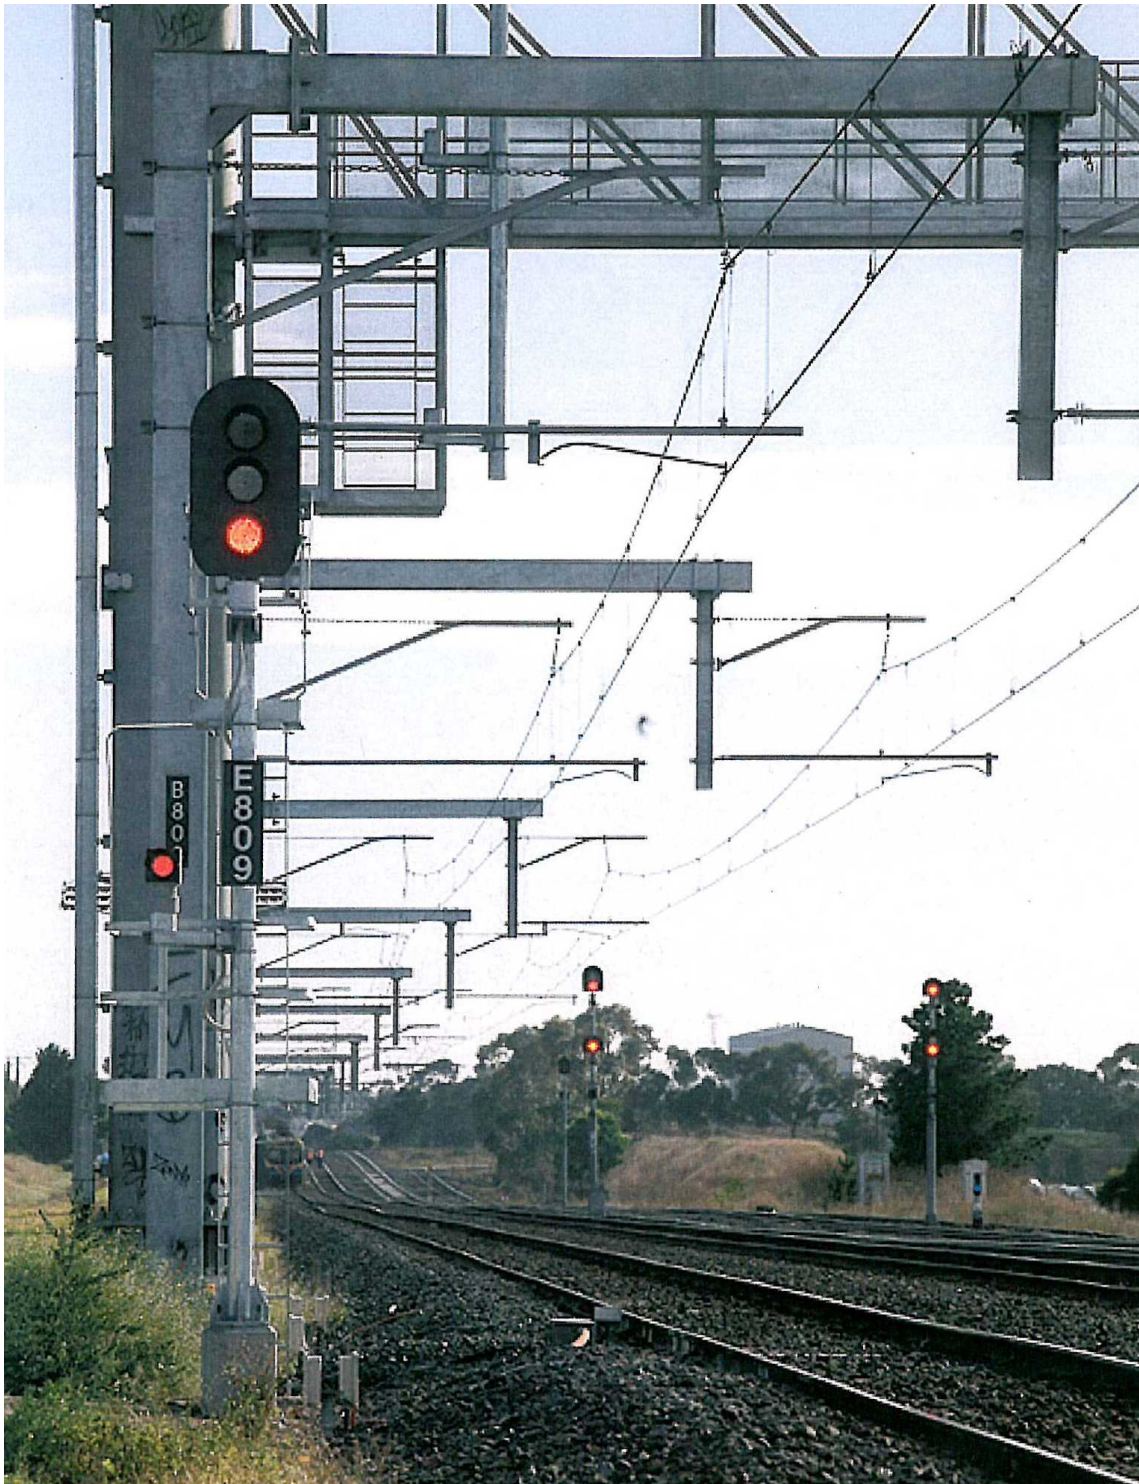
Figure 19 – Automatic signal E809 courtesy of C. Gordon.

Automatic signal E809 was observed displaying a stop aspect with the automatic train stop in the raised position.

Signal E809, a three-position Down automatic signal (see Figure 19), is situated about 1,183 metres on the Up side of signal CGB539 (see Figure 18) and was commissioned during November 2009 as part of the upgrade. It is fitted with LEDs which have a medium spread and a nominal sight distance of 600 metres. A signal sighting inspection involving engineering and operational personnel from MTM and V/Line conducted during March 2010 identified that previous issues with this signal had been addressed and that the focussing and performance of this signal was satisfactory.
