Office of the Chief Investigator  
Transport Safety

**Rail Safety Investigation  
Report No 2012/07**

Collision  
Truck and Passenger Train  
Abbotts Road Level Crossing, South Dandenong  
3 November 2012

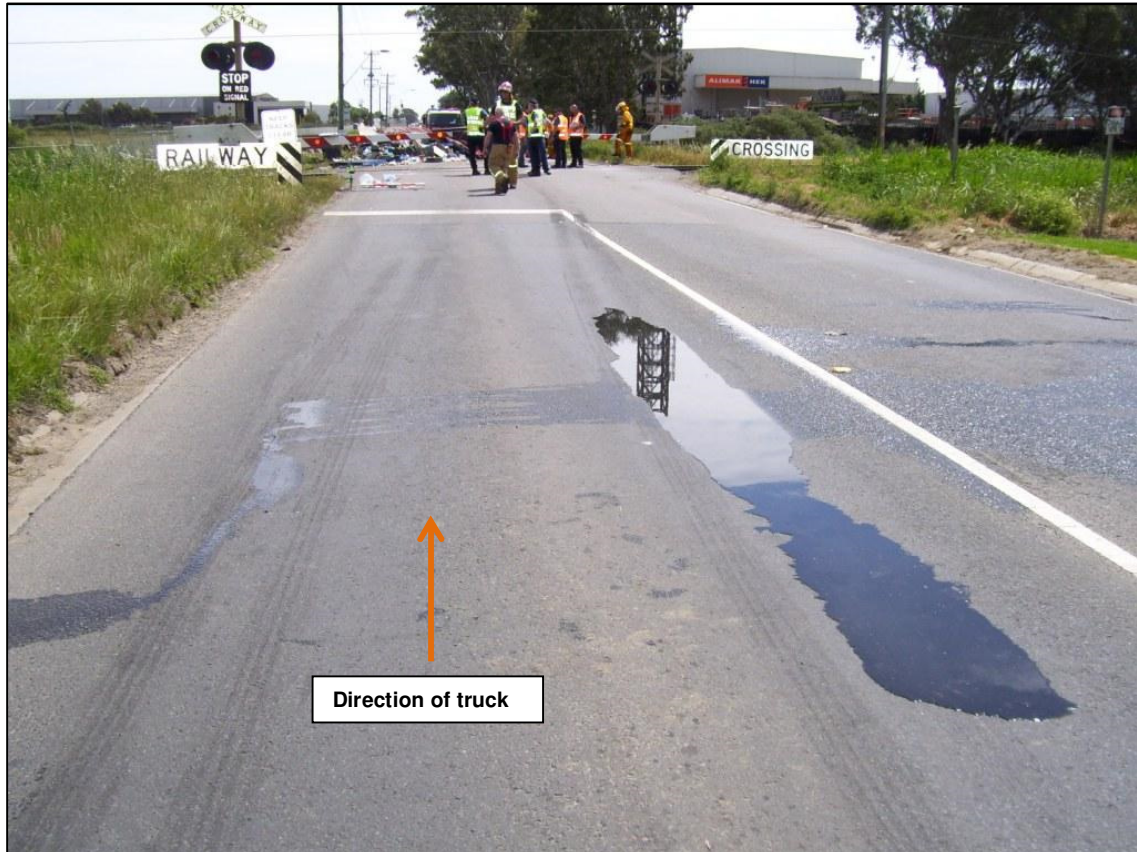
At the time of the incident the road was dry and the truck had left distinctive marks indicating its path and a section of heavy brake application. There was a pair of dual tyre skid marks commencing about 20.7 metres from the Stop line and curving to the right (Figure 4). The skid marks stopped at the crossing Stop line and rolling tyre prints continued on from that point, turning back to the left towards the lane. Later inspection of the truck trailer tyres (see section 2.7.3) indicated that the skid marks were most likely from the leading or mid trailer axles.

**Figure 4: Truck skid marks (Note, the water on the road was not present at the time of the event)**

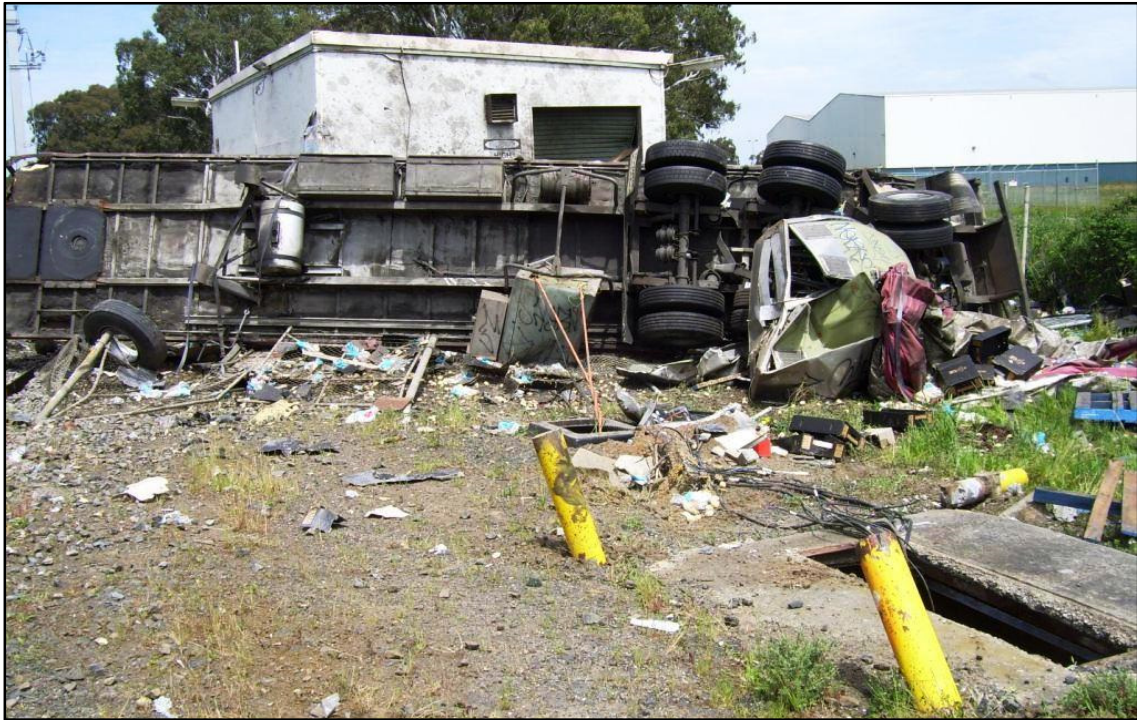
As a result of the impact with the train, the king-pin connecting the truck's trailer to the prime mover had been torn off, with distortion to both the mounting flange and the pin. The deck of the trailer (Figure 5) was propelled about 23 metres to the south, and had come to rest against a rail infrastructure building, destroying signalling equipment to the south west of the crossing. The top of the trailer was detached from the deck and had landed about 13 metres to the west of the point of impact.

Figure 5: The deck of the trailer resting against the track infrastructure building. In the foreground are the exposed pits over which signal equipment boxes had been located.

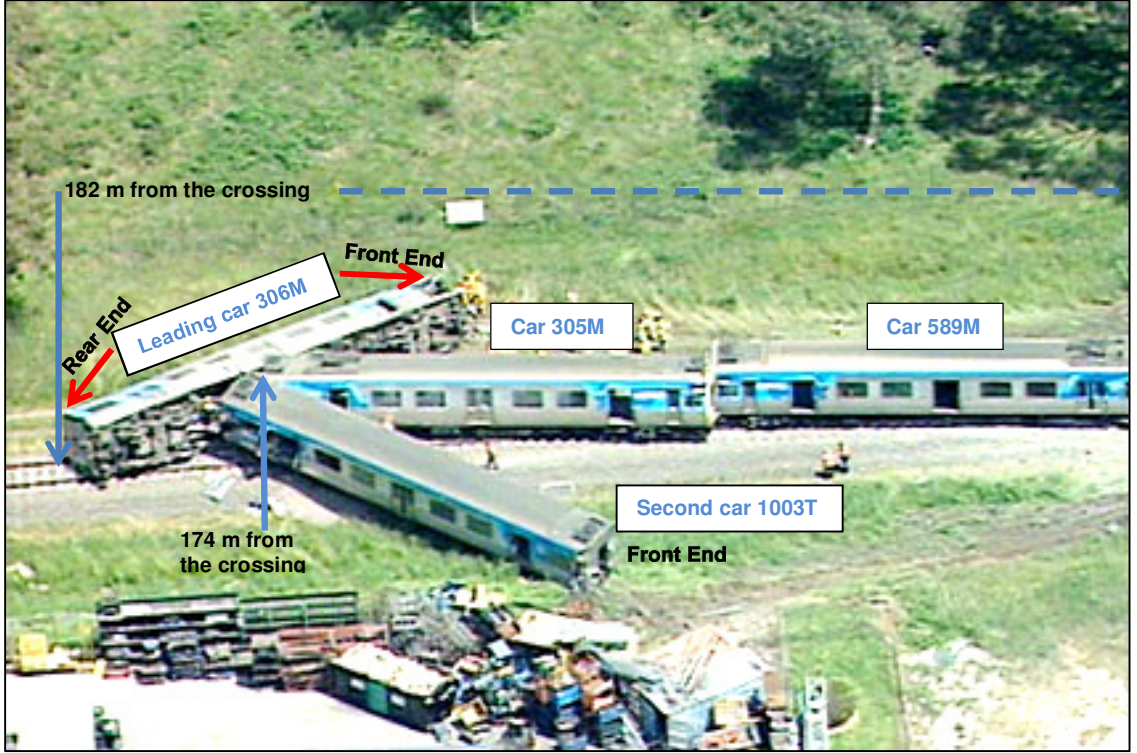
The collision caused the first five carriages of the train to derail and there was substantial damage to the first three (Figure 6). The leading car had swung to the west side of the tracks. It had rolled onto its side and detached from the second carriage, its trailing end stopping about 182 metres from the crossing.

Figure 6: Aerial view of the incident site. © Seven Network (Operations) Limited

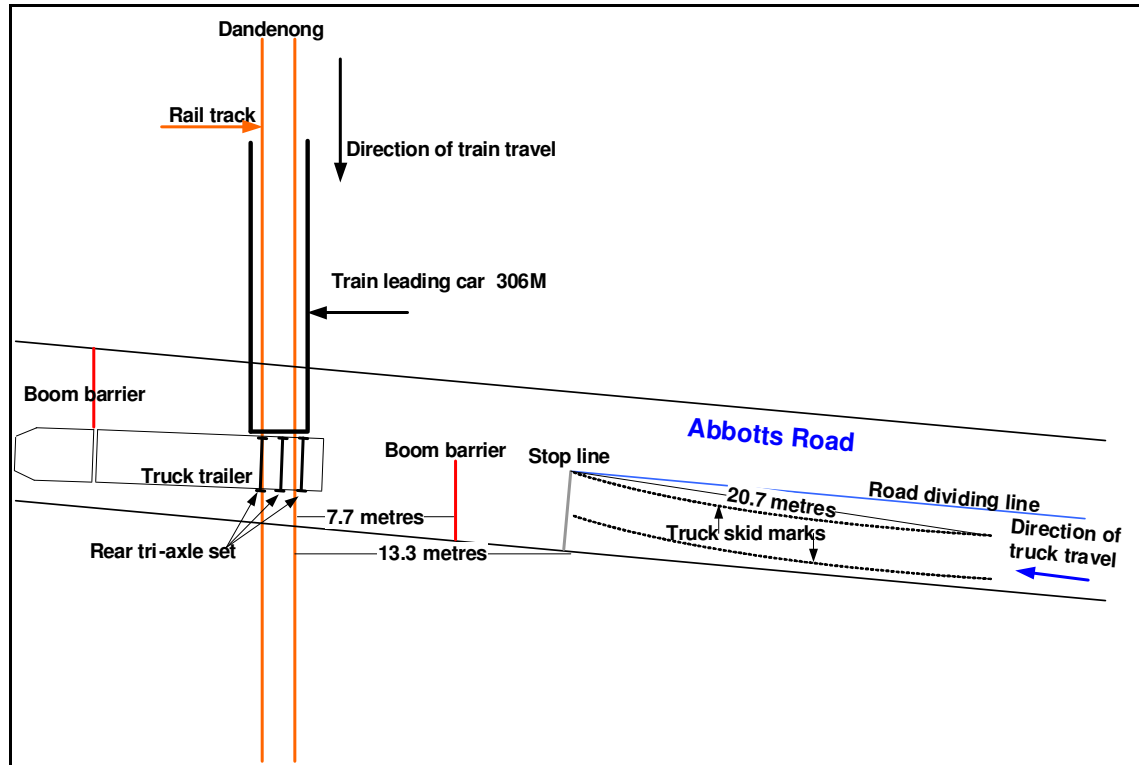
The forward-most impact by the train on the truck occurred on the right hand side of the truck's trailer, at its leading axle. At impact, the leading axle of the trailer tri-axle set was therefore approximately aligned with the west rail (Figure 7).

Figure 7: Incident site dimensions and approximate location of truck at time of collision

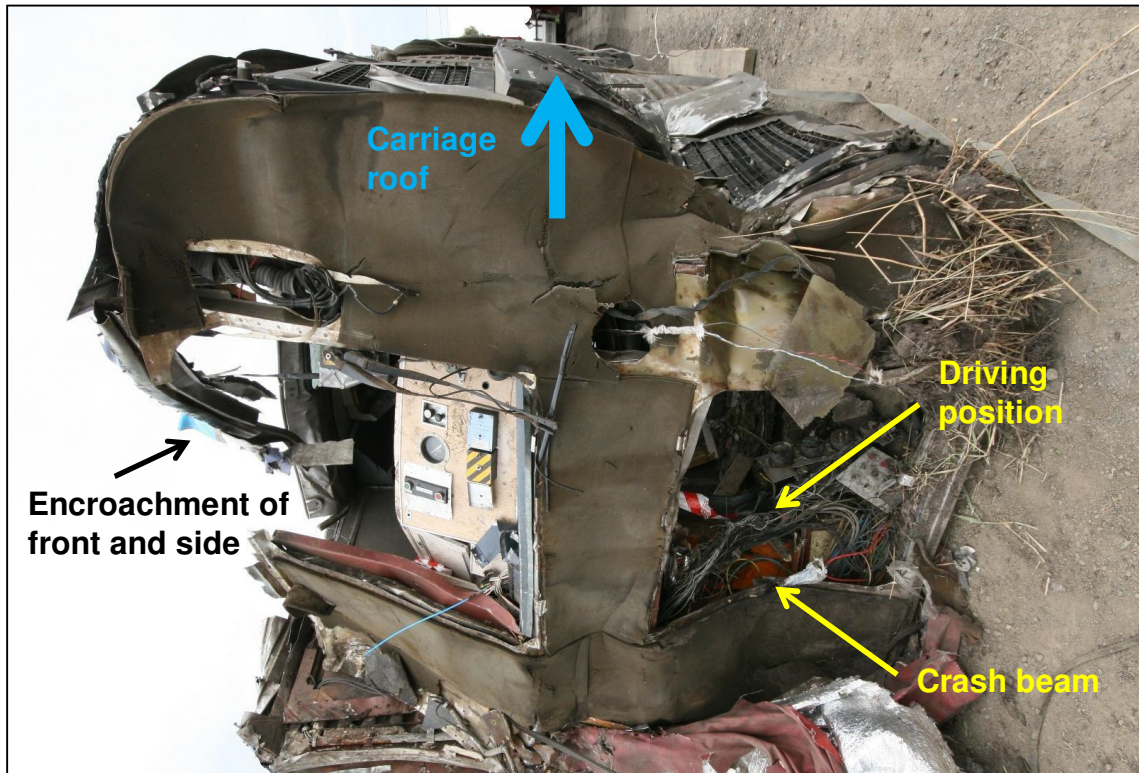
There was considerable damage to the front of car 306M (Figure 9) and the coupler had been torn off. The car front had been penetrated on both the driver's side (left in the direction of travel) and the right side and debris from the truck's load was inside the carriage compartment. There was considerable loss of carriage side structures on the right side including into the passenger compartment.

**Figure 9: Front of car 306M, picture rotated to orientate roof at top**

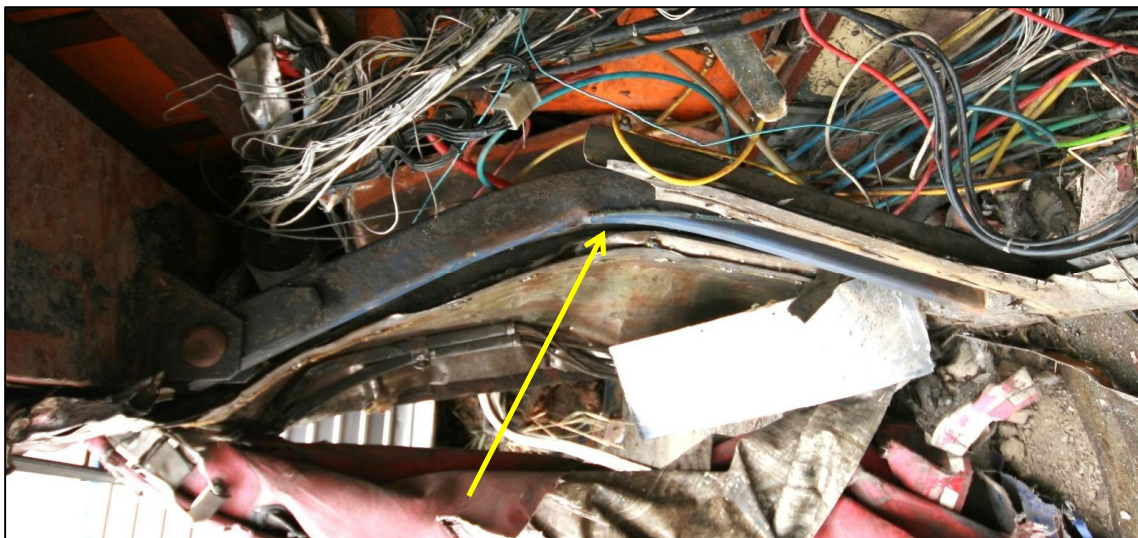
The two vertical collision posts on the cab front were intact. Both posts were connected at their ends and there was no notable distortion of these members. The horizontal 'crash beam' that was located at the front of the driving position, below the driver's window, was severely deformed but remained connected at its ends, indicating that it absorbed significant energy. Maximum deformation was measured as being about 175 mm at the beam's central point (Figure 10). It is probable that the beam acted to reduce the level of damage encroachment into the driver's space.

**Figure 10: View from above of deformed crash beam at front of driver's cab**

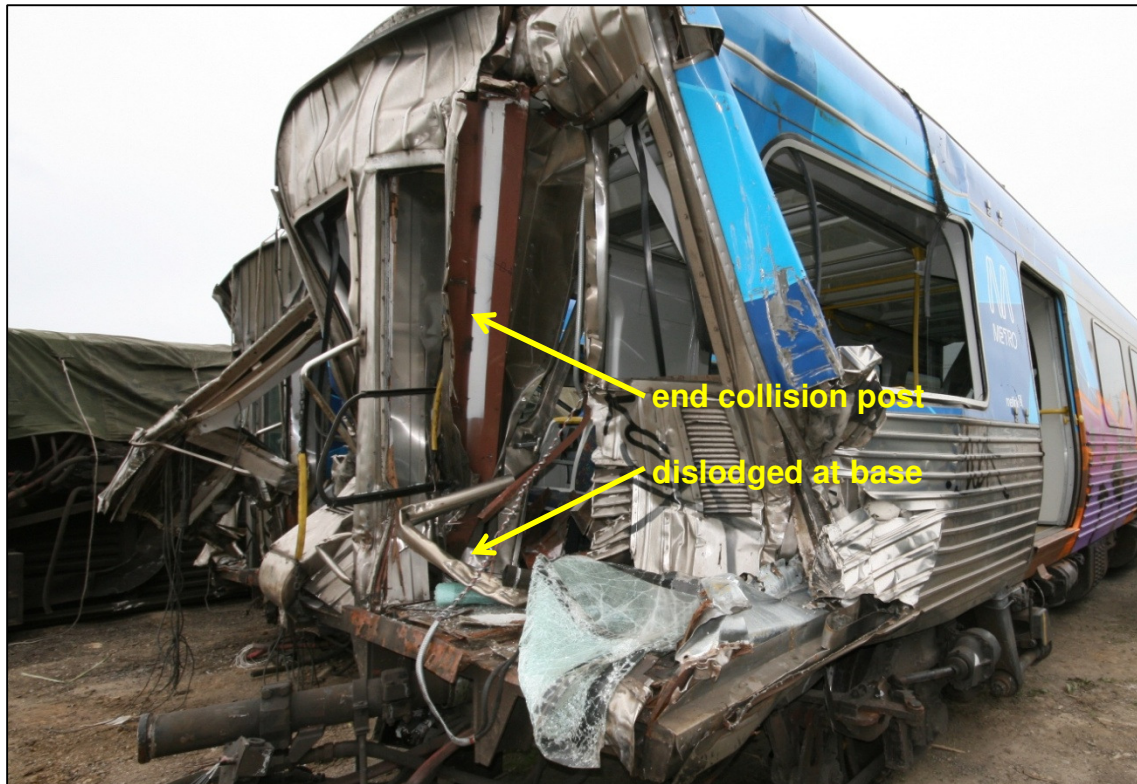
The trailing car of the leading car-set, 305M, similarly exhibited localised structural damage where there had been interaction with an adjacent car and damage to the internal spaces and fixtures was again limited to these areas. The most severe damage was at the leading end of the car and an end collision post had been dislodged from its base connection (Figure 11).

**Figure 11: Leading end of car 305M, note dislodged vertical collision end-post**

The damage to the leading end of car 305M and dislocation of the collision post was consistent with override by the side sill of the trailing end of car 1003T. The connection detail of the damaged collision post was consistent with its design and there was no evidence of pre-existing material defect.
