Office of the Chief Investigator  
Transport Safety

**Rail Safety Investigation  
Report No 2011 / 05**

**Derailment  
Tram 3515  
Melbourne University Terminus  
20 April 2011**

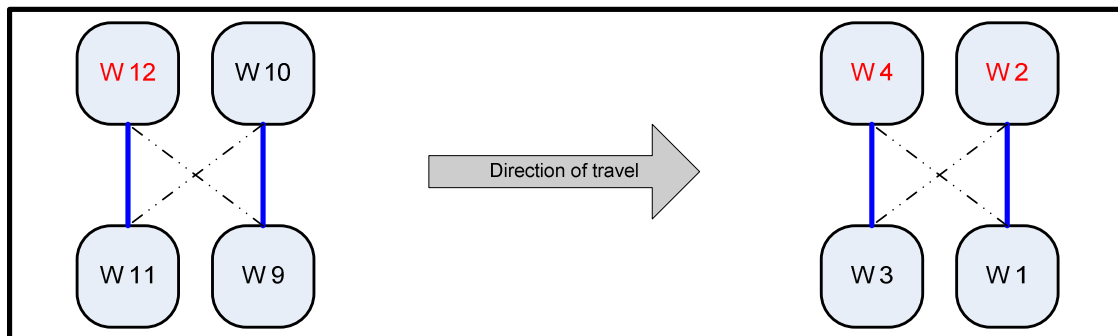
Figure 4 – Wheel configuration of D class Combino tram and defective EBU on tram 3515 (in red)

Following the incident, Tram 3515 was driven to the Malvern depot for inspection by Yarra Trams' engineering department. When the wheel earth system was checked, it was found that there were open circuits in the earth brush units on wheels 2, 4 and 12.

Figure 6 shows the wheel configuration of the D class Combino and the lateral and diagonal electrical interconnection between wheels. The EBUs found to be defective on Tram 3515 are highlighted in red.

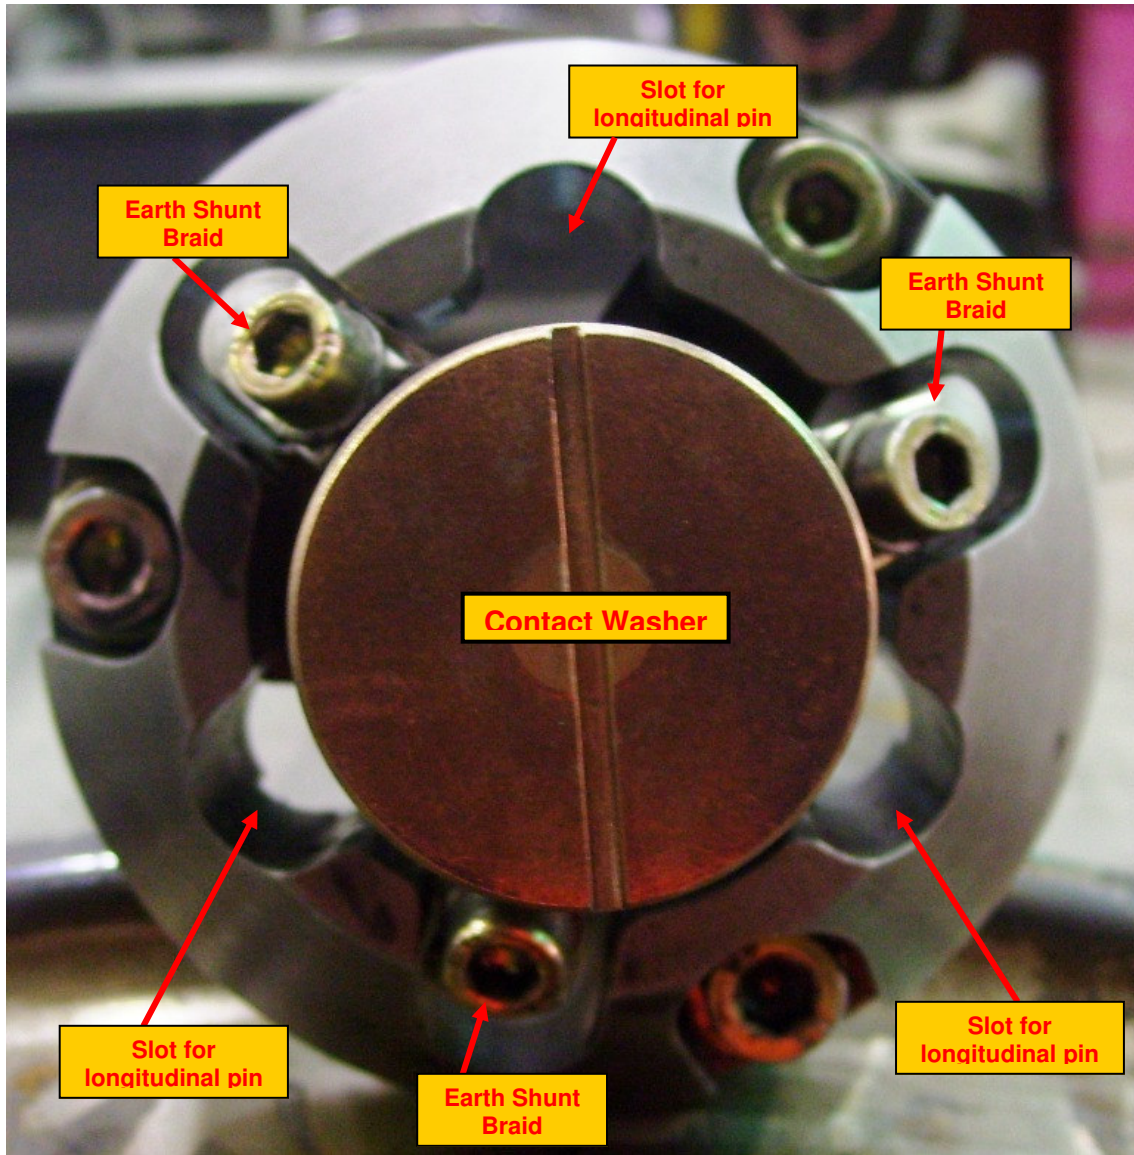
**Figure 6 – Contact washer and earth shunt braids EBU Version 3**

Version 3 of the EBU was fitted to Tram 3515 and at the time of the incident was the latest model of the EBU produced by this manufacturer. This version did not include longitudinal pins to restrict rotation of the contact washer, although the slots for the pins are still evident in the surrounding casing (see also section 2.6.4)

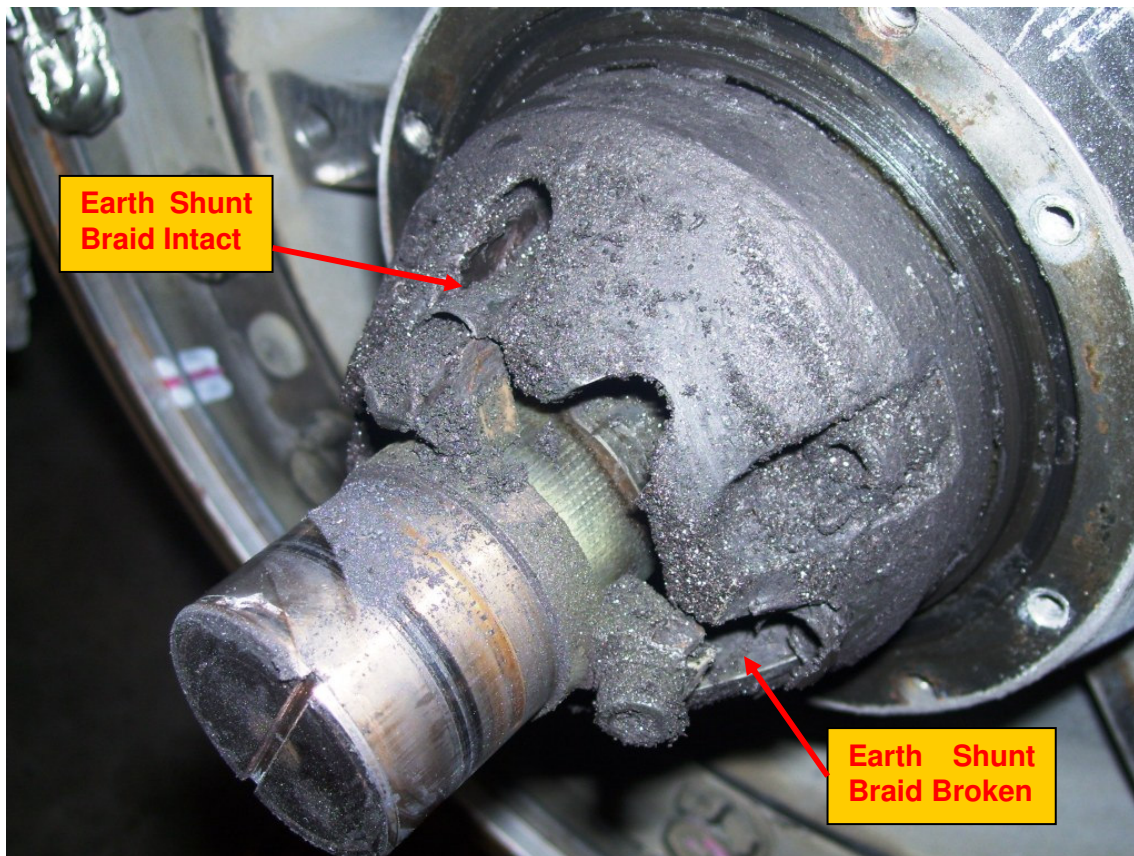
Figure 7 – Typical condition of an EBU after a few weeks in use, as reported by Yarra Trams

- There was excessive earth brush wear.
- The rubber sealing ring was not adequate and permitted the earth brush particles to enter the rear of the earth brush assembly and subsequently the wheel bearing.
- The contact washer on the earth brush was rotating "back and forth" causing the earth shunt braids to snap as well as causing damage to the aluminium housing.

- EBUs were not remaining serviceable for planned maintenance cycles and required premature repairs.
- The life-span of an earth brush was between six and 18 months whereas the manufacturer's maintenance manual suggested that the earth brush should have a life-span of eight years.

Yarra Trams and Siemens are conducting a trial on one D class Combino tram with earth brush units from another manufacturer. Until trials demonstrate the reliability of the unit and the fleet is upgraded, Yarra Trams is considering undertaking earth brush unit resistance measurements during the 15-weekly servicing of the units and mandatory replacement of earth brush units and wheel bearings every eight years.
