Office of the Chief Investigator
Transport Safety

Rail Safety Investigation
Report No 2017/04

Overcurrent Fault
B2 Class Tram 2109
Plenty Road, Bundoora
11 September 2017

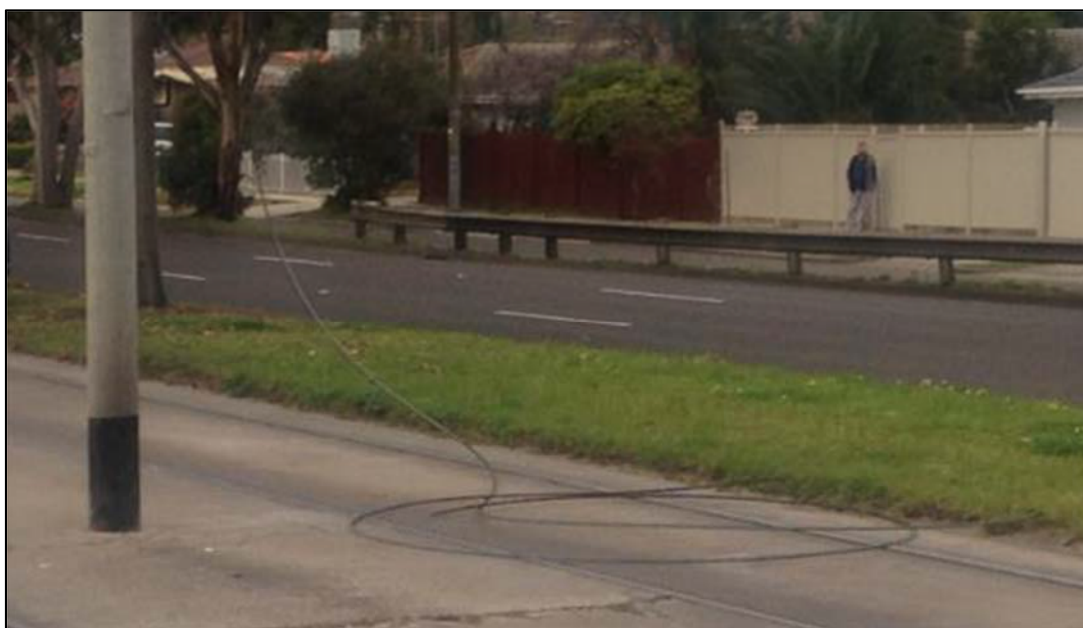
Figure 1: Traction contact wire lying on the tram tracks

After requesting passengers to stay in the tram (in case the tram was electrically alive), the driver inspected the outside of the tram and the overhead wire. He observed the tram overhead wire lying on the ground, across the tracks (Figure 1). The driver also noted a strong burning smell emanating from the tram.

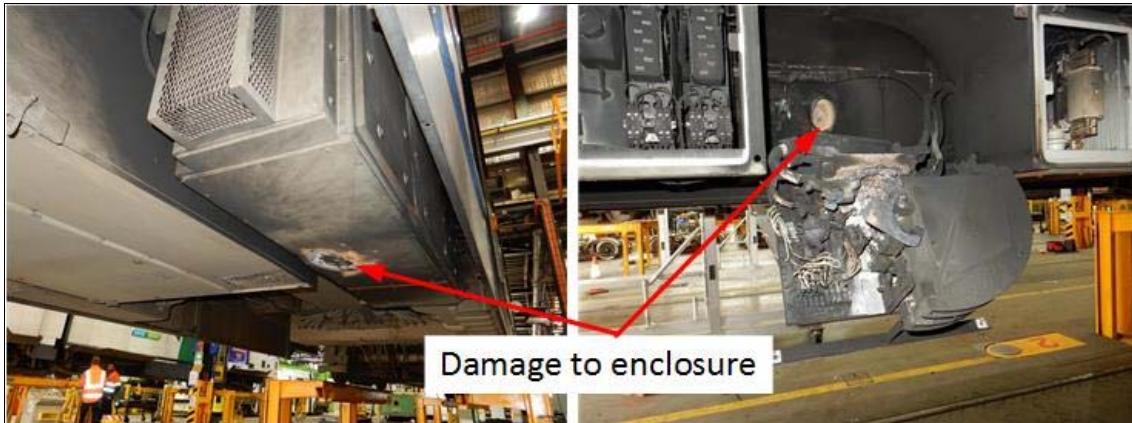
Figure 6 Line Breaker and enclosure damage

A significant flashover had occurred during the tripping of the breaker resulting in severe damage to the line breaker and the enclosure, burning a hole through the base and side (Figure 6).

In the event of a traction fault on a tram, the line breaker is the primary protection device. The line breaker tripped due to the high fault current and a significant flashover occurred within the line breaker enclosure during the opening of the contacts. This flashover and resulting arcing caused severe damage to the line breaker, its enclosure, and adjacent equipment and cabling. The flashover extended to the 24V system, disabling radio communications and electric door operation. In the event of failure of the traction system and the 24V system, the disc brakes apply automatically bringing the tram to a stop. It is likely that the arcing within the line breaker enclosure produced rapid heating and expansion of gases within the equipment box leading to the reported explosion, flames and smoke.

The severe damage sustained by the line breaker made identification of the immediate cause of its failure difficult. The arc chutes were in satisfactory condition, but both sets of contacts were severely damaged. It is likely that the arc runners were not in contact, either due to incorrect installation of the arc chutes or prior damage to the arc runners. This resulted in the fault current not being cleared by the line breaker.

A recommendation in the investigation by Yarra Trams into the incident in May 2017, was that the line breaker major overhaul frequency be reduced from 500,000 km to 250,000 km. At the time of this incident, the recommendation had not been implemented by Yarra Trams.

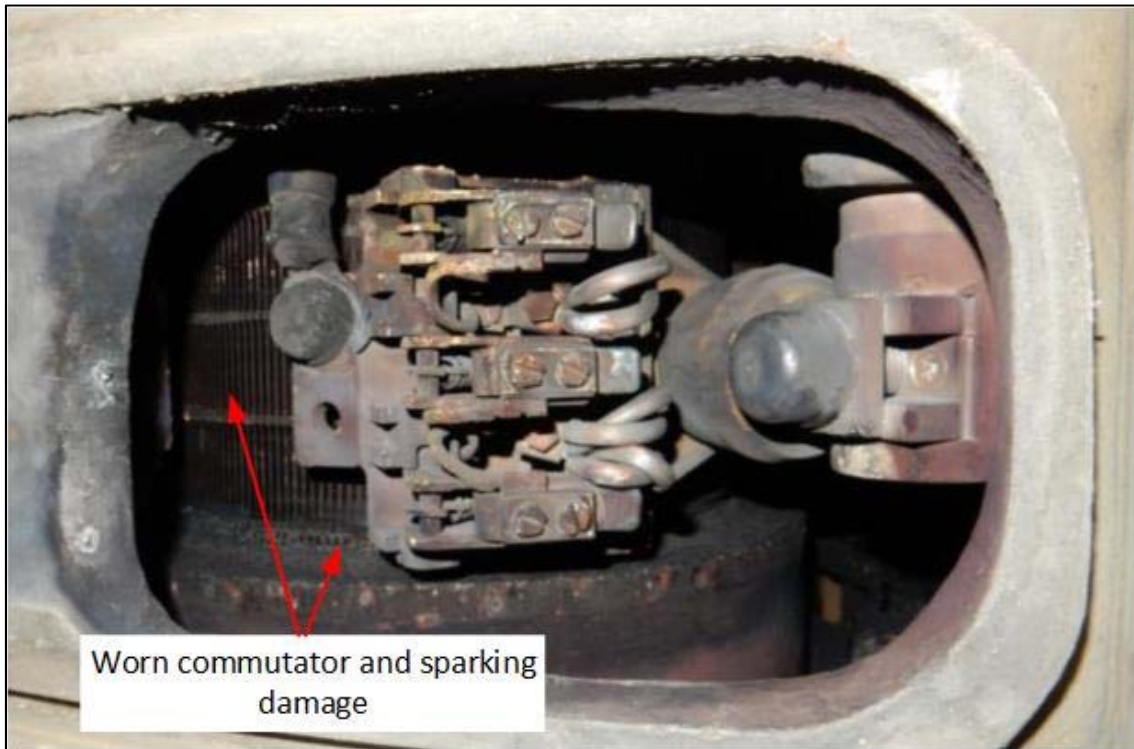
Figure 7: No.2 motor commutator grooving and sparking damage

Inspection of the No.2 traction motor commutator showed it was severely worn and grooved. The carbon brushes were also worn and there were signs of brush chattering and sparking on the brush holder (Figure 7).

In this instance, the commutator was in poor condition and the motor should have been replaced. Three days prior to this incident, the line breaker was recorded as opening on a line breaker fault and was also recorded as opening three times on the morning of the incident and prior to the opening that resulted in this incident.

- The No. 2 tram traction motor flashed over due to poor commutator condition.
- **The motor had been inspected five days prior to the incident as part of scheduled maintenance, but the motor was not exchanged as required by maintenance procedures. [Safety Issue]**
- The fault current that resulted from the motor flashover was not cleared by the tram line breaker due to the arc chutes not being installed correctly or pre-existing damage to the contact runners.
- **The tripping and reclose function operating independently at the two substations resulted in traction supply continuing even though a fault was present. This led to the eventual melting of the overhead contact wire. [Safety Issue]**

Yarra Trams have inspected the line breakers and traction motors of all B Class trams. A maintenance instruction has been issued to ensure maintainer awareness of the importance of proper maintenance techniques and the timely replacement of traction motors subject to inspection results. They further advised that maintenance documentation is being currently reviewed to provide better instruction to maintenance personnel with respect to accept/reject criteria for traction motors and line breakers.
