Office of the Chief Investigator  
Transport Safety

**Marine Safety Investigation  
Report No 2020/02**

Breakaway from berth  
*MV Florida Highway*  
Webb Dock, Port of Melbourne  
27 December 2020

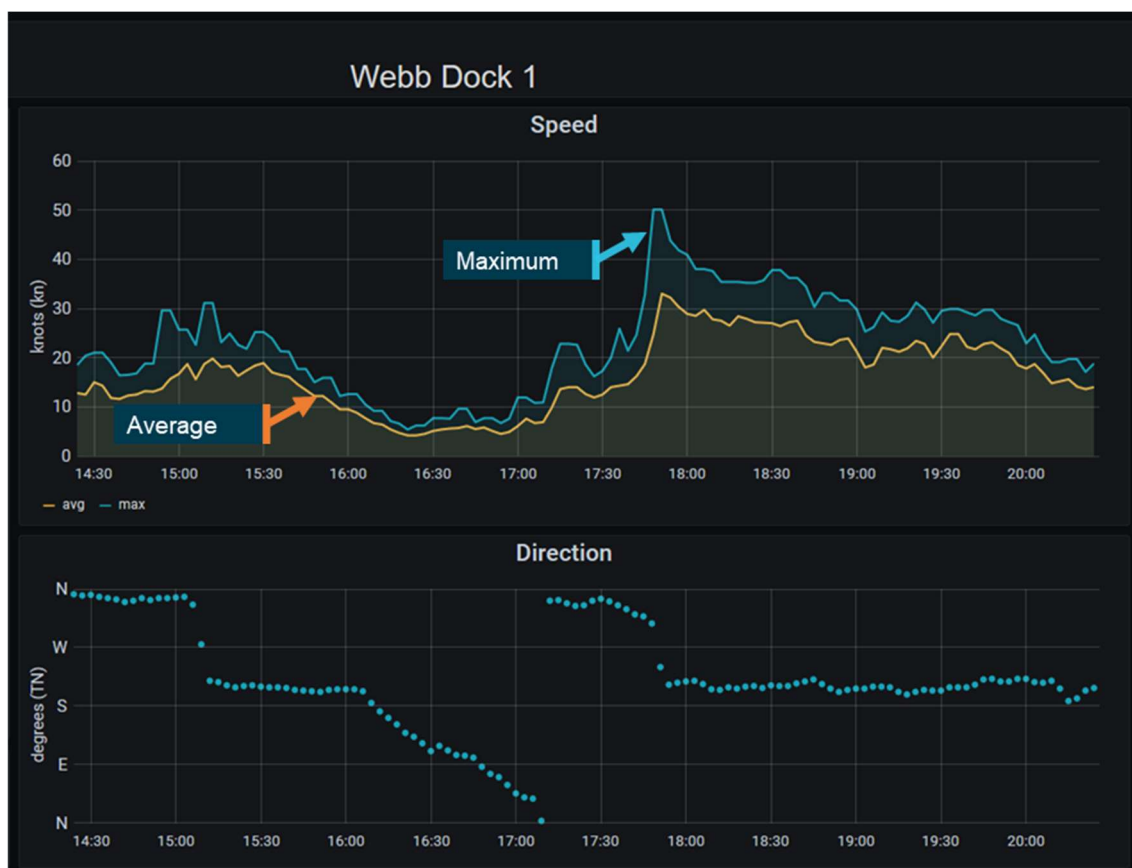
Figure 1: Recorded wind speed and direction at Webb Dock (measured at 11 m above sea level)

During the afternoon of 27 December, the wind at Webb Dock changed direction and strength on a number of occasions as a cold front approached and then passed over the port (Figure 1). At about 1430, the wind was from the north, averaging<sup>3</sup> about 15 knots<sup>4</sup> with gusts up to about 20 knots. From about 1450 there were wind gusts up to 30 knots and at about and 1510 a rapid change in wind direction to the southwest. The wind then eased while wind direction remained steady, settling in the south southwest.

Between 1745 and 1754, at Webb Dock wind gusts reached at least 50 knots and wind direction swung through about 105° to the south southwest. The most significant change occurred between 1748 and 1751 (Table 1).

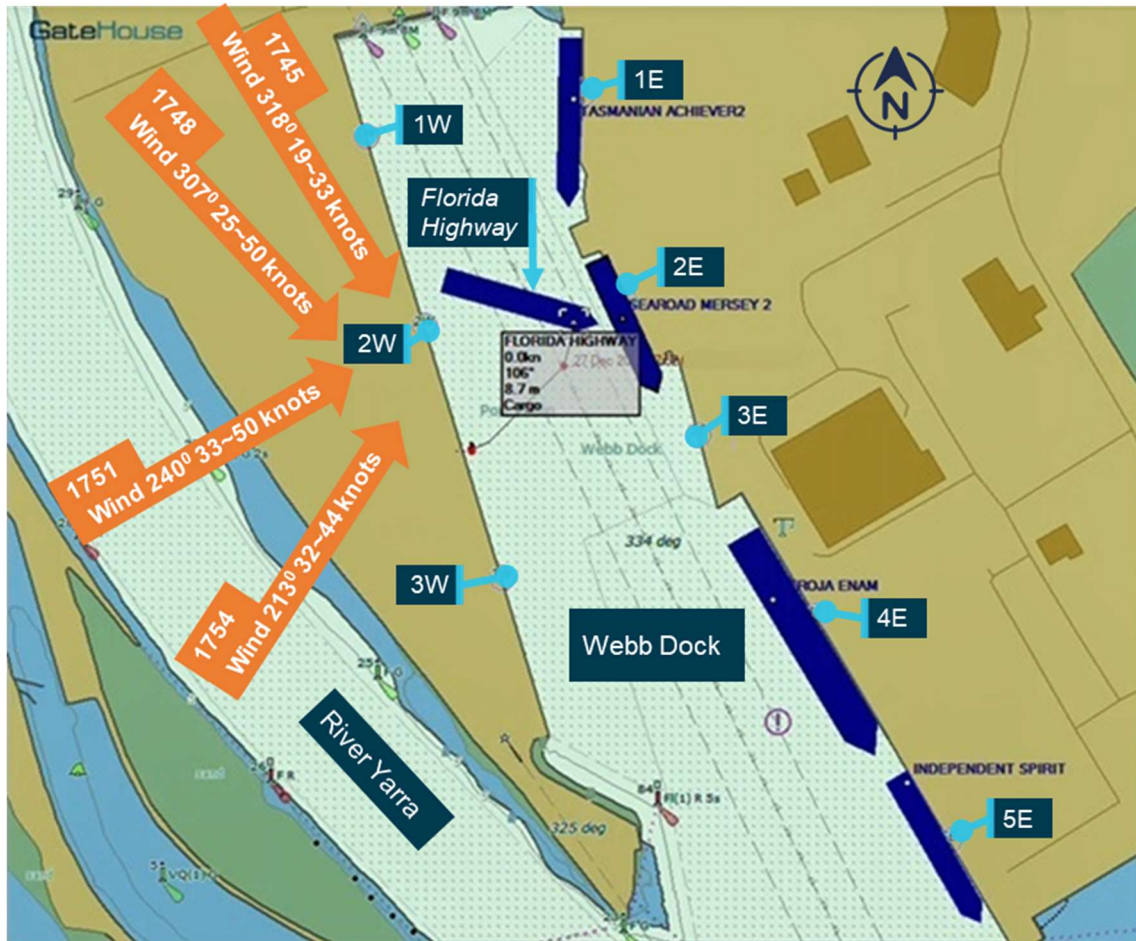
Figure 2: VTS AIS plot of *Florida Highway* orientation at about 1758

After the ship's bow broke away from the wharf, the bow swung towards the opposite side of the dock. One aft breast line and one aft spring line parted as the ship rotated to port. The stern ramp became wedged on a shore bollard and the ship's stern was held to the wharf.

The master stated that about three minutes after the bow broke away, the bow thruster was engaged, thrusting to starboard at full power. Shortly after, on instruction from the VTS, *Florida Highway* dropped both anchors (port, then starboard) to arrest the swing to port. The ship had rotated to about 60° to the berth and its bow stopped swinging when about 20 m from *Searoad Mersey 2* that was berthed at 2-East Webb Dock (Figure 2).

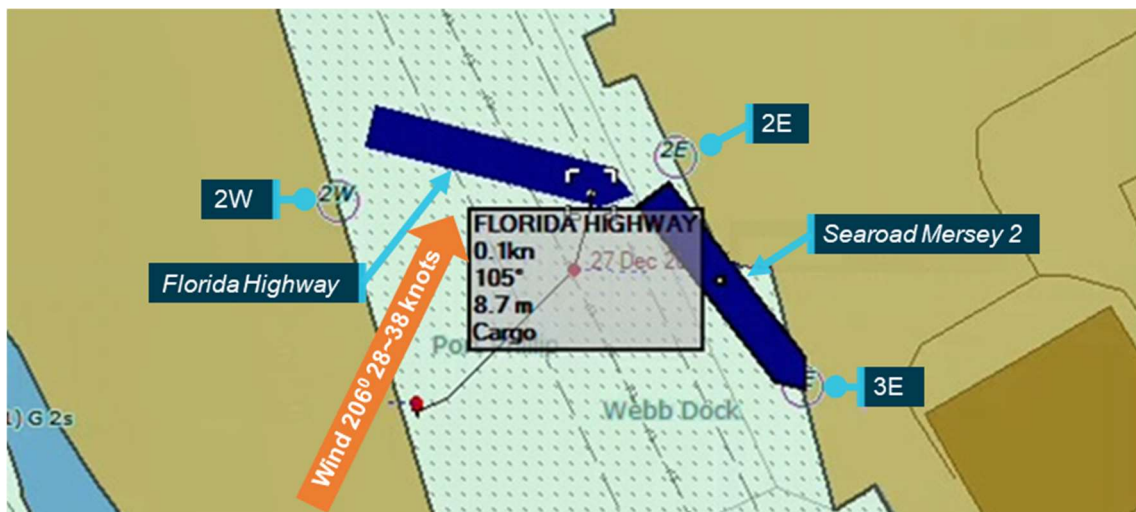
Figure 3: VTS AIS plot of *Florida Highway* and *Searoad Mersey 2* orientation at about 1808

On the other side of the dock, *Searoad Mersey 2* had observed *Florida Highway*'s breakaway from the wharf and immediately started their engines. They then moved forward along the wharf until their stern was clear of *Florida Highway*'s bow (Figure 3).

As a result of taking this evasive action, *Searoad Mersey 2*'s bow was overhanging the wharf 'knuckle' and its bow was blown onto the wharf at 3-East. The bow made contact with the wharf and suffered minor damage.

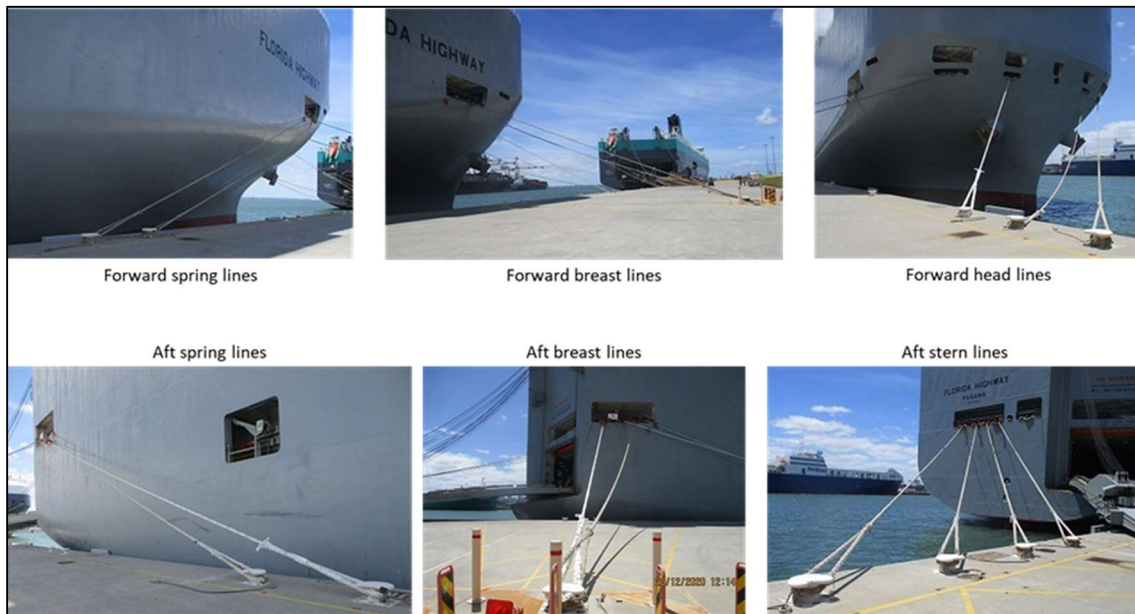
Figure 6: Reported arrangement of mooring lines at the time of breakaway (photo taken day after).

As strong winds were expected during their port stay, the ship was secured with additional lines (Figure 6). The ship was made fast with seven lines forward that included three headlines, two breast lines and two spring lines. The ship was secured with eight lines aft that included four stern lines, two breast lines and two spring lines. The forward and aft breast lines were secured to the wharf storm bollards in accordance with Harbour Master's directions, and the remaining lines were secured to the wharf edge bollards.

Mooring lines were 8-strand synthetic fibre rope of 68 mm diameter and minimum breaking load of 98.1 tonnes (when new). The inboard end of each mooring line was secured to winch drums, each having a holding power of 441 kN (45 tonne-force), except one spring forward and one spring aft that were made fast to mooring bits. The mooring winches were not auto-tensioning, and the state of tension of each line at the time of failure is not known.

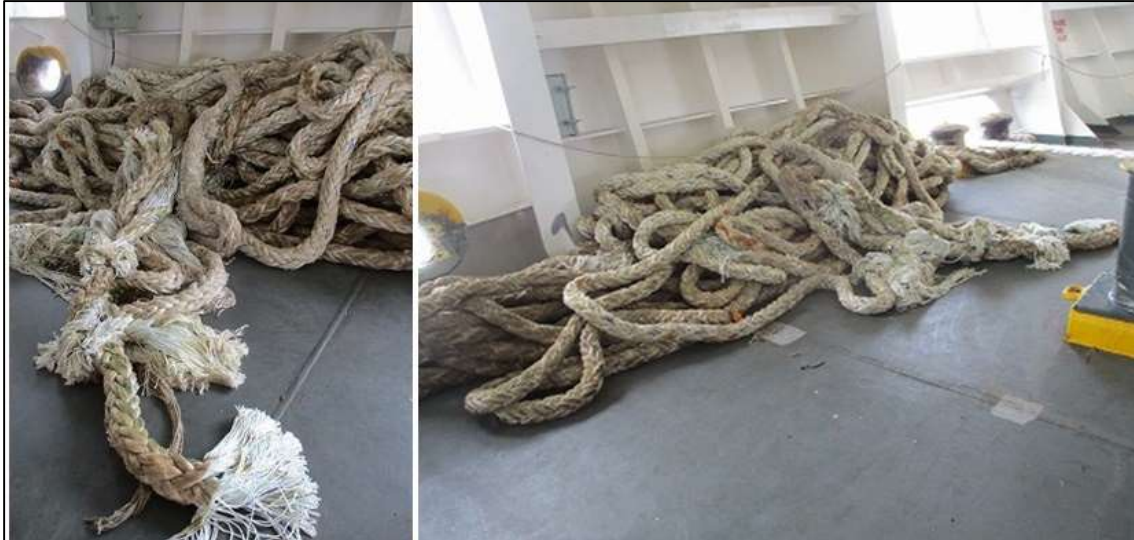
Figure 7: Photographs of damaged mooring lines.

The mooring lines were reported as being in a satisfactory condition at the time (Figure 7).

The profile of a car carrier is large, making this type of ship more susceptible to high loads from beam winds. Forces are proportional to the square of wind velocity acting on the ship and as a result forces increase rapidly with increasing wind speed. In this instance, the mooring lines in place and as tensioned at the time of the changed wind conditions could not withstand the applied wind loading and the ship broke away from its berth. The headlines were reported as the first mooring lines to part, followed by the forward breast lines and a forward spring. Subsequently, two aft lines, parted.

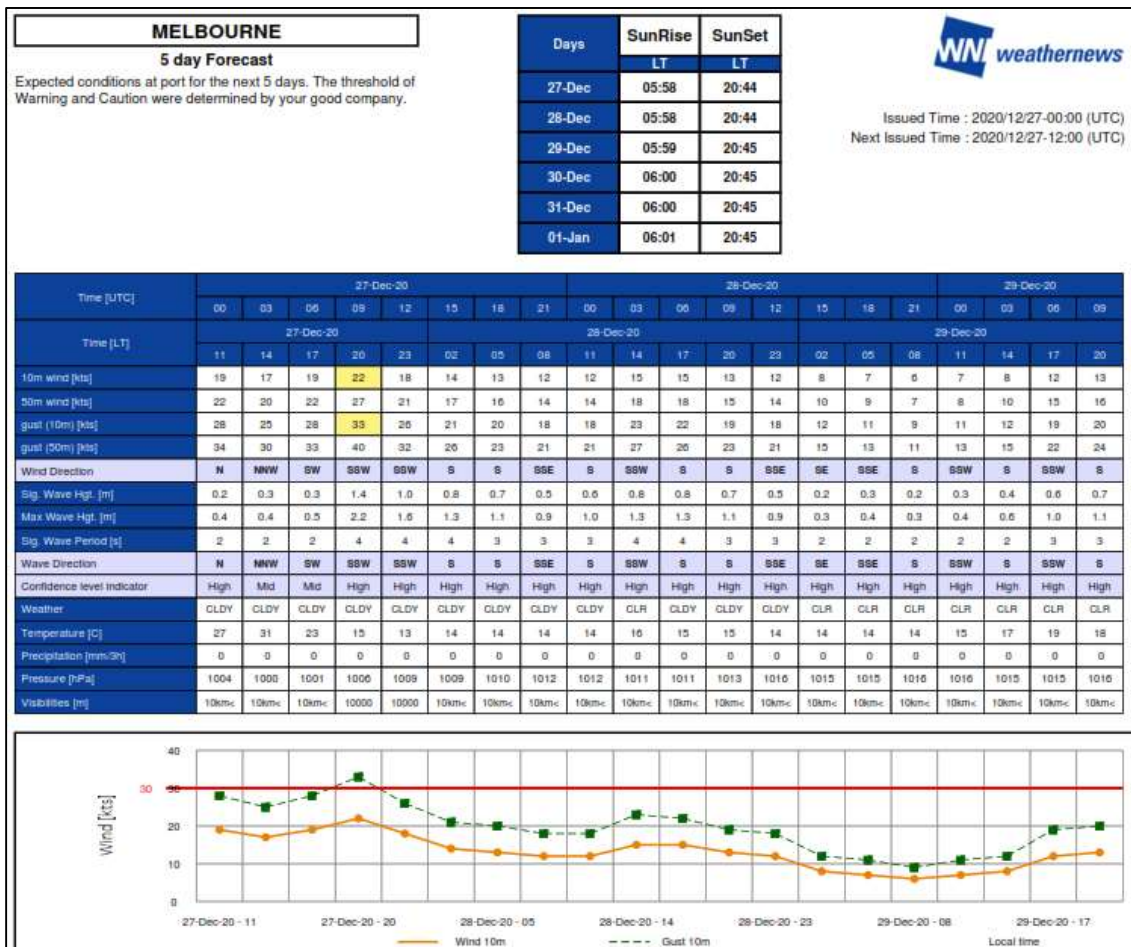
Figure 8: WNI weather forecast issued at 00:00 UTC (11:00 LT) on 27 December 2020

The Weather News Inc (WNI) weather update at 2300 on 26 December indicated that wind intensity would gradually increase over the next day (27 December), reaching a maximum of about 21 knots (average) and 31 knots (gusting) at about 2000, then gradually reduce.<sup>12</sup> The next WNI update at 1100 on 27 December forecast a slight increase in predicted wind strength at 2000, forecasting an average wind of 22 knots and gusts to 33 knots (Figure 8).
