Office of the Chief Investigator
Transport Safety

**Rail Safety Investigation
Report No 2018/01**

**Derailment of Tram No.190
At Moonee Ponds, Victoria
27 March 2018**

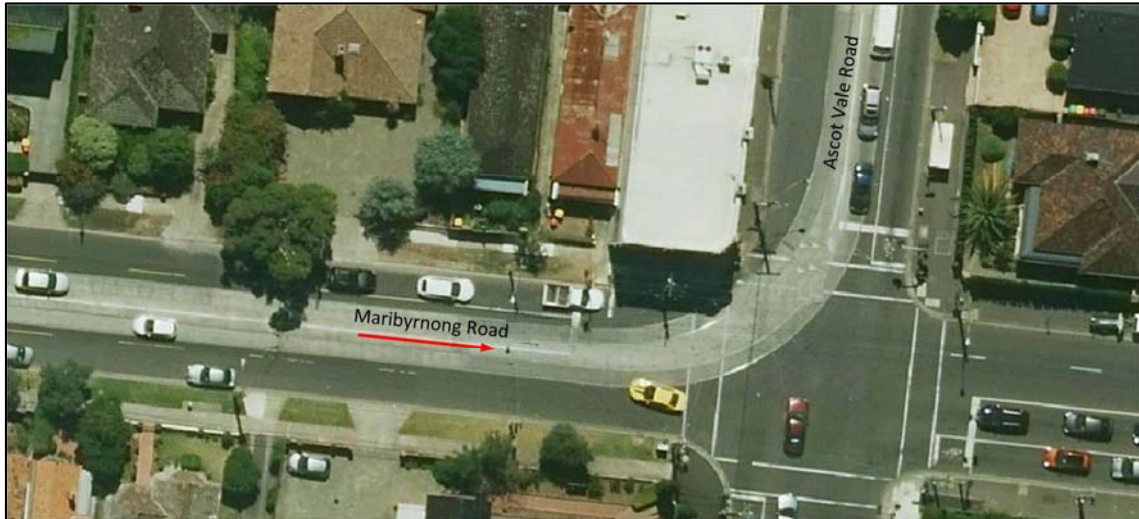
Figure 2: Intersection of Maribyrnong and Ascot Vale Roads

After passing Stop 35, the tram continued towards Ascot Vale Road. The tram was not fitted with a data logger to provide information about its operation or speed. However, sampling of its speed was available through the network's AVM system.² This data indicated that Tram 190 was travelling at about 45 km/h when it was about 100 m from the intersection. The driver had no recollection of events approaching the left-hand curve at this intersection (Figure 2).

At 0013 on 27 March 2018, Tram 190 entered the left-hand curve at the intersection of Maribyrnong and Ascot Vale Roads at an estimated speed of 45 km/h (12.5 m/s). This speed significantly exceeded the design speed of 13 km/h for this curve, and the tram derailed to the outside of the curve.

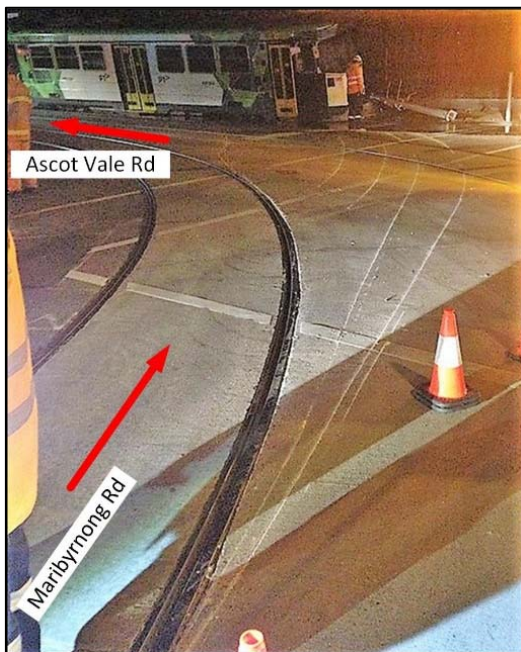
Figure 3: Derailment marks

There was no evidence that the tram's brakes were applied in the approach to or within the curve. It is therefore probable that the tram was travelling around the polled 45 km/h speed as it entered the intersection. The curve has a design speed of 13 km/h. The tram derailed to the outside of this curve (Figure 3).

The derailed tram collided with road infrastructure and a tram overhead stanchion, causing extensive damage to the tram and infrastructure.

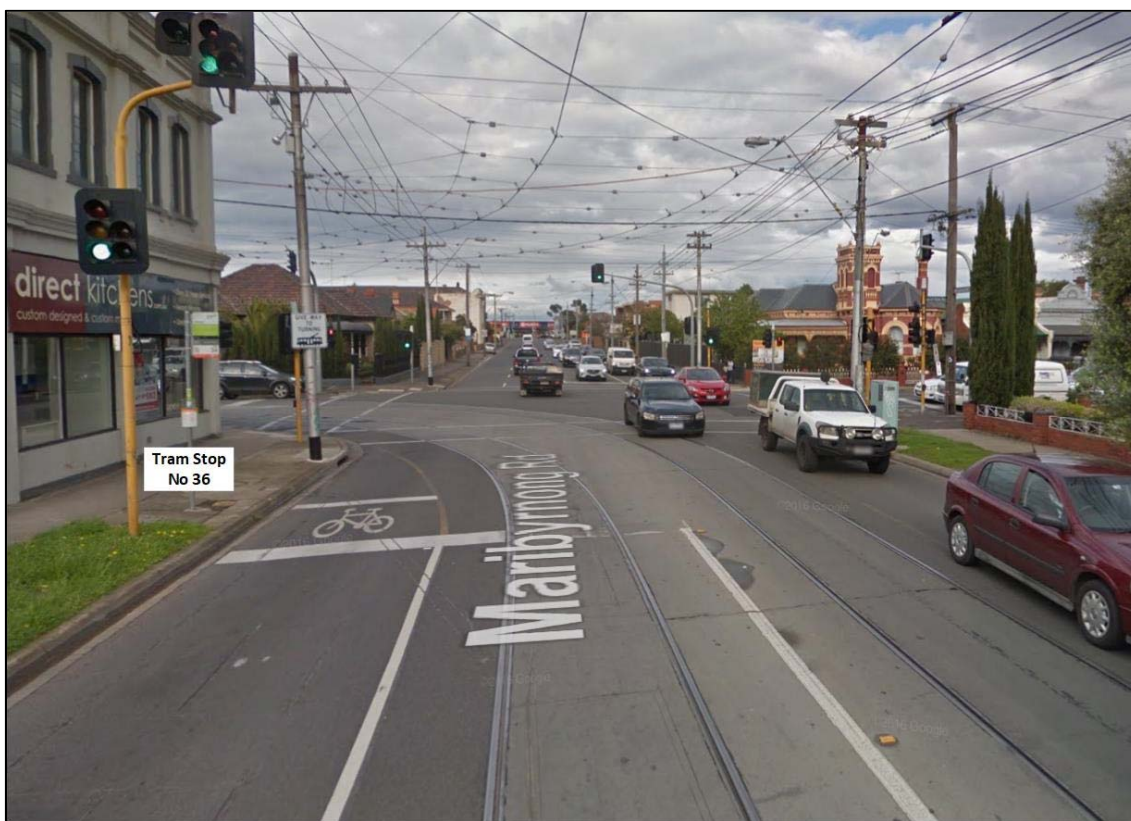
Figure 4: On Maribyrnong Road approaching Ascot Vale Road in the same direction as the tram.

Maribyrnong Road intersects Ascot Vale Road at 90 degrees. The intersection was fitted with active traffic controls (Figure 4), although their status at the time of the event is unknown.

The track was rail-in-concrete that included a check rail. The curve at the intersection had a radius of 18.3 m and was tight compared to other mainline curves. Yarra Trams advised that the design limit speed through this curve was 13 km/h although operational rules permitted a speed of 15 km/h. There was no signage specifying the speed limit for this curve.

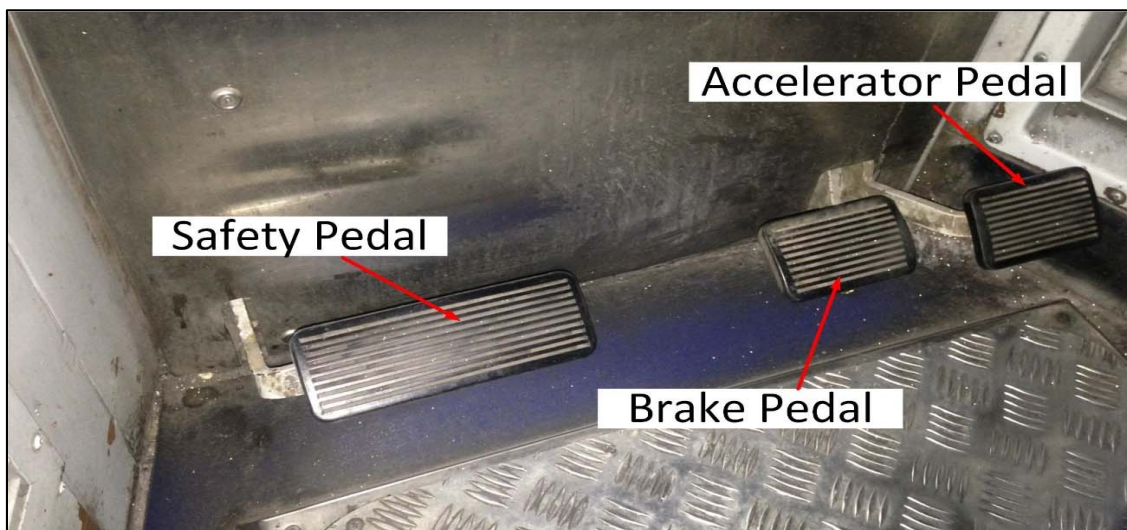
Figure 6: Z3 Class tram driving controls

Traction and braking controls of the Z3 Class tram are foot-operated from a seated position. Pedals include a safety pedal operated by the left foot, and accelerator and brake pedals operated by the right foot (Figure 6). There is a footrest platform in front of the pedals.

The safety pedal is the 'deadman' system on the Z3 Class tram. It is intended to stop the tram in the case of driver incapacitation. To operate the tram, the safety pedal is depressed to a 'mid-way' position that completes a safety circuit. If the pedal is released or fully depressed while the tram is in motion, braking is applied automatically.

This class of tram was not equipped with a task-linked driver vigilance system as typically fitted to late model trams.

In 2004 a trial was conducted on several Melbourne trams, including the Z Class, to test the efficacy of the type of safety pedal used in these trams.³³ Functional tests were carried out with four drivers of body mass ranging from 62 kg to 120 kg. The report concluded that it was possible to rest the foot on the pedal in a standard driving posture and hold the pedal in a set position without effort, and probably while incapacitated.

It was found that due to the pedal dual spring mechanism, the pedal would function as a foot rest with minimal safety utility for a large proportion of the drivers. Further, it appeared that accommodating occupational health requirements to minimise lower limb

Yarra Trams has conducted a review of the safety pedal system on Z Class trams that has resulted in a recommendation to install a contemporary vigilance control system in Z class trams. The proposed recommendation is undergoing a business case assessment and installation of the system is expected to commence in July 2019.
