Track worker struck by a passenger train

near Laverton station, Victoria | 2 October 2015

ATSB Transport Safety Report
Rail Occurrence Investigation
RO-2015-019
Final – 24 August 2016

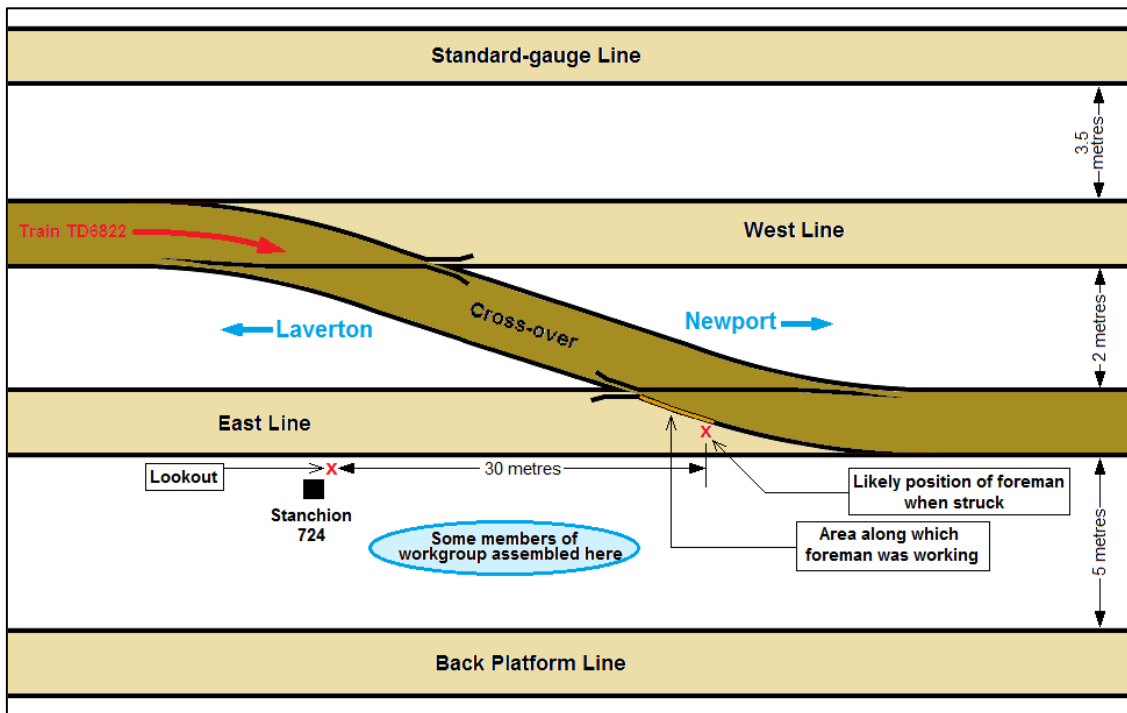
Figure 2: Schematic diagram of the accident site and approximate location of track workers

Soon after, the Infrastructure Works Supervisor (the supervisor) arrived on site. He walked onto the tracks, followed by the TFPC and other track workers. After a short discussion, the supervisor commenced marking the sleepers from which dogspikes were to be removed. The TFPC then returned to an assembly area to commence the safety briefing and on his way back called for lookout protection for the supervisor. A suitably qualified track worker responded to the call and positioned himself at stanchion 724, about 30 m from the supervisor (Figure 2). Other track workers remained in the area between the East Line and Back Platform Line (Figure 2).

At about 0917⁵ the train driver sounded the train horn, then departed the station, travelling on the West Line (Figure 2). The lookout heard the horn and reported that he again informed the supervisor that the train was approaching. Two other track workers confirmed they heard the lookout's warning. The lookout stated that he saw the supervisor move away from the tracks and then he turned to observe the approaching train.

Shortly after departing Laverton station, the train driver noticed track workers between the East and Back Platform Lines. He sounded the horn again and shut-off power, letting the train coast. At that point, the lookout gave the train driver the 'All-Right' hand signal. The train had entered the cross-over by this time and the driver sounded the horn again. The lookout continued to observe the train.

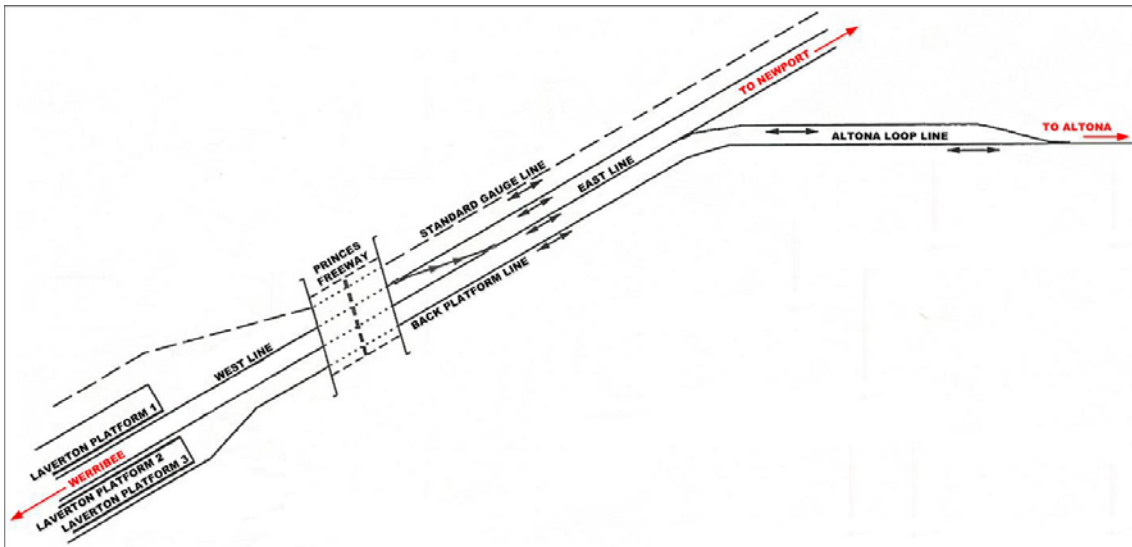
Figure 3: Trackage including station platforms

There are three broad-gauge and one standard-gauge tracks at this location. The broad-gauge West Line, East Line and Back Platform Line pass through Laverton Railway Station at platforms № 1, № 2 and № 3 respectively (Figure 3). The crossover from the West to the East Line commences about 330 m from the Melbourne-side of Laverton station. The Altona Loop Line is a further 300 m towards Melbourne.

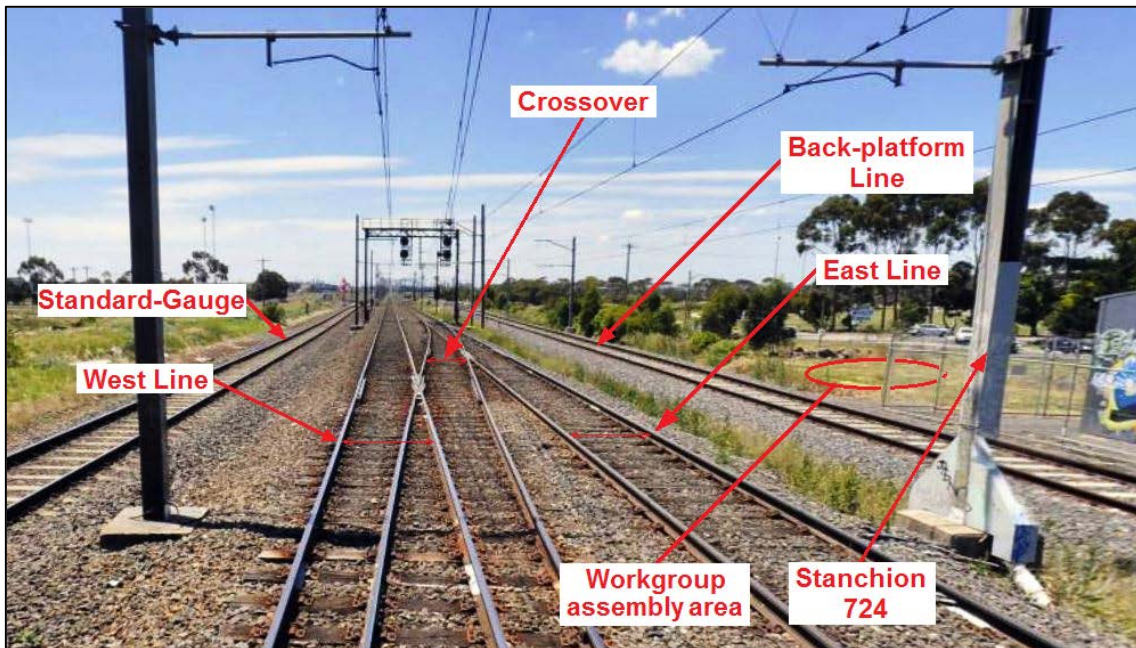
Figure 4: The accident site, viewed in the direction of train travel

The incident occurred at the crossover from the West Line to the East Line (Figure 4). The supervisor was marking sleepers along the right-hand rail (in the direction of travel) of the crossover towards the East Line. The Lookout was about 30 m away at stanchion 724 between the East Line and the Back Platform Line. The distance between the East Line and the Back Platform Line was about five metres.
