Derailment of grain train 9150

Nunga, near Ouyen, Victoria | 9 November 2015

ATSB Transport Safety Report
Rail Occurrence Investigation
RO-2015-022
Final – 15 May 2017

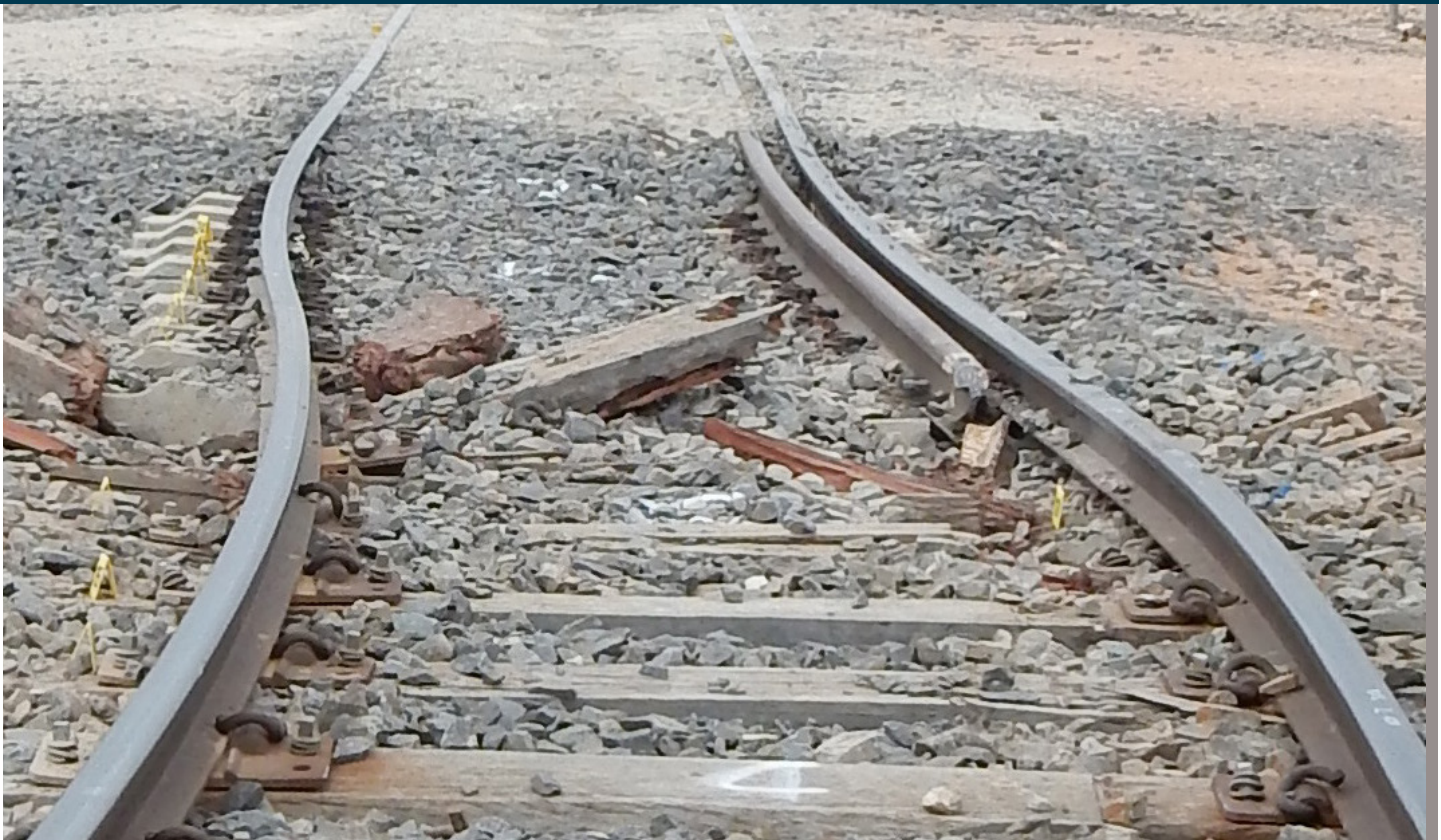
Cover photo: Buckled track on approach to level crossing

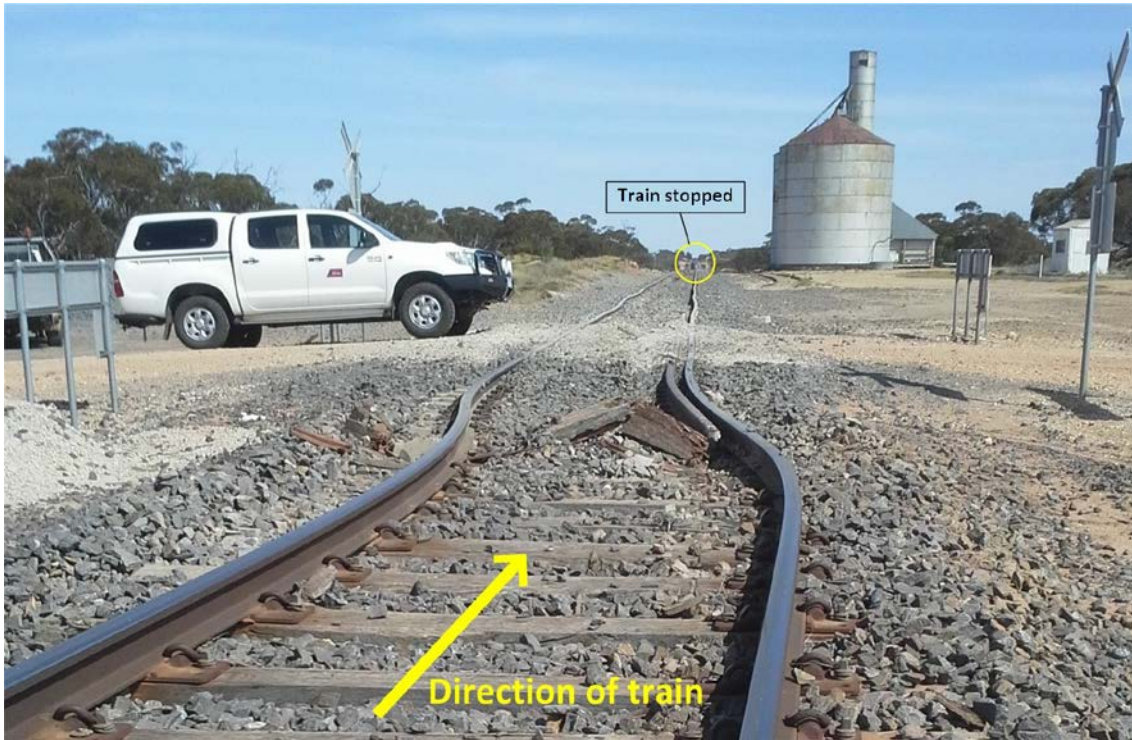
The train had almost cleared the crossing when, at about 1532, the trailing bogie of the last wagon derailed. Following the derailment, the track was observed to be laterally displaced just prior to the crossing (Figure 2).

Figure 2: Laterally displaced track just prior to the Janiels Road level crossing, looking in the train's direction of travel.

In the ambient and solar conditions of the afternoon of the 9 November 2015, the rail temperature was probably in the mid-50s °C and the rails in a state of severe longitudinal compression. The track-train dynamics generated by the passage of 9150 at 80 km/h, in combination with this compression, resulted in lateral loads that could not be contained by the rail and track support, and the rails buckled.

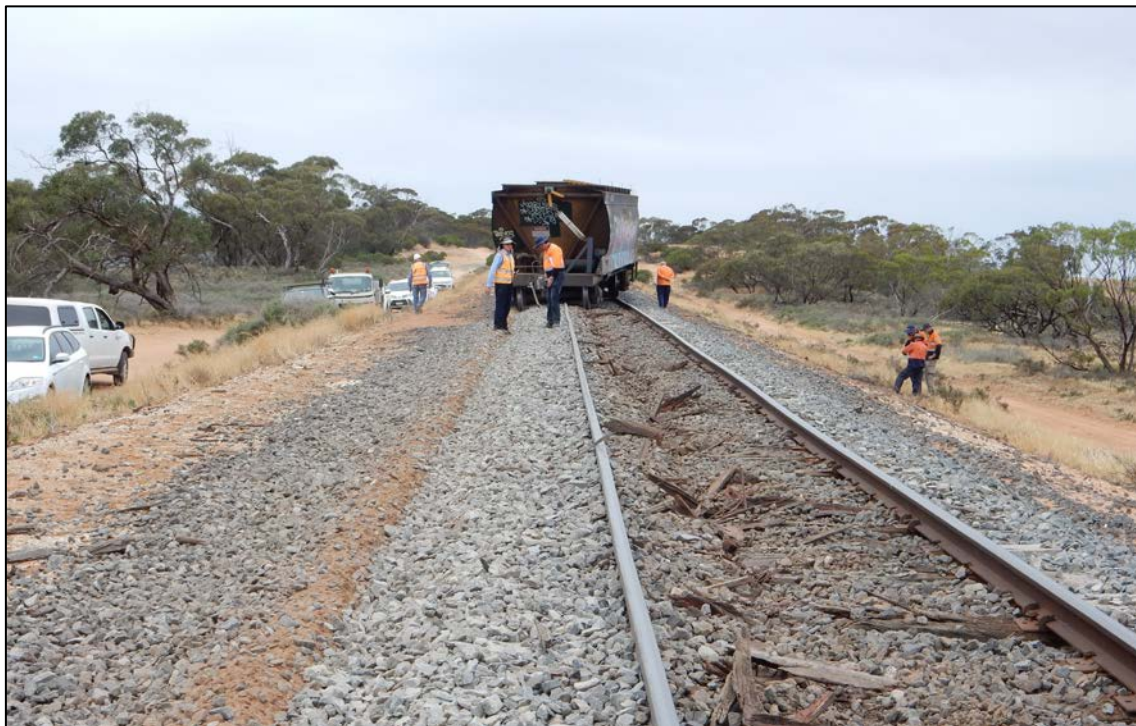
The derailed wagon disturbed the continuity of the brake pipe, with a reported minor loss of air pressure. Alerted by this, the driver looked back and saw dust and ballast coming from the rear of the train. In response, he made a brake application and the train stopped about 1,400 m beyond the crossing (Figure 3).

Figure 3: The derailed trailing wagon and track damage

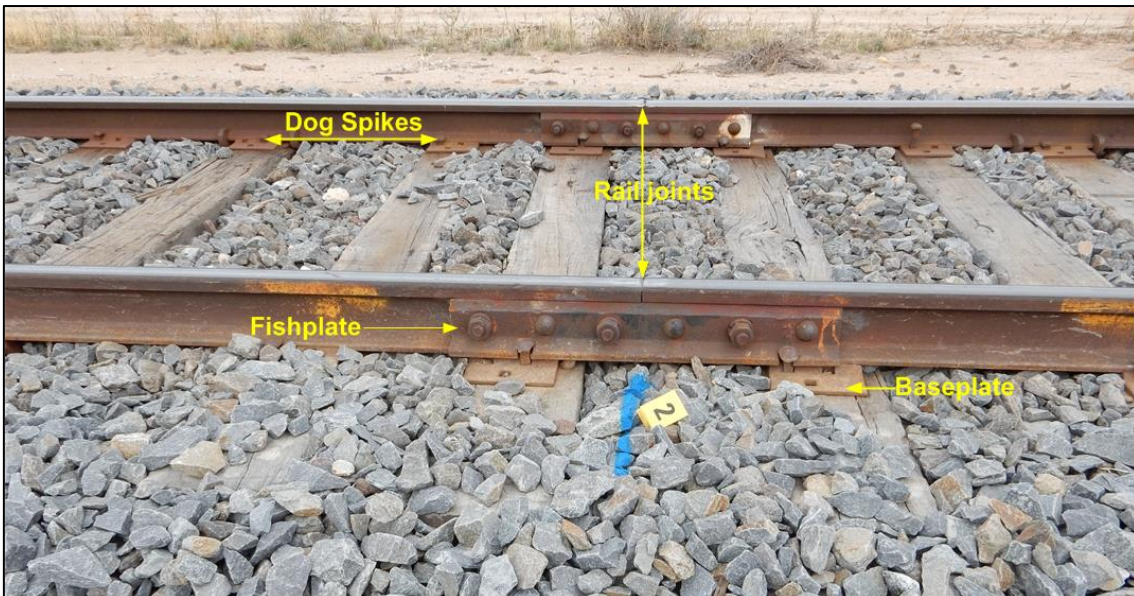
Figure 4: Typical track condition at Nunga showing joints, rail fixtures and ballast

Sleepers were in fair condition and the ballast condition and shoulder profile was generally good. Mechanical joints on both rail legs were closed.

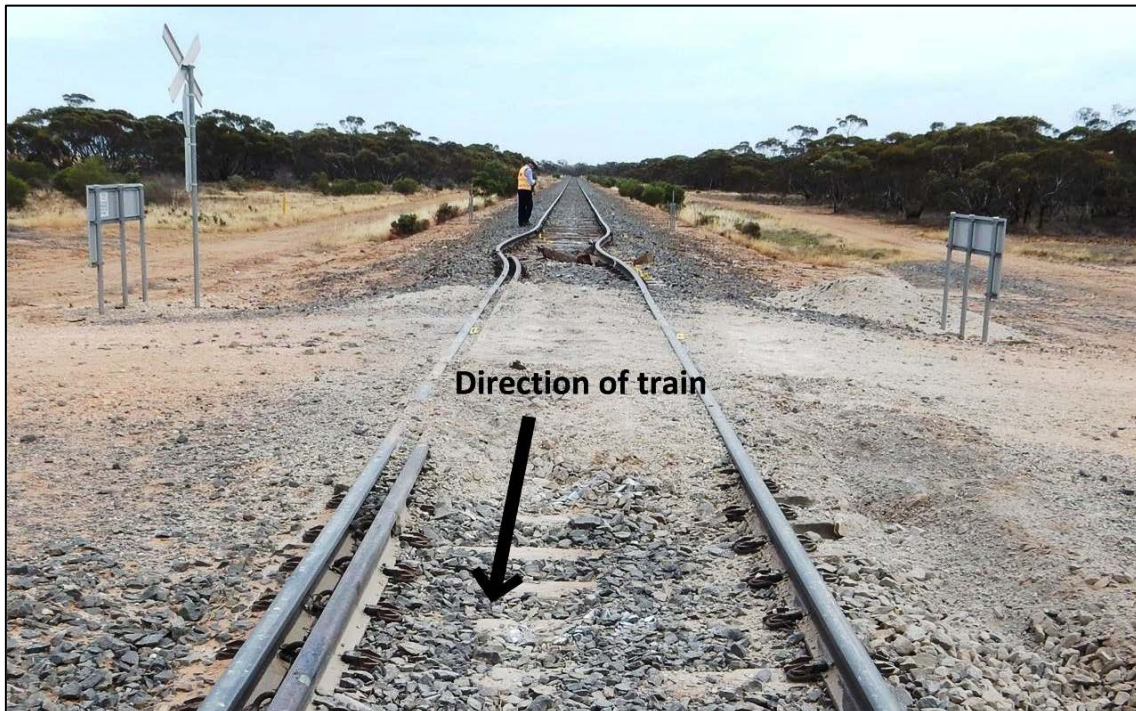
The Janiels Road level crossing was unsealed and consisted of a dual-gauge 11 m track panel that incorporated concrete sleepers supporting 47 kg/m rail affixed using resilient fasteners⁴ (Figure 5). Records indicate that the panel was installed in October 2008 as part of the Mildura Rail Corridor upgrade.⁵

Figure 5: Janiels Road level crossing, upgraded to dual-gauge rail configuration supported on concrete sleepers and affixed using resilient fasteners.

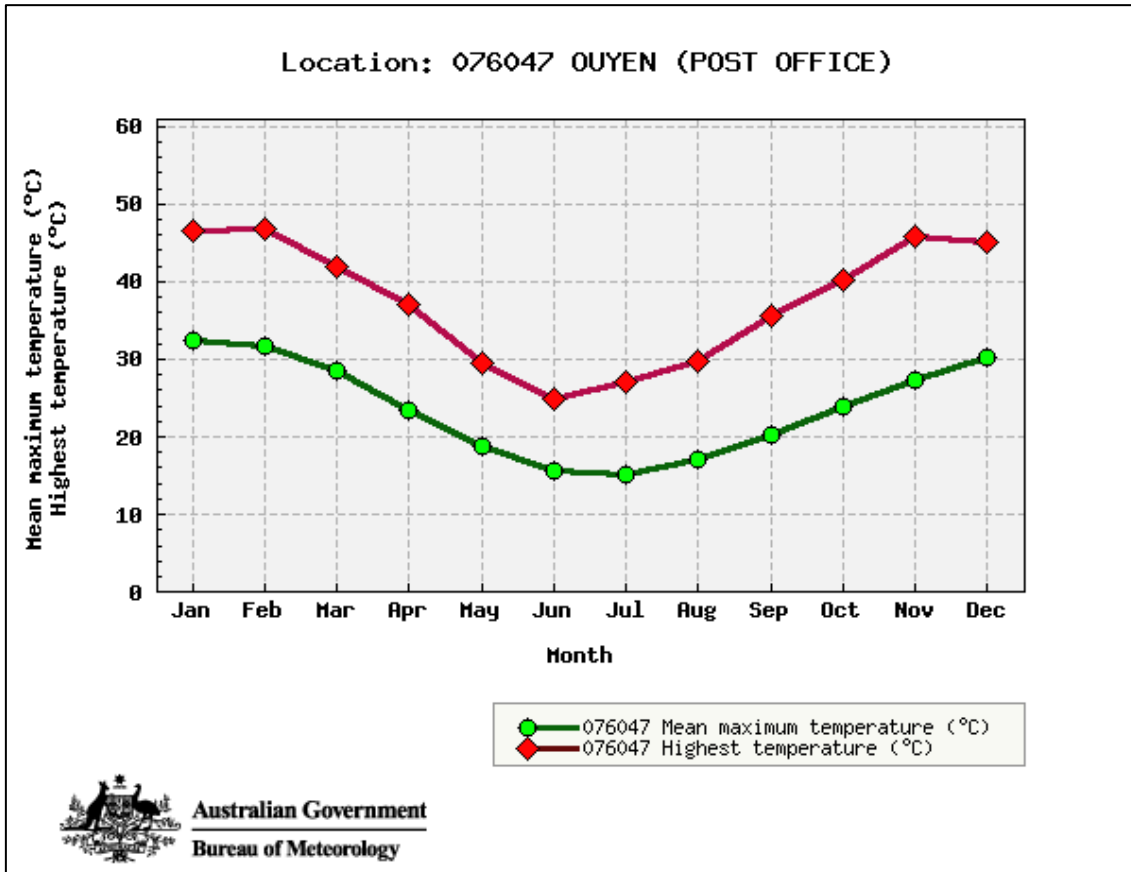
Climate statistics for Ouyen indicate a mean maximum temperature (Figure 8, green graph) for November of 27.4 °C and a maximum recorded temperature (Figure 8, red graph) for November comparable with the summer months of December-February. This suggests that in this district creep related defects should be addressed prior to November.

Figure 8: Climate statistics for Ouyen, showing mean maximum temperatures (green) and highest recorded temperatures (red) by month.
