Derailment of grain train 9130

Emu, Victoria | 12 February 2014

ATSB Transport Safety Report
Rail Occurrence Investigation
RO-2014-003
Final – 20 May 2015

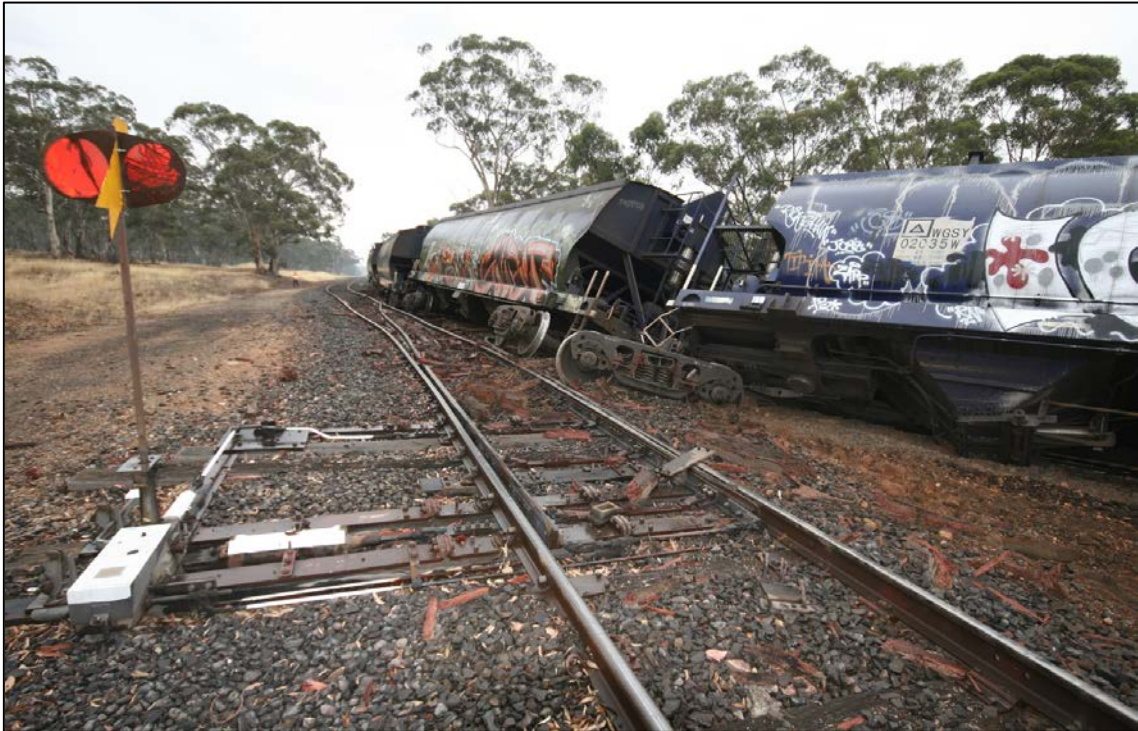
Figure 2: Incident site viewed from the Up-end points

Ten wagons towards the rear of the train had derailed just prior to the Up-end of the loop (Figure 2). Five of the derailed wagons had toppled resulting in a significant loss of load. The initial point of derailment was identified within the loop, about 30 m from the trailable points. About 210 m of track, including the turnout assembly, was severely damaged.

The train crew did not observe any misalignment in the track which is consistent with the site observations of the misalignment not having been initiated until the passage of the locomotives and 27 wagons.

The rail temperature was measured at about 50° C some hours after the event and it is probable that the rail was at this temperature or higher at the time of derailment. As a result the rails would have been in a state of compression and probably in a higher compressive state than the 'design' stress condition due to rail creep.

The track-train dynamics generated by the passage of 9130, even at the relatively low speeds of 40 to 50 km/h, in combination with the compressed state of the rail produced lateral loads exceeding the lateral resistance of the ballast, causing misalignment. Site observations identified wheel flange marks on the railhead that were consistent with a lateral movement of the track and aggressive wheel flange climb activity.

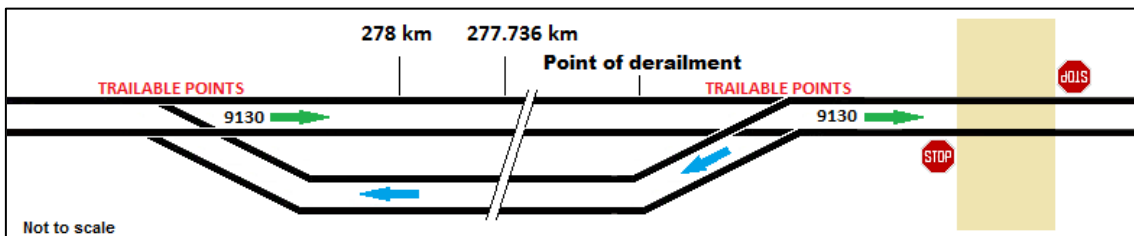
Figure 3: Schematic of track layout at Emu Loop

Emu Loop was an 840 m long crossing loop configured so that trains were routed onto the left-hand track in the direction of travel and through trailable points at the opposite end (Figure 3). The loop (mid-point) was located 277.736 km from Melbourne, between Dunolly and St Arnaud. A trackside distance marker and creep monument⁵ was provided at 278 km.

The traffic pattern between Mildura and Maryborough, and therefore through Emu, was such that loaded traffic was predominant in the Up direction. Up trains approached the permanent speed restriction of 65 km/h for the Up end trailable point on a slight descending gradient. The combination of these operational and physical characteristics created conditions conducive to rail creep of the left-hand track in the Up direction. The fixed points at the loop's Up-end, comprising of the turnout and the level crossing, provided resistance to any creep and therefore heightened the potential for high rail compression at this location.

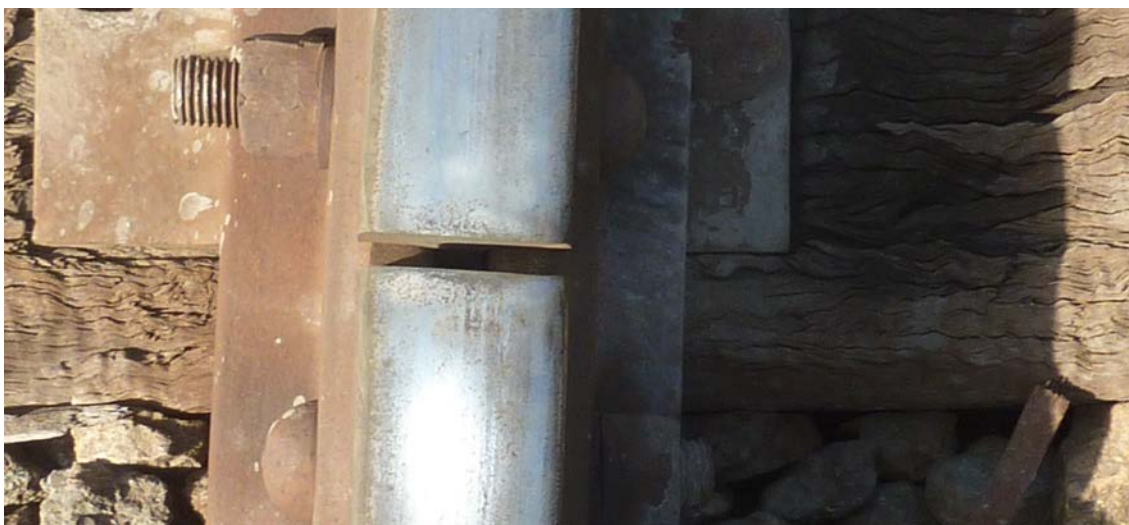
Figure 4: Typical expansion gap in jointed rail

Rails in jointed track are laid to make use of an expansion gap between the lengths of rail (Figure 4). The objective is to install rails so that the extremes of weather can be tolerated. This is a balance aimed at minimising rail fractures in cold weather (rails contracted and in tension) and track misalignment in hot weather (rails expanded and in compression).

The ongoing management of stress in rails relies on a number of factors including maintaining the function of mechanical rail joints. Frozen joints that no longer allow movement of the rail ends removes one component of rail stress management.

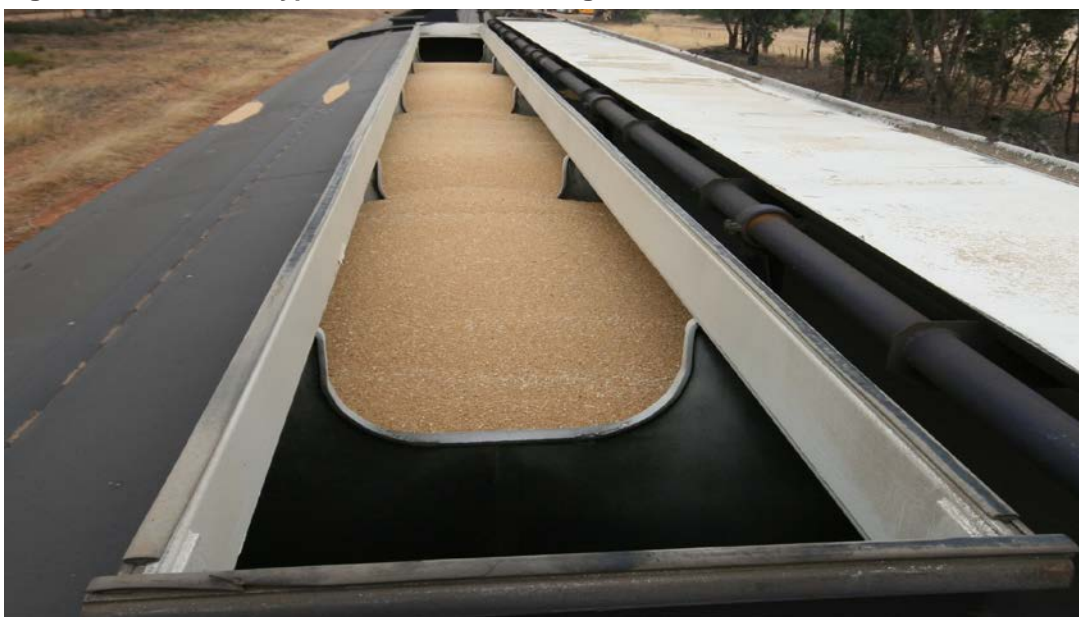
Figure 5: Train 9130 typical loaded WGSY wagon

WGSY wagons have a tare of 24 t and a capacity of 68 t, for a gross vehicle mass of 92 t. However, they were limited on the V/Line network between Birchip and North Geelong to a maximum vehicle mass of 76 t, meaning they have excess capacity and are susceptible to overloading. Inspection at site found that in this instance (compared to previous investigation⁹) the hopper end-bins had not been loaded (Figure 5).

The train consist report indicated that the last wagon was empty, the second last partially loaded and all other WGSY wagons loaded to the network limit of 76 t. However, it was identified that the last and second last wagon were both empty and the third last partially loaded. In effect, this meant that the total train load was distributed across the other loaded wagons. Post derailment weighing of the leading 25 wagons confirmed that 11 of these wagons had a mass exceeding the network limit, by up to five tonnes.

Improvements have been achieved in the loading process of WGSY wagons by keeping the hopper end-bins empty, however a proportion of these wagons continue traversing the V/Line network in an overloaded condition.
