# Passenger train collision with maintenance equipment

Montgomery, near Sale, Victoria | 16 February 2015

**ATSB Transport Safety Report**  
Rail Occurrence Investigation  
RO-2015-003  
Final – 9 December 2015

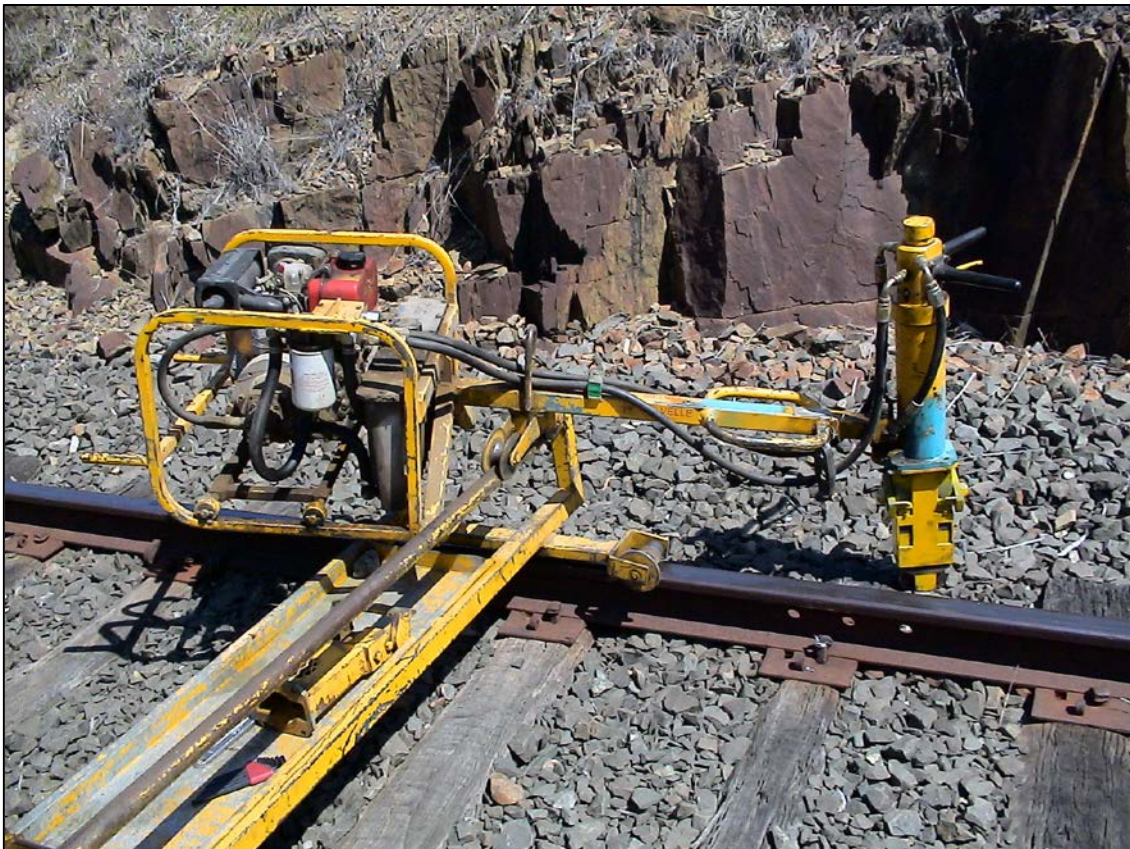
As part of the maintenance works, hand and light mechanical tools were being used. One of the tools was a dog spike puller (Figure 1). At some point, when it was not being used, the dog spike puller was moved along the track, about 20 m away from the work area, and left unattended.

**Figure 1: A dog spike puller similar to that used at Montgomery**

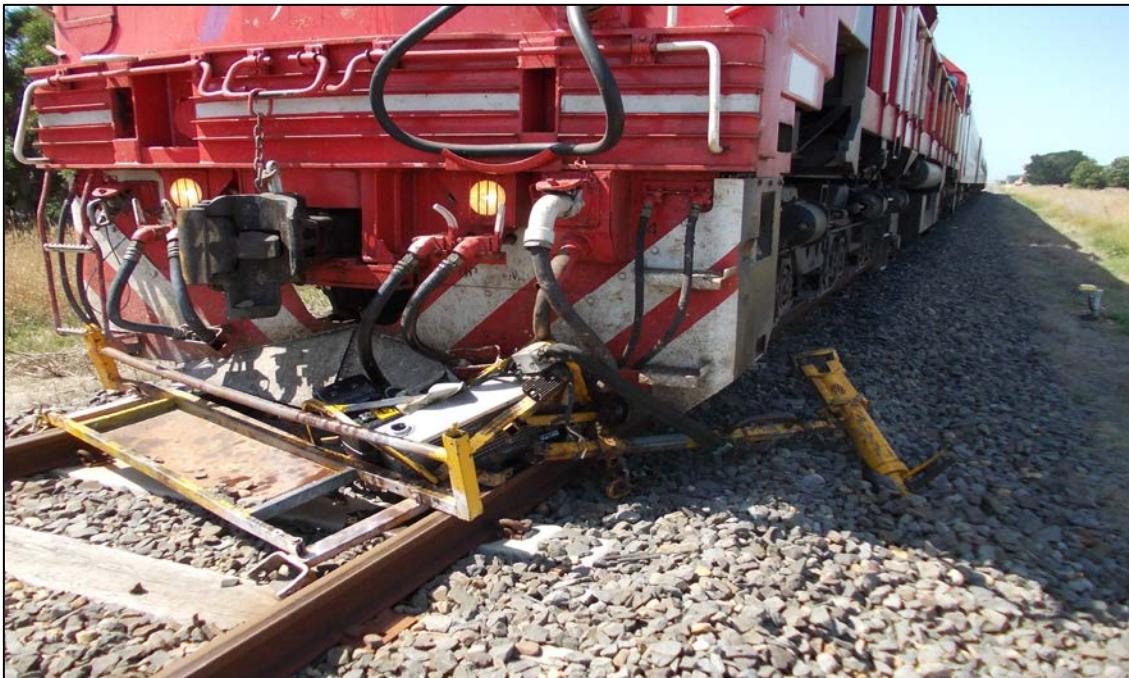
The train could not stop in time to prevent the collision with the dog spike puller that had been left on the track. The equipment was pushed along the track by the locomotive and train 8403 came to a stop at 1033, about 380 m past the crossing.

**Figure 2: Destroyed dog spike puller under the cow catcher of locomotive N452**

The dog spike puller had been moved away from the direct area of works and left unattended. It is probable that this led to the lead Ganger overlooking that it was still on the track.

- The dog spike puller was overlooked when the maintenance gang cleared the track to permit the passage of train 8403. As a result, the line was obstructed and the dog spike puller was impacted by the train.

As a result of this incident and other related Safeworking incidents, V/Line has completed a 'Take 5' (stand down day) where work was halted to review and discuss the following topics with major works and maintenance personnel workers.

As part of its 'Destination Zero Strategy' (refer Additional Safety actions) and particularly pertinent to this incident, a Track Worker Safety Review has been commenced. This involves a review of tasks, rules, procedures, and training for works. It includes a review of the levels for Safeworking and rules for infrastructure works.
