Signals Passed at Danger by train 7750

Marshall, Victoria | 2 January 2018

ATSB Transport Safety Report
Rail Occurrence Investigation
RO-2018-001
Final – 15 January 2020

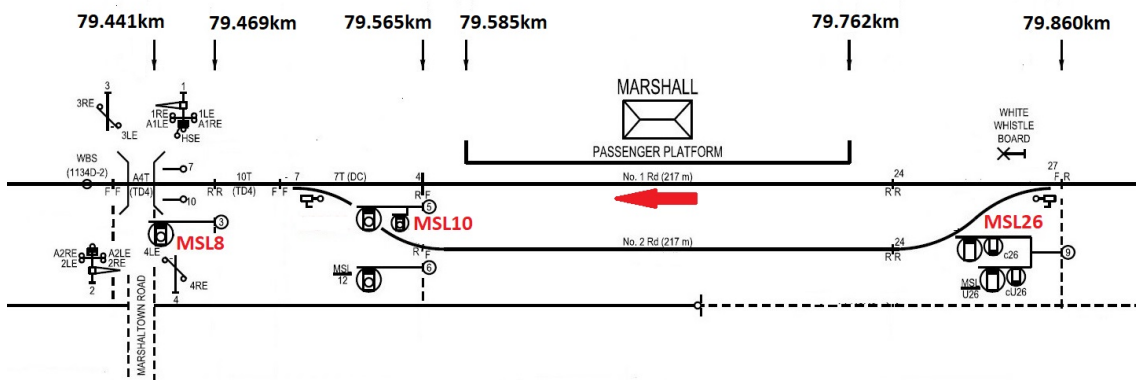
Figure 3: Extract of signalling diagram at Marshall Railway Station

MSL26 was located before Marshall Railway Station, and MSL10 and MSL8 following the station and before Marshalltown Road level crossing (Figure 3).

The Marshalltown Road level crossing was track-circuit activated. However, when signal MSL10 displayed a Stop indication, the level crossing would not be activated if a train passed the signal and occupied the track circuit on the Geelong side of the signal. This configuration was to cater for a low-speed run-around movement⁸ where a calling-on signal⁹ provided authority for a locomotive to move from one end of a train to the other without activating the Marshalltown Road level crossing. Consistent with this configuration, train 7750 did not trigger the crossing protection system until it had travelled beyond signal MSL8, approximately 28 m before the level crossing.

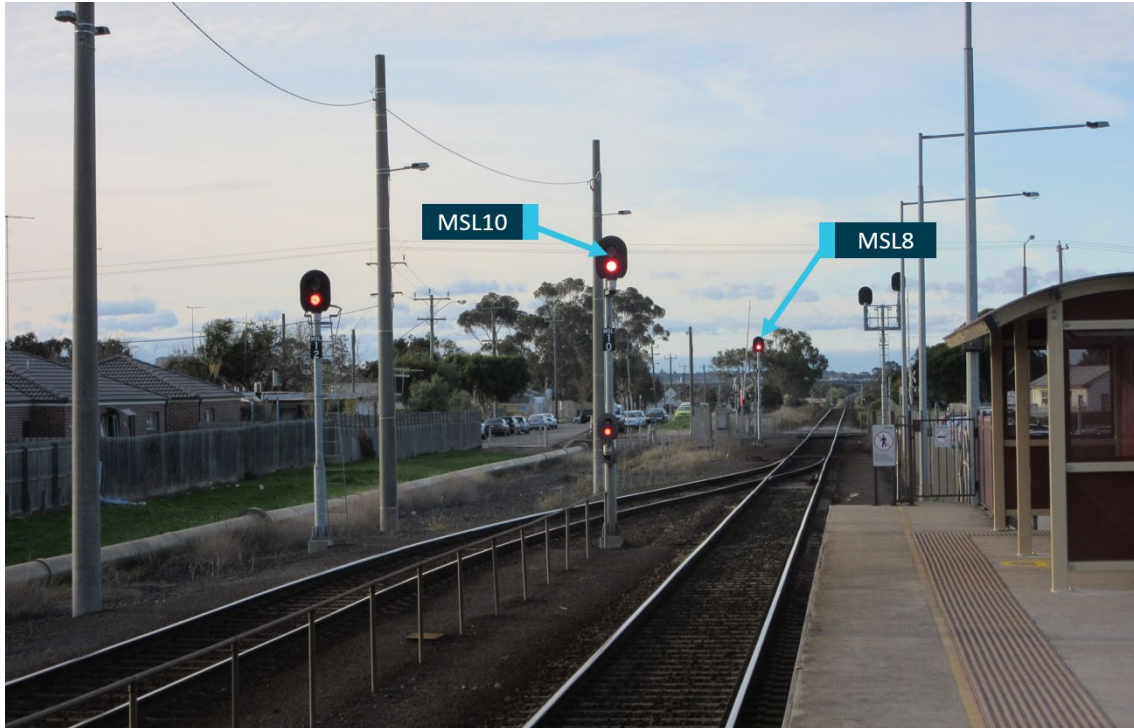
Figure 4: Signals MSL10 and MSL8 at Marshall, pictured displaying ‘Stop’ indications

After passing MSL26, the speed of train 7750 further reduced. Home signals MSL10 and MSL8 were at Stop and the train passed both signals at a speed of about 64 km/h, at 14:13:24 and 14:13:29 respectively. The train had passed signals MSL10 and MSL8 without authority. This type of event is referred to as a Signal Passed At Danger (SPAD).

The driver reported noticing that the Marshalltown Road level crossing booms were up and making an Emergency brake application. The train entered the single line between Marshall and South Geelong and then the level crossing, before the booms had lowered.

V/Line has installed a train protection system at this location to stop a train that has passed a signal at Danger. The system also has several over-speed sensors to prevent a train entering the Marshalltown Road level crossing when unprotected.

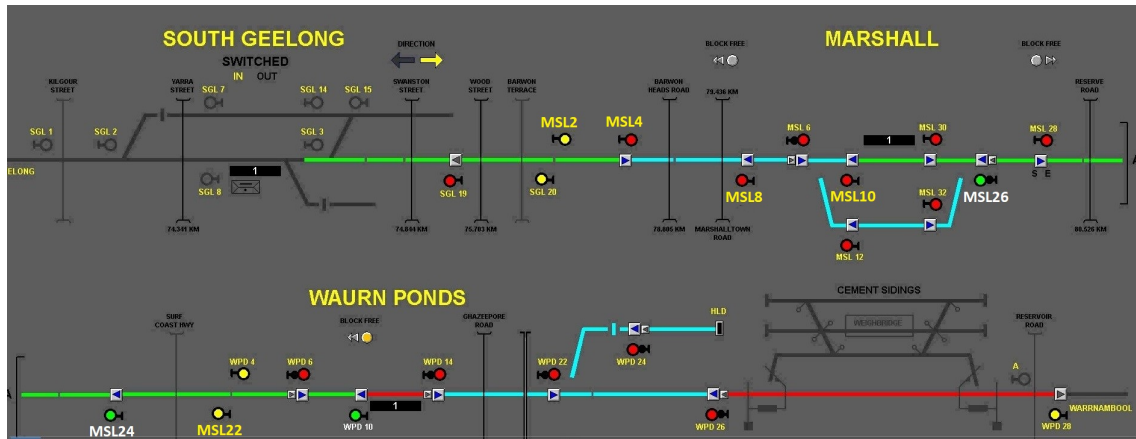
Figure 5: Snapshot of VDU when train 7750 was at Waurn Ponds

At this point, a route had been set (in green) from Waurn Ponds Railway Station to Marshall. Departure signal WPD10 was at Proceed, MSL22 at Caution (because MSL10 and MSL8 were at Stop), MSL24 and MSL26 were at Proceed, and MSL10 was at Stop to hold train 7750 at Marshall Railway Station.

Beyond MSL10, the track was clear but a route had not yet been set beyond MSL10. This route condition remained unchanged until train 7750 later occupied this single-line section of track.

A route had been set from Waurn Ponds to Marshall Railway Station. Distant signal MSL22 was at Caution (because MSL10 and MSL8 were at Stop) and signals MSL24 and MSL26 were at Proceed. Beyond MSL10, the track was clear but a route had not yet been set beyond MSL10.

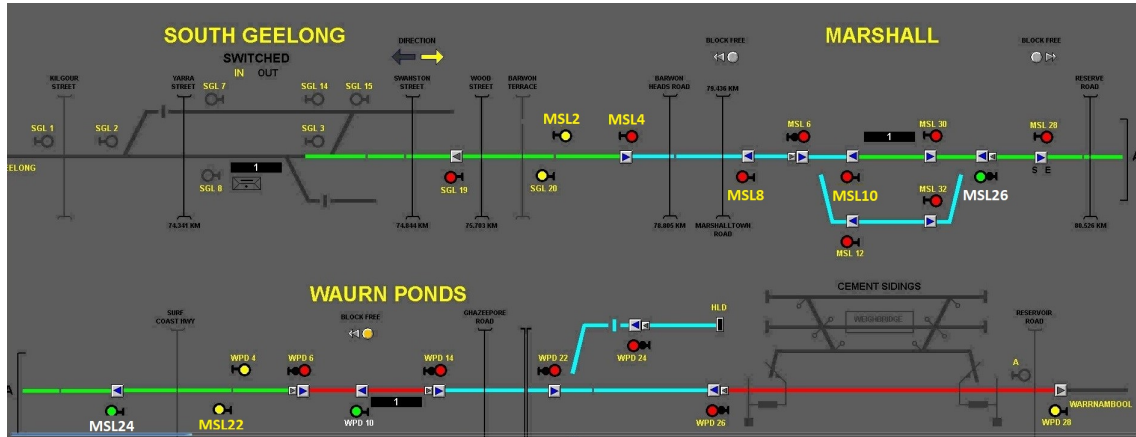
Figure 6: Snapshot of VDU after train 7750 had departed Waurn Ponds

The second snapshot (Figure 6) showed the status of the network as train 7750 passed WPD10. The route for train 8865 (green) was set from South Geelong through to MSL4 but the train had not yet been detected in this section. The status of signals and points at Marshall remained unchanged.

The route for train 8865 (the Melbourne to Warrnambool) was set through to MSL4 but the train had not yet been detected in the section beyond South Geelong. The status of signals and points at Marshall remained unchanged.
Source: V/Line, annotated by Chief Investigator, Transport Safety (Vic)

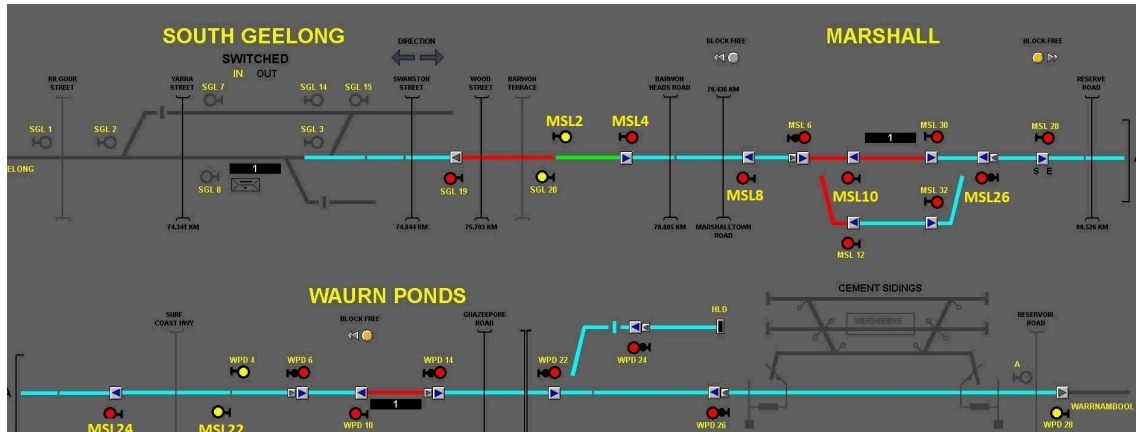
Figure 7: Snapshot of VDU when train 7750 was passing Marshall Railway Station

The third snapshot (Figure 7) showed train 7750 having passed signals MSL24 and MSL26, and these had reverted to Stop. The train was now in the track sections adjacent to the Marshall Railway Station. It had passed MSL10, but had not yet reached MSL8. The Warrnambool-bound train 8865 occupied the section up to Distant signal MSL2.

Train 8865 had a route (green) set towards Marshall, but not beyond signal MSL 4, which was at Stop.

Train 7750 had passed MSL24 and MSL 26, and the train was in the track sections adjacent to the Marshall Railway Station and beyond MSL10, but not yet past MSL8. The Warrnambool-bound train 8865 was in the section up to Distant signal MSL 2, and had a route set towards Marshall, but not beyond signal MSL 4 which was at Stop.
Source: V/Line, annotated by Chief Investigator, Transport Safety (Vic)

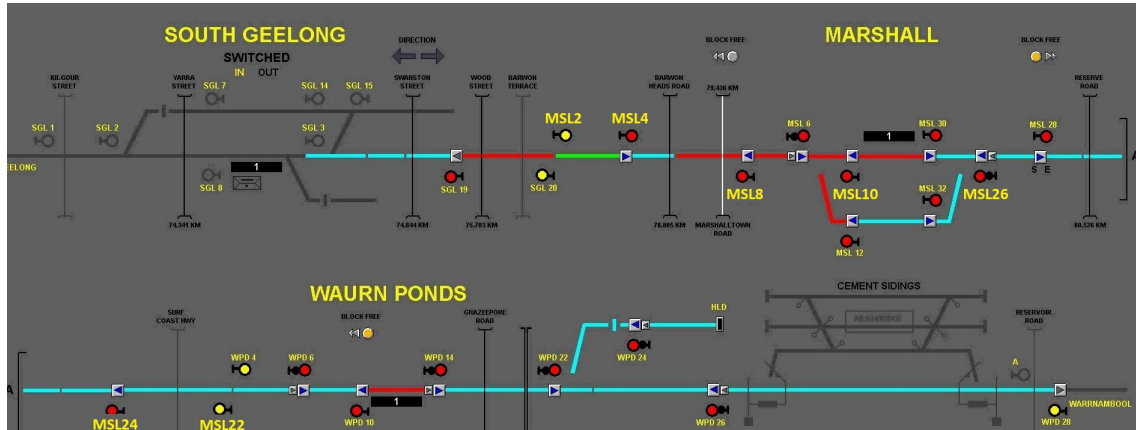
Figure 8: Snapshot of VDU when train 7750 passes MSL8 and enters the level crossing

The VDU recording showed that train 7750 travelled beyond signal MSL8 and entered the Marshalltown Road level crossing travelling on the single line towards South Geelong (Figure 8). The level crossing protection had also activated (indicated by its change on the VDU from a black line to white).

This had placed the trains in potential conflict. Once past MSL8, the next Home signal that would face train 7750 was SGL19 at South Geelong, beyond the location of train 8865.

Train 7750 was now on the single line towards South Geelong, placing the trains in conflict.
 Source: V/Line, annotated by Chief Investigator, Transport Safety (Vic)

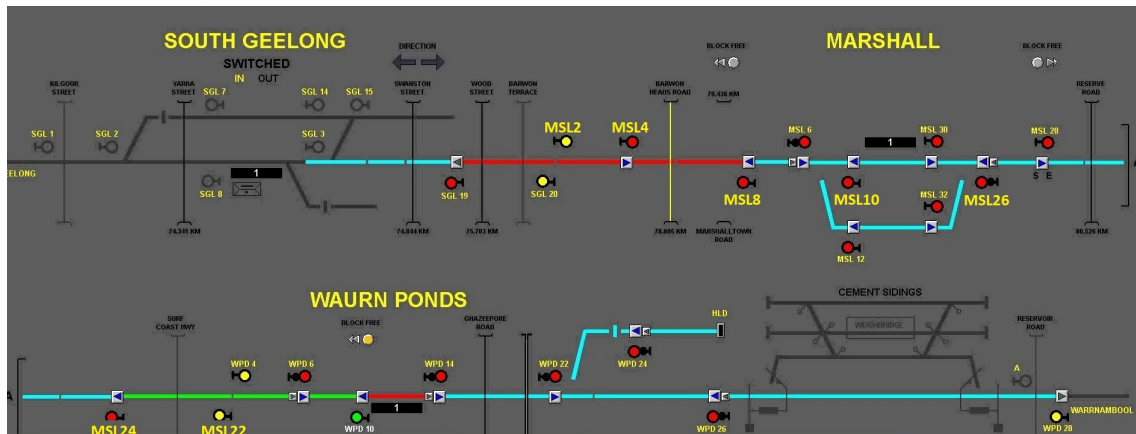
Figure 9: Snapshot of VDU with trains 7750 and 8865 stopped in adjacent sections

The recording then showed that train 8865 had passed signal MSL2 and entered the section up to signal MSL4, that was at Stop (Figure 9). The trains were now in adjacent track sections. There were no further signals that could have prevented train 7750 continuing to the location of train 8865.

Train 8865 would be held by signal MSL4 that was at Stop. However, there was no signal ahead of train 7750 that would prevent it from continuing to the location of train 8865.
 Source: V/Line, annotated by Chief Investigator, Transport Safety (Vic)
