# Derailment of freight train 6BM9

Creighton, Victoria on 21 January 2019

**ATSB Transport Safety Report**

RO-2019-003

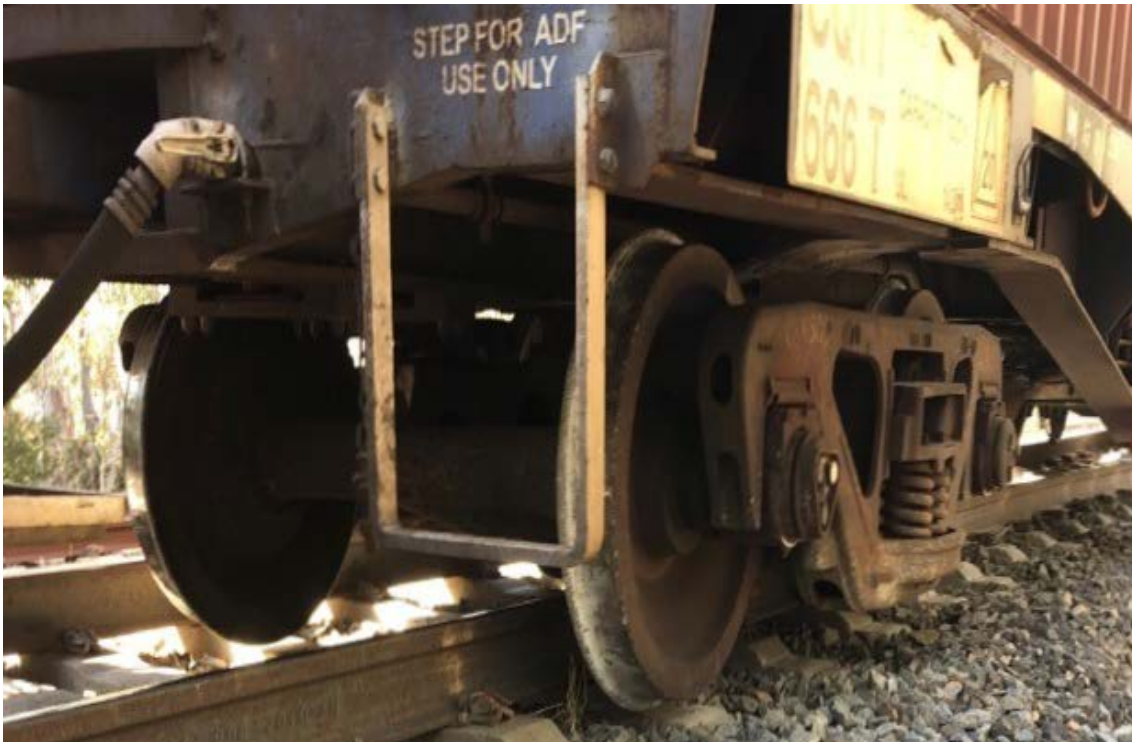
**Figure 2: Derailed bogie of wagon CQTY 666T**

The train came to a stop with the lead locomotive just past the 141 km post. After stopping, the crew initiated an emergency call to network control. One of the crew then inspected the train and identified that the leading bogie of the third-last wagon (CTQY 666T) had derailed (Figure 2).

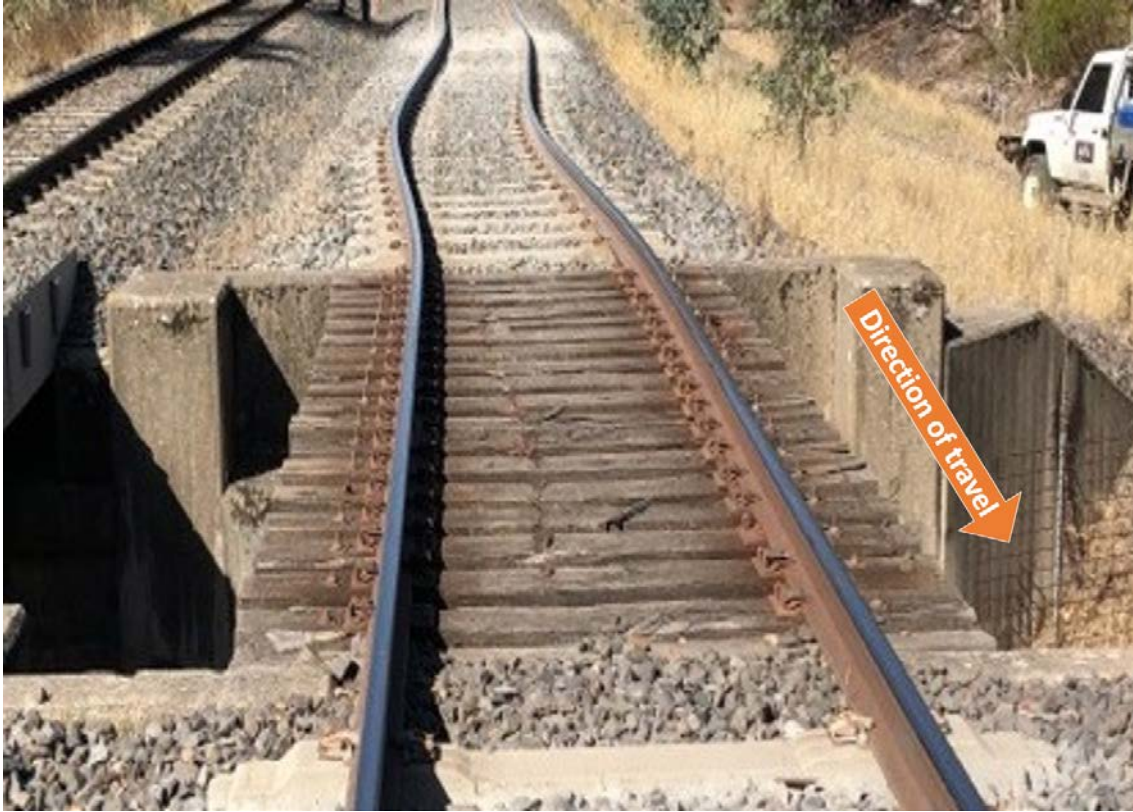
**Figure 3: Track misalignment photographed at 1710 on 21 January, after derailment.**

Immediately following the derailment and prior to the drop in temperatures that evening, the track at the derailment location was inspected by the rail infrastructure manager, the Australian Rail Track Corporation (ARTC). The track exhibited a significant lateral misalignment (Figure 3).

*This photograph was taken soon after the derailment in temperatures similar to those existing at the time of the derailment, and prior to the track cooling overnight. It shows a significant track misalignment ahead of the rail bridge.*

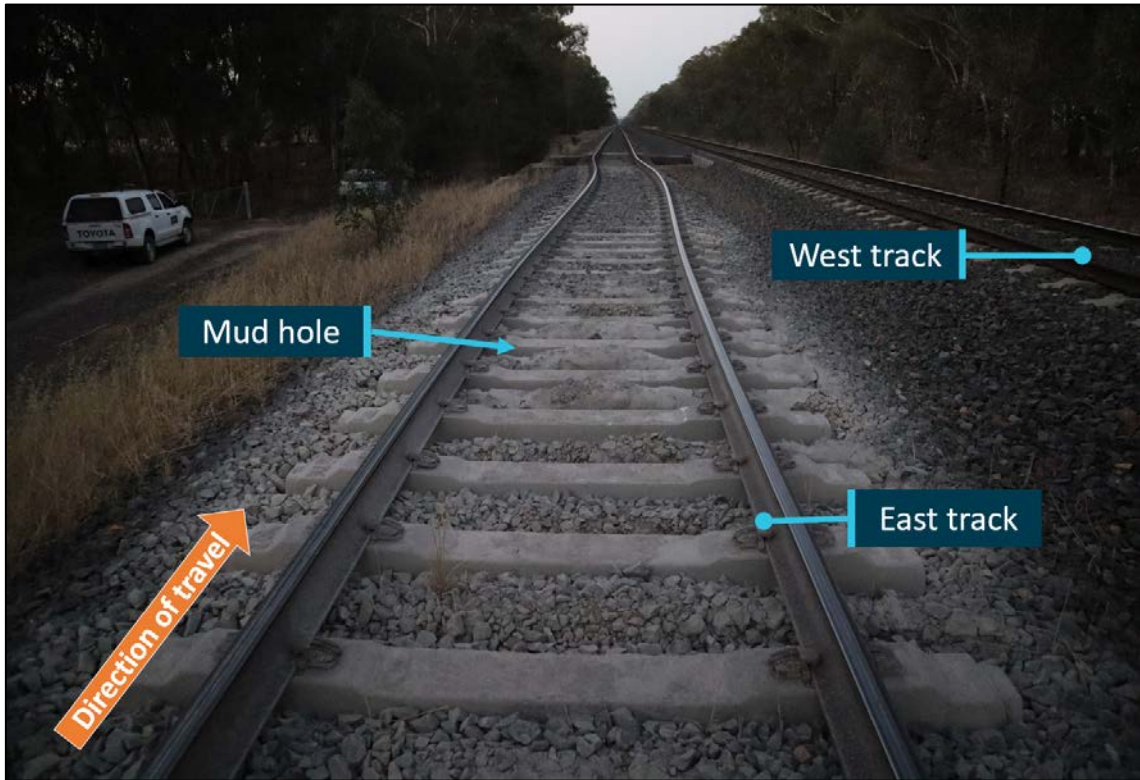
Figure 7: Mud hole and track buckle on east track before bridge located at 142.710 km.

An examination of the track following the derailment identified misaligned track up to the 142.710 km rail bridge and associated lateral displacement of sleepers. Significant ballast fouling was observed from 16 to 27 m before the rail bridge. The most severe fouling and loss of ballast profile was from about 20 to 24 m prior to the rail bridge (Figure 7). A dip in the track through this mud hole location was observed.

Site evidence indicated that the initial derailment was of a single wheelset that had derailed to the left of the track before the bridge at 142.710 km. The point of mount of the left-hand wheel and the drop-off points of both wheels could not be determined with certainty. There was some indication of the right-hand wheel having dropped inside the right rail about 10 m before the rail bridge. There was further evidence indicating that the second wheelset (of the same bogie) derailed prior to the next bridge at 141.827 km.

*This photograph was taken in the early morning of the day following the derailment. The rails had contracted in the cooler overnight temperatures and the magnitude of the track misalignment had reduced from its peak. The photograph shows the heavy fouling of the ballast about 20-24 m ahead of a short rail bridge.*

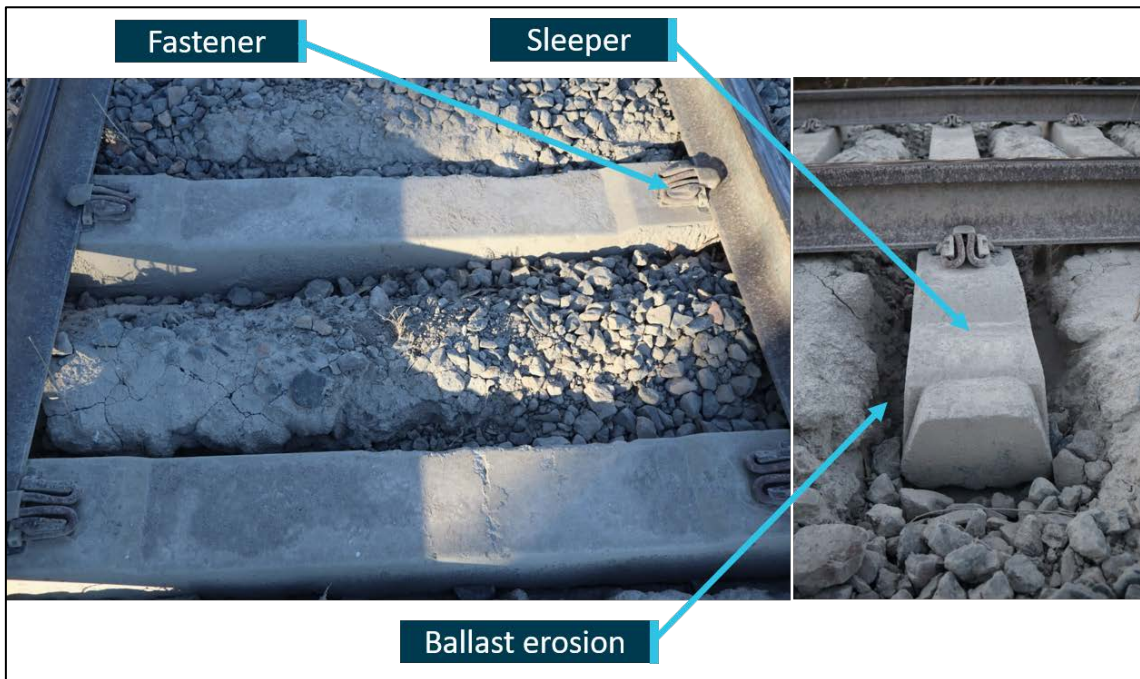
Figure 8: Mud hole at the derailment location

At the location of the mud hole there was severe contamination of the ballast and a loss of ballast between sleepers, and at sleeper ends (Figure 8).

Under such conditions, maintaining track stability relies on rail fastenings and track support, including ballast, to resist the forces acting to laterally misalign (buckle) the rails. Ahead of the rail bridge at 142.710 km, there was a mud hole and a loss of ballast profile around sleepers. This reduced resistance to track lateral movement and increased the potential for track instability at this location.

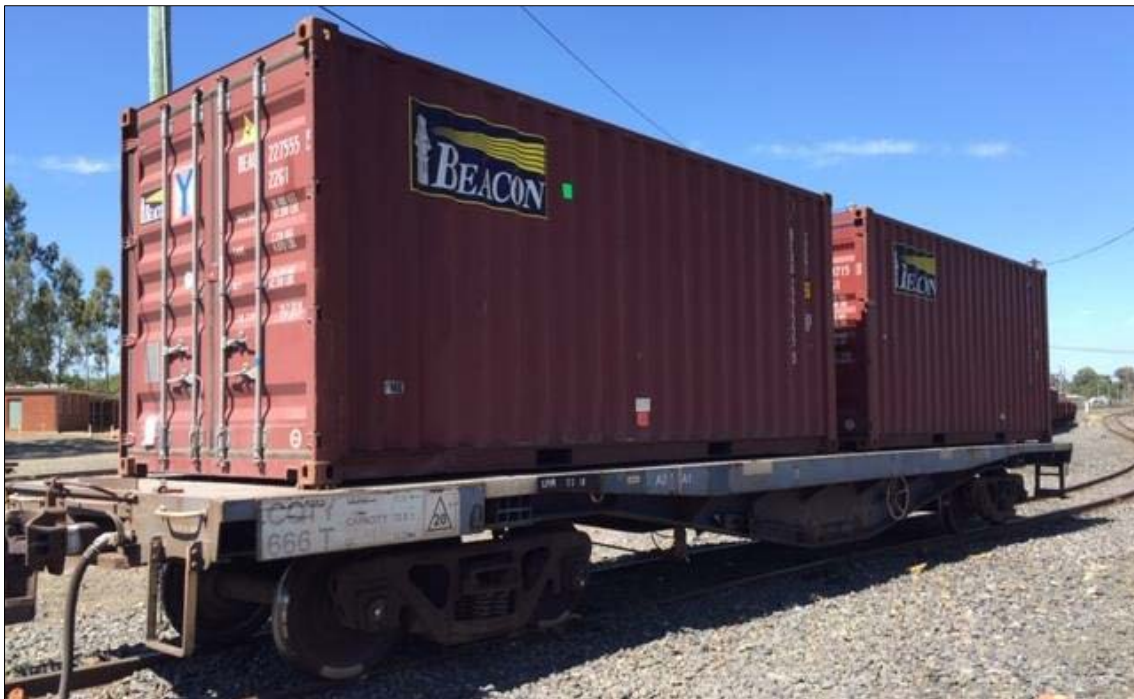
**Figure 9: Derailed wagon CQTY 666T**

The derailed wagon CQTY666T (wagon 29) was a two-slot container flat wagon loaded with two empty containers, each weighing about 2.28 t (Figure 9).

Post-incident inspection of the wagon and the bogies revealed minimal wheel tread wear with moderate operational spalling damage. The light to moderate bolster gibbon contact indicated either extended operation on poor track or bogie hunting.

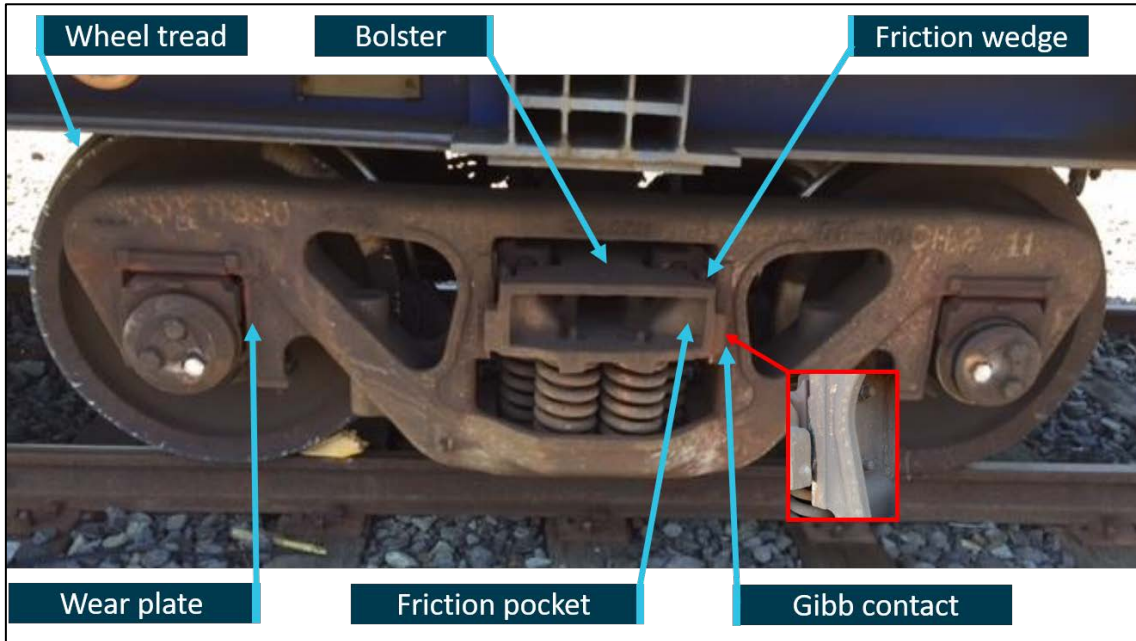
**Figure 10: Bogie components**

Components of the friction wedge system such as wear plates, friction wedges and bolster pockets were all partially worn, while the wedges and side frame column wear plates were in good condition. The most likely cause of this wear would be inadequate attention to friction wedge pockets in the bolster at overhaul (Figure 10).

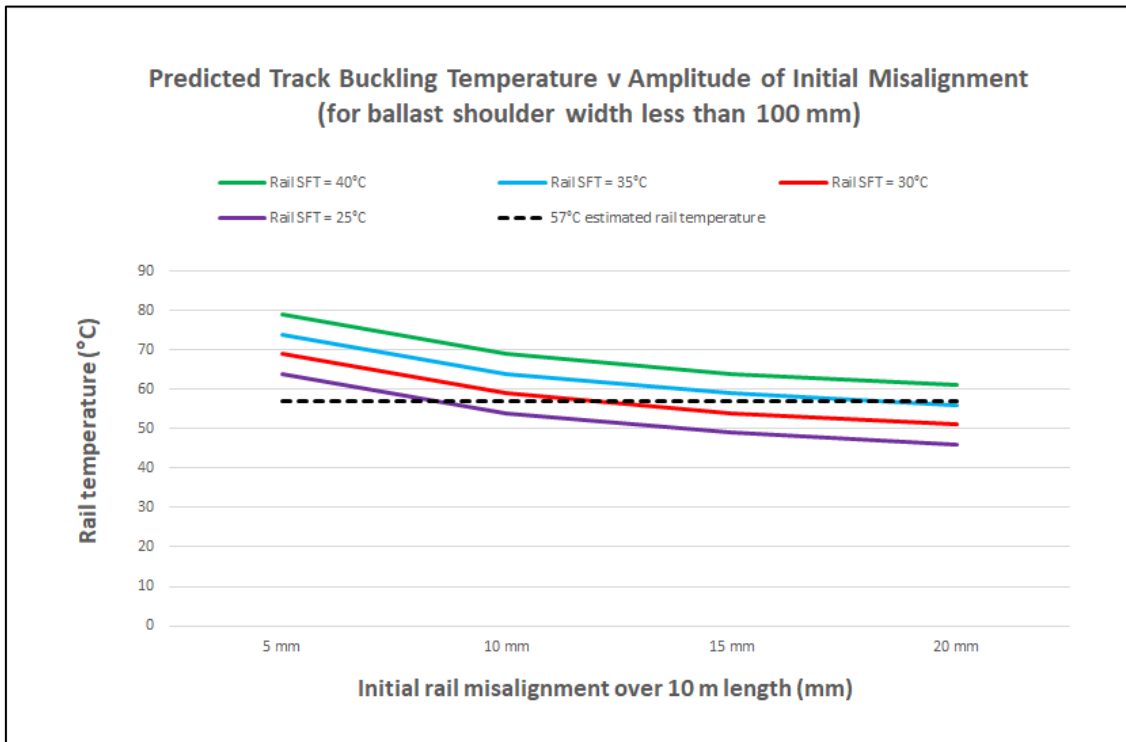
**Figure 12: The influence of rail misalignment on predicted track buckling temperature**

The predicted buckling temperatures for a range of scenarios was compared to the estimated rail temperature at the time of the incident. The results of the predictor model indicate that the magnitude of the buckling initiator is a significant factor in the predicted magnitude of the lateral buckling force and the potential for a heat-induced buckle. The model suggests that with an initial lateral misalignment of over 10 mm, track buckle was plausible, particularly in the presence of lower rail stress-free-temperatures (Figure 12).

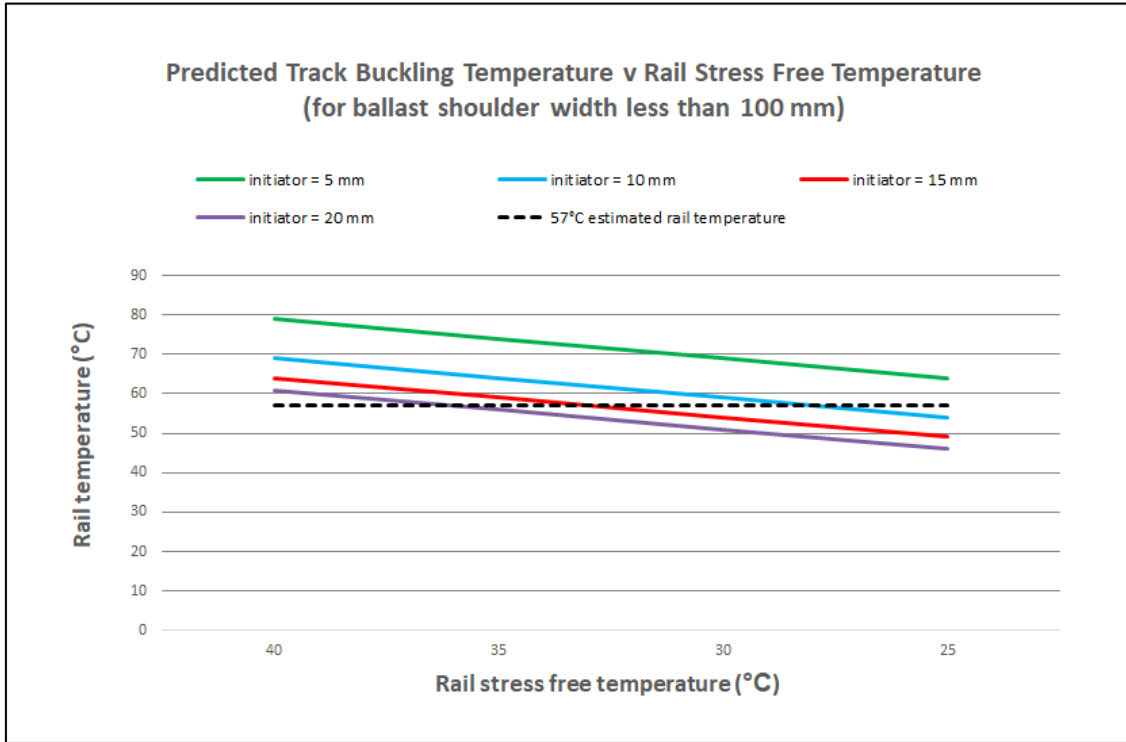
**Figure 14: The influence of rail SFT on predicted track buckling temperature**

A localised reduction of SFT of 5-10°C on the measured post-incident 35 °C ‘average’ for the section (to an SFT of 25-30°C) would have resulted in heightened likelihood of track buckle, particularly in the presence of an initial lateral misalignment of more than 10 mm (Figure 14).
