Parting of Metro Trains Melbourne passenger train TD 3817

Croydon, Victoria, 9 November 2018

Rail Occurrence Investigation

RO-2018-019

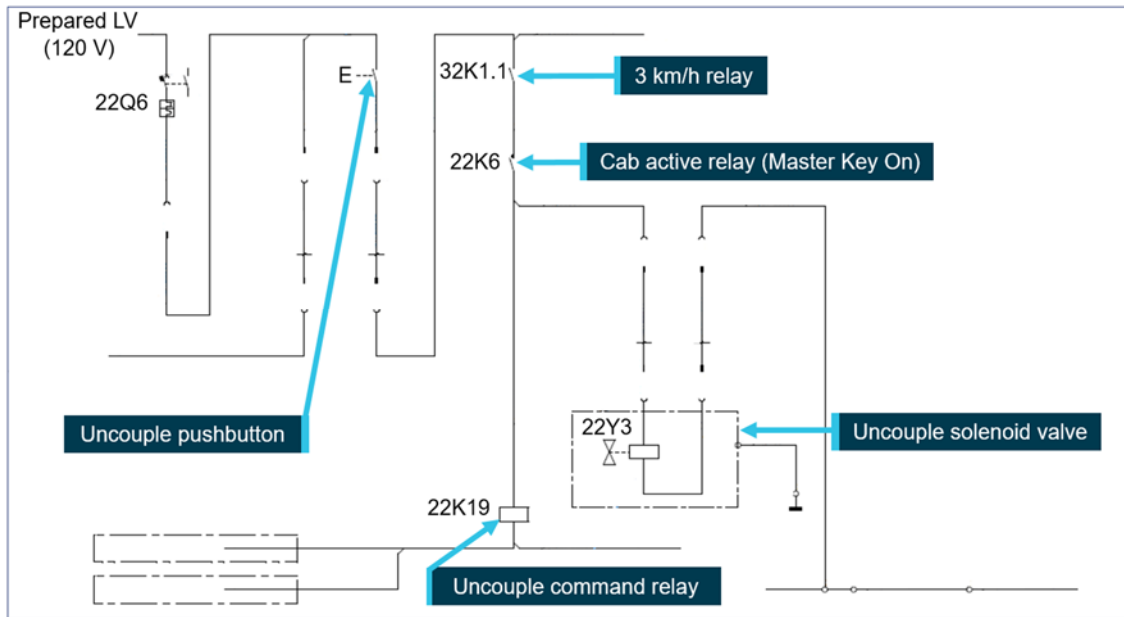
Figure 8: Wiring diagram for uncoupling system

For the uncouple pushbutton to activate the uncouple solenoid valve, the cab has to be in-service (cab active) and the train speed has to be below 3 km/h (Figure 8). Pressing the uncouple pushbutton from the active cab energises the uncouple command relay which deactivates the coupling detection contactor relays. These in turn disconnect the traction and braking signals across the coupler electrical heads prior to uncoupling.

In this instance, the uncoupling function was activated through an electrical circuit that was created by a wiring error in car 959M and the low IR of the uncouple solenoid of car 882M. This error resulted in the cab active relay, push button and the 3 km/h relay interlock devices being bypassed and allowing the unintended activation of the uncoupling circuit. The safety loop circuit on the lead car unit maintained the closed safety loop, hence emergency braking was not applied and it continued its journey until the driver realised that the trailing car unit had uncoupled, and brought the lead 3-car unit to a stop. As there were no active cabs in the trailing 3-car unit, the safety loop was opened, de-energising the emergency brake solenoid valves, resulting in the application of the emergency brakes on the trailing car unit bringing it to a stop.

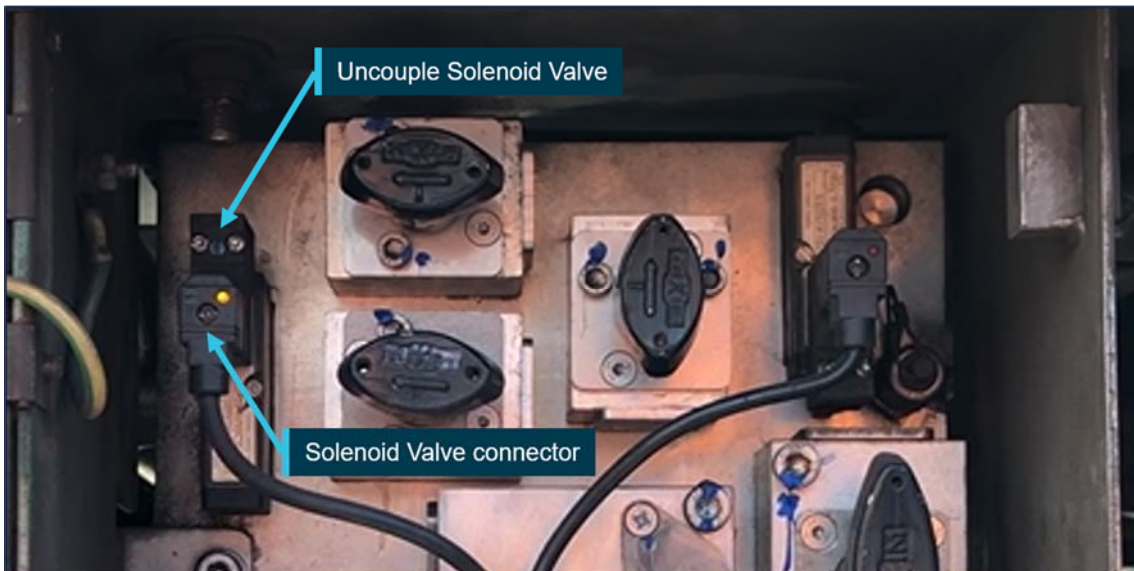
Figure 10: Electro-pneumatic panel box showing uncouple solenoid valve

Uncouple solenoid connectors of the coupled motor cars (959M and 882M) were tested for insulation resistance (IR)⁷ to ground (vehicle body/frame). The IR value for the uncoupling solenoid connector of car 882M was found to be 20 kΩ, when the typical IR is required to be over 100 MΩ. However, the low IR would not result in unintentional energising of the uncoupling solenoid valve without a power source to the solenoid.

Further, testing indicated that both the uncoupling solenoid and the uncouple relay picked-up and actuated at a minimum voltage of about 50 V, which was not unusual.

Insulation resistance testing carried out on all the uncoupling solenoid connectors of the X'Trapolis fleet revealed that 15 uncoupling solenoid connectors measured low insulation resistance. In addition, 19 trip re-set connectors⁸ and 15 trip raise connectors⁹ also indicated low insulation resistance.

MTM advised that it has implemented a program of mandatory insulation resistance testing of the uncoupling solenoid connectors. The information from the testing will be provided to the original equipment manufacturer in order to assist with determining the root cause for the failure and take appropriate remedial action.

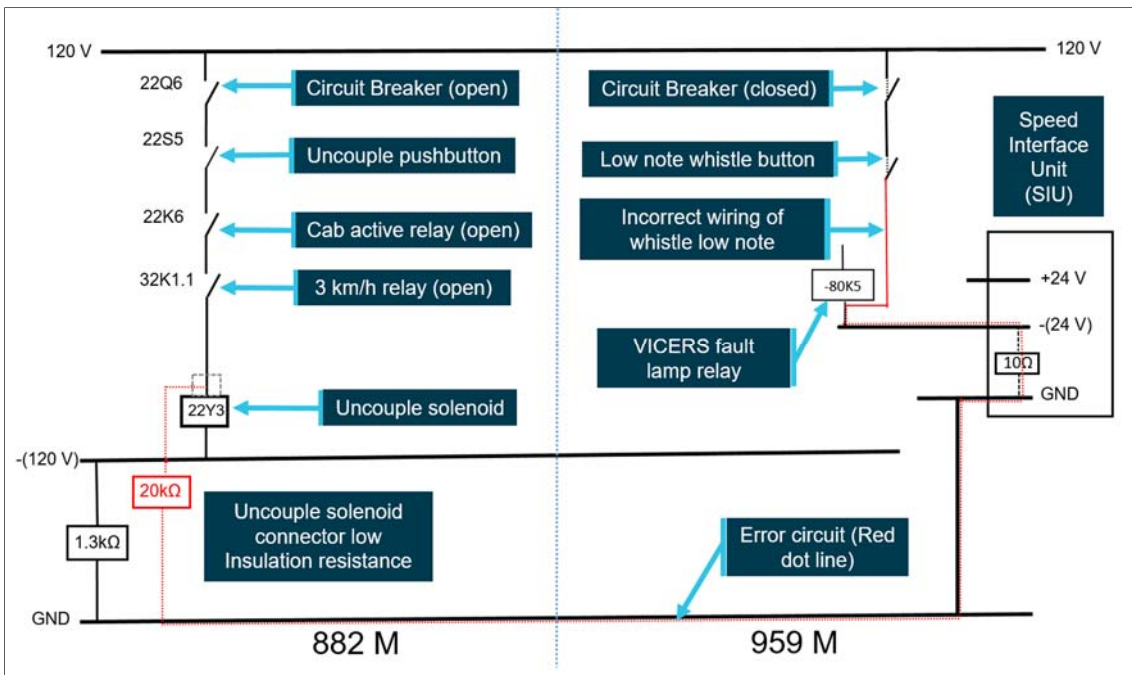
Figure 11: Electrical schematic showing incorrect wiring of low-note whistle

MTM conducted test runs of the 3-car set with car 959M as the lead cab-active car. Normally, zero voltage should exist between a power supply common negative and ground (earth/vehicle body). However, during the tests on car 959M, an oscilloscope measured an intermittent 120 V between the common 120 V negative and ground. Examination of the VICERS download trace indicated that the voltage spike coincided with the use of the low-note whistle (Figure 4). Further, static testing confirmed that activation of the low-note whistle resulted in the application of 120 V supply between common negative to ground.

Examination of the low-note whistle wiring indicated that a relay on car 959M was installed incorrectly and a cable was connected to a wrong terminal. This error resulted in the low-note whistle’s 120 V supply being connected to the negative (24 V) of the Speed Interface Unit (SIU), which is an interface between the car’s speed detector and the VICERS unit (Figure 11).

MTM’s investigation of the wiring error revealed that although the electrical circuit diagrams were accurate, the technician carrying out the modification had made a cable connection error. Inspection of the X’Trapolis fleet indicated that 11 low-note whistles were wired incorrectly by the same technician. A function test would not reveal the wiring error, as pushing the low-note whistle button would complete the circuit to actuate the low-note whistle. In this instance, an assurance program involving a secondary and independent check of the wiring modification may have been the only means of detecting this error.

The low-note whistle wiring document has been updated to provide further clarity and to prevent future wiring errors with respect to this modification. In addition, maintainers involved in low-note whistle modification work have been briefed and re-trained on the modification method statements. Further, completed modification work will require self-checks and supervisor checks.
