Impact with wharf by MV Lady Cutler

Docklands, Victoria on 14 January 2023

CITS Transport Safety Investigation Report

MO-01-2023

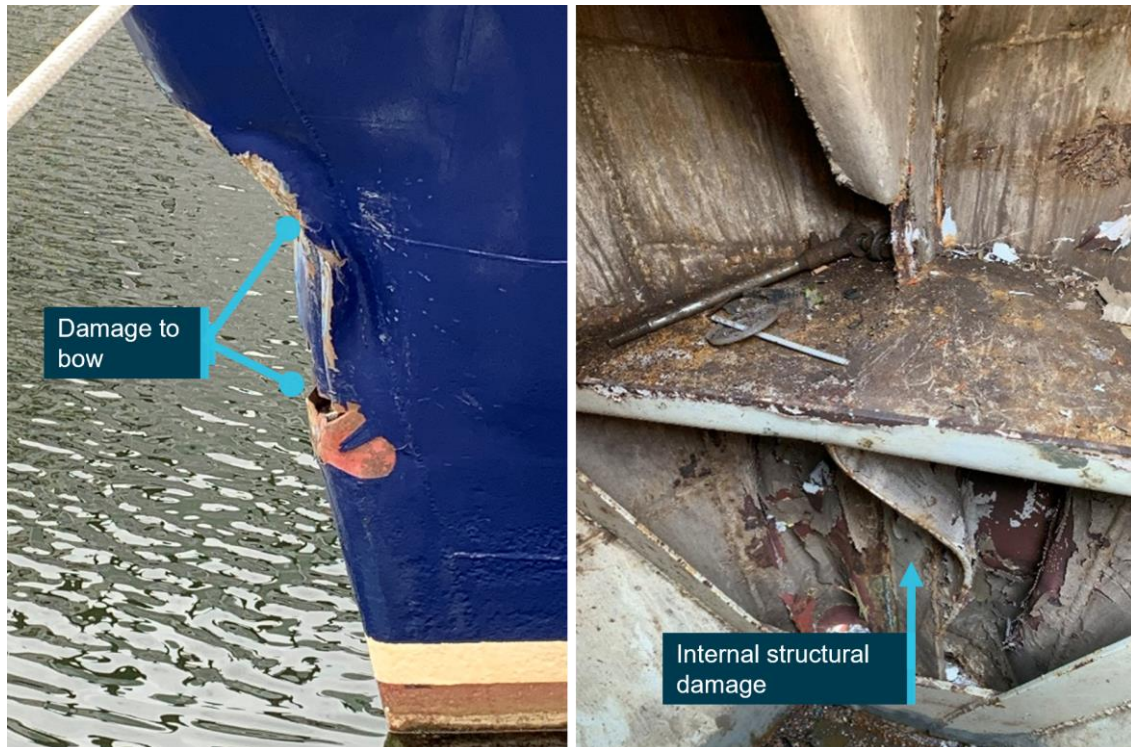
CCTV footage showed passengers falling at the time of impact. About 19 passengers sustained minor injuries. Five passengers were transported to hospital and later released. The bow of Lady Cutler and the wharf were damaged (Figures 2 and 3).

Figure 2: Impact damage to Lady Cutler's bow

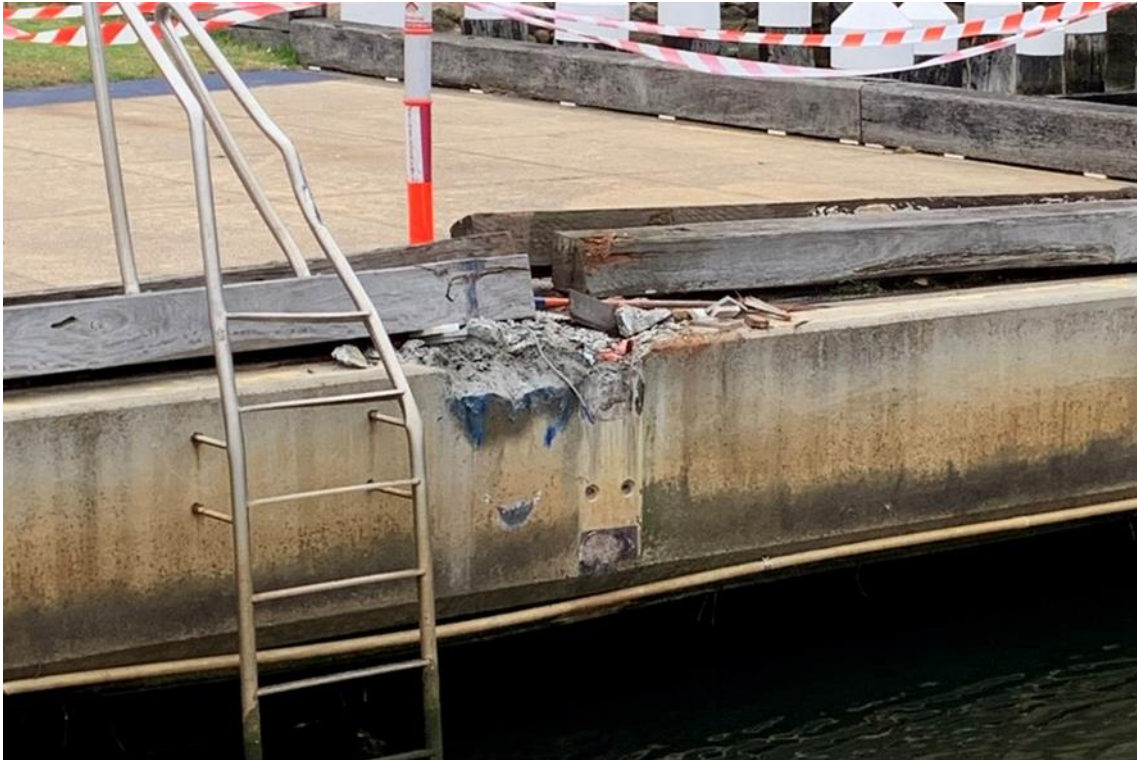
Figure 3: Impact damage to Yanonung Quay wharf

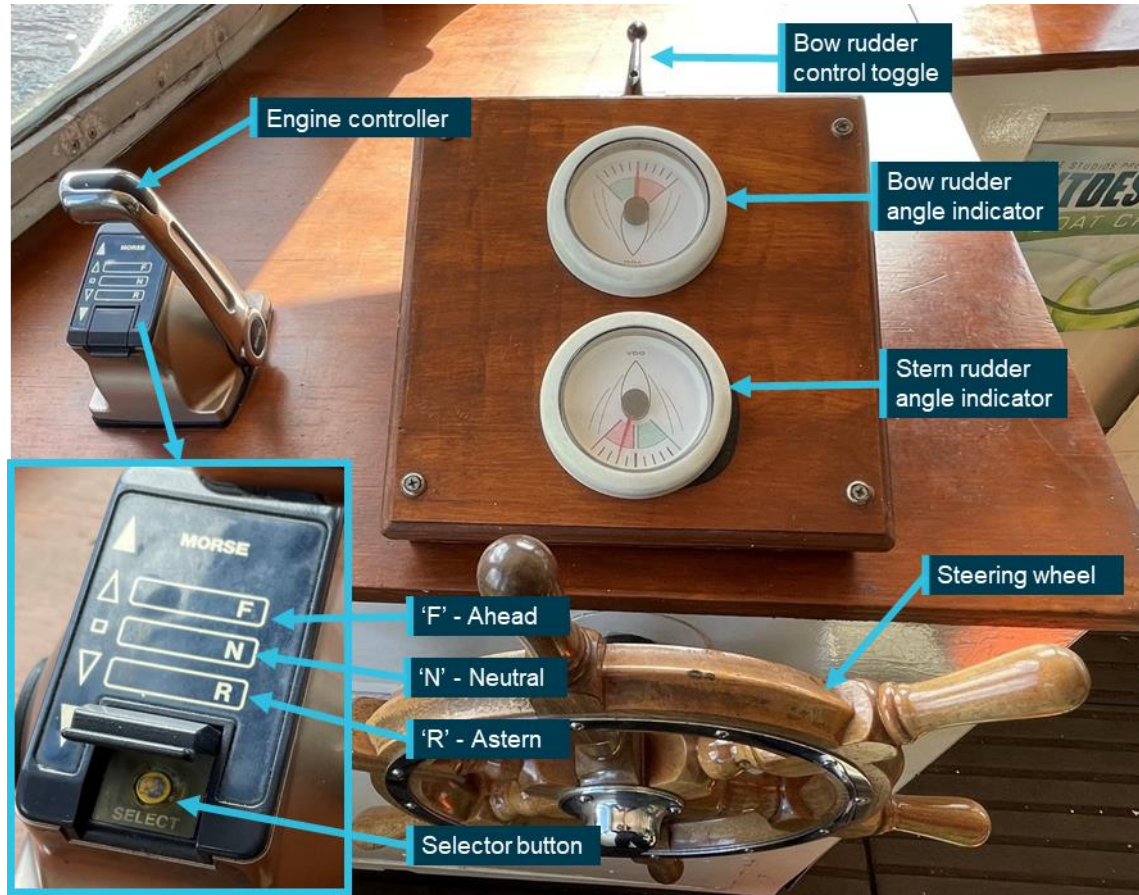
Figure 8: Lady Cutler port side navigation console

The most probable reasons for the unsuccessful propulsion control change-over to the port side console was that the master either did not return the port side controller to neutral before pressing the selector button or did not correctly press the button. There was no evidence of an electrical or mechanical defect in the control change-over system.
