Reaction to fire test report

Test standard: Ad-hoc test based off ISO 13785-1:2002

System: Aluminium composite panel wall system representative of the in-situ wall located at [REDACTED]
[REDACTED] – Scenario 1 - Test 1

Job number: RTF220102

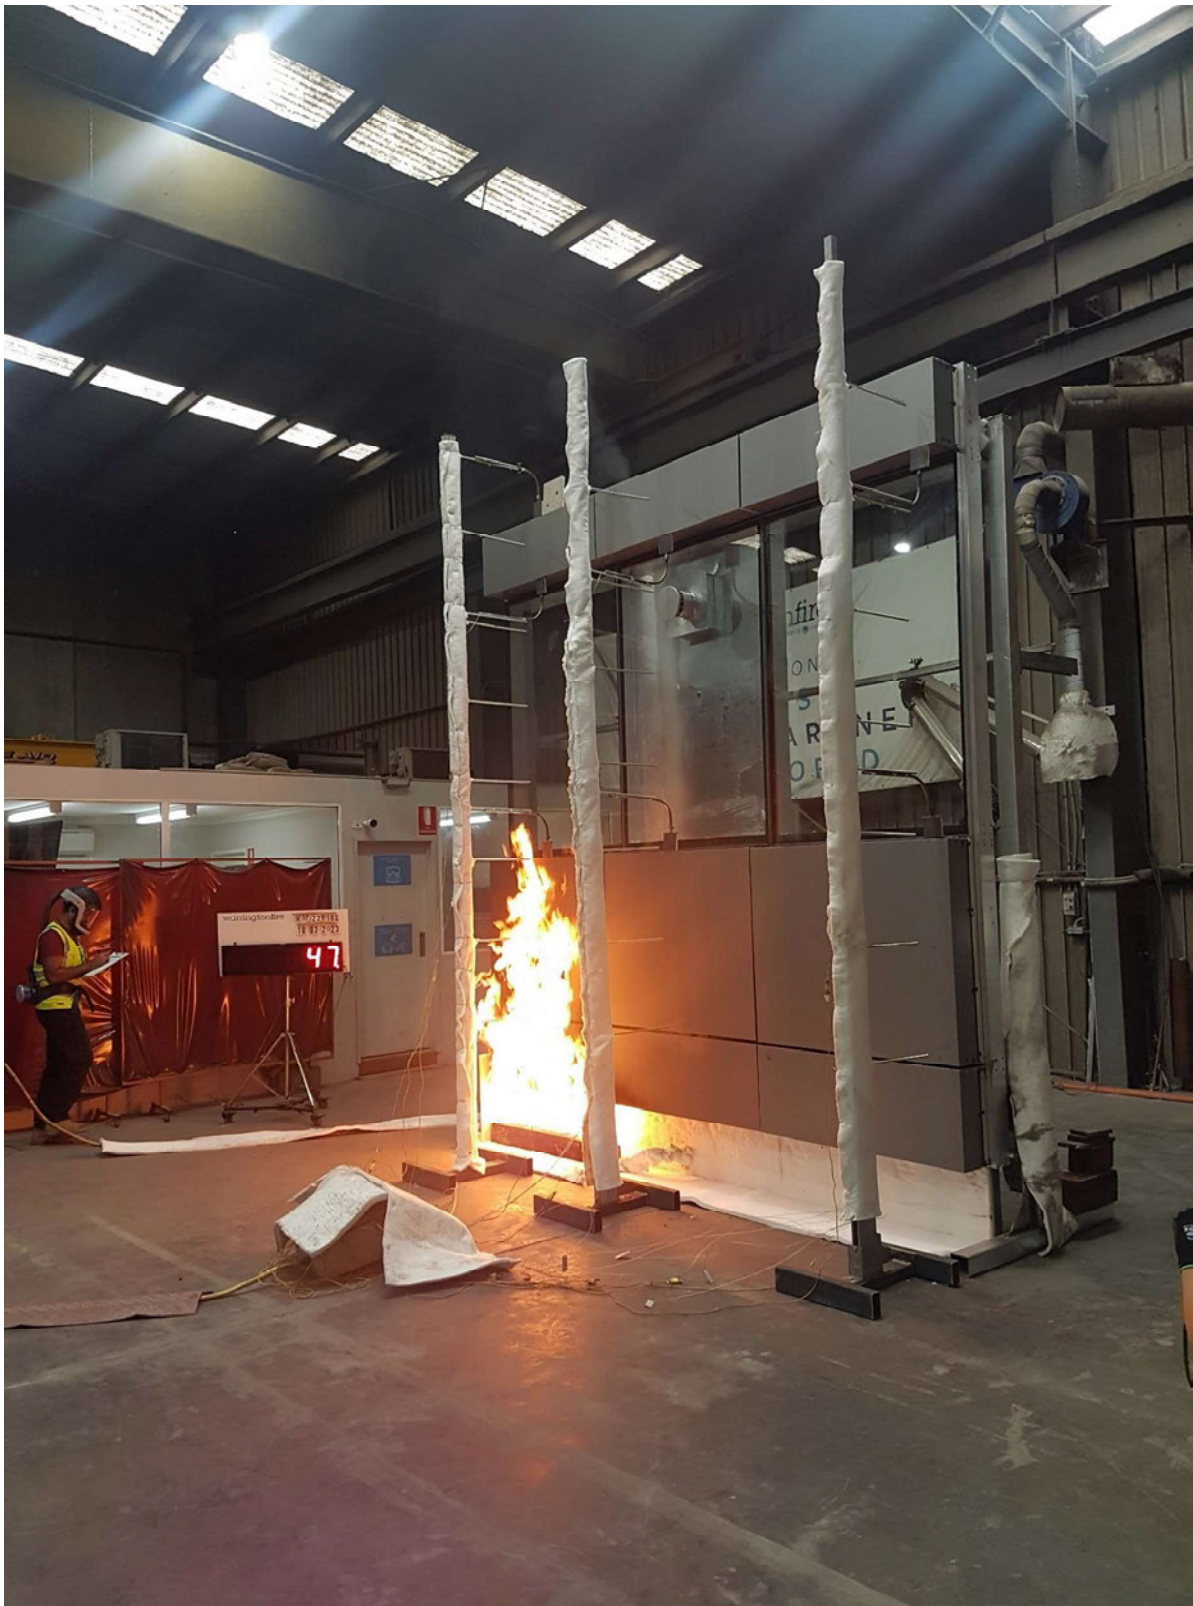
Figure 23 The specimen 47 seconds into the test (burner output at 300 kW)

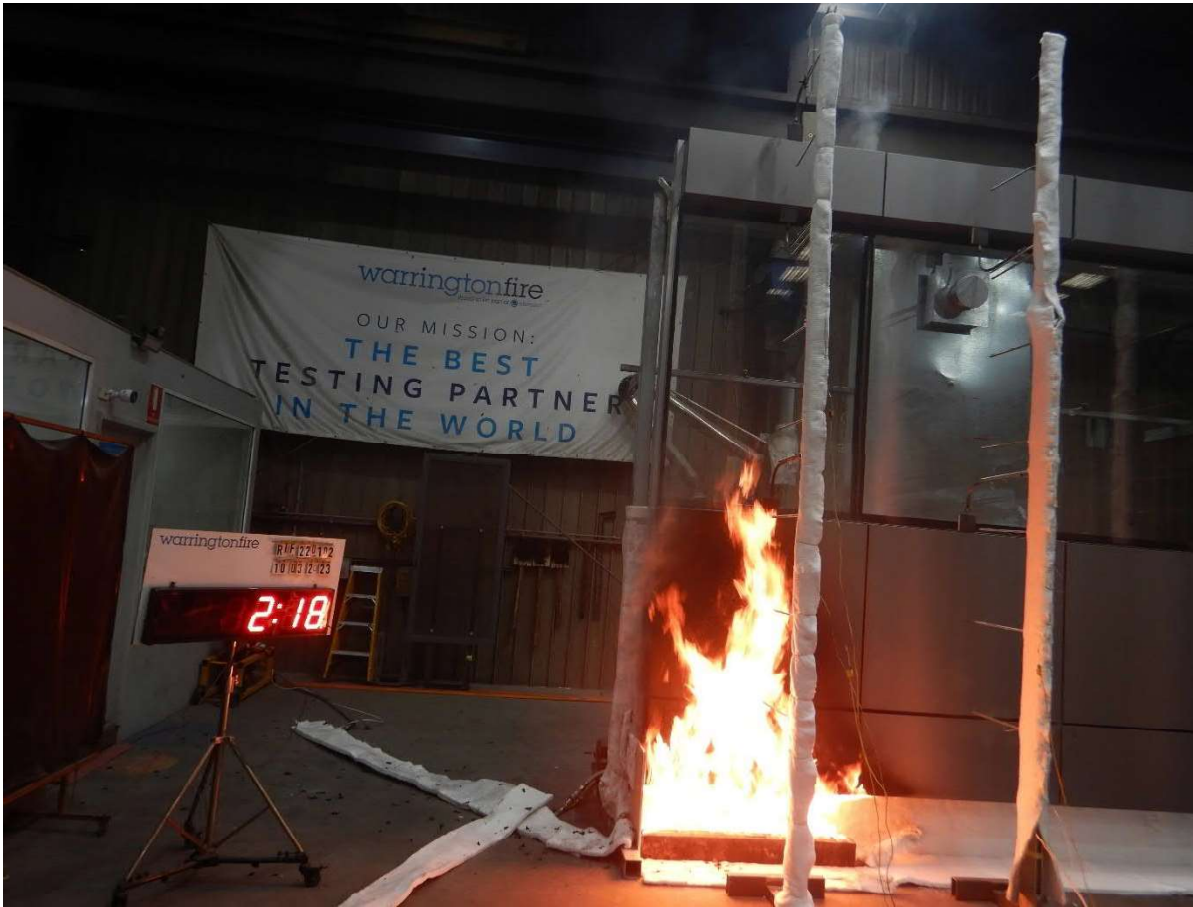
Figure 24 The specimen 2 minutes 18 seconds into the test (burner output at 300 kW)

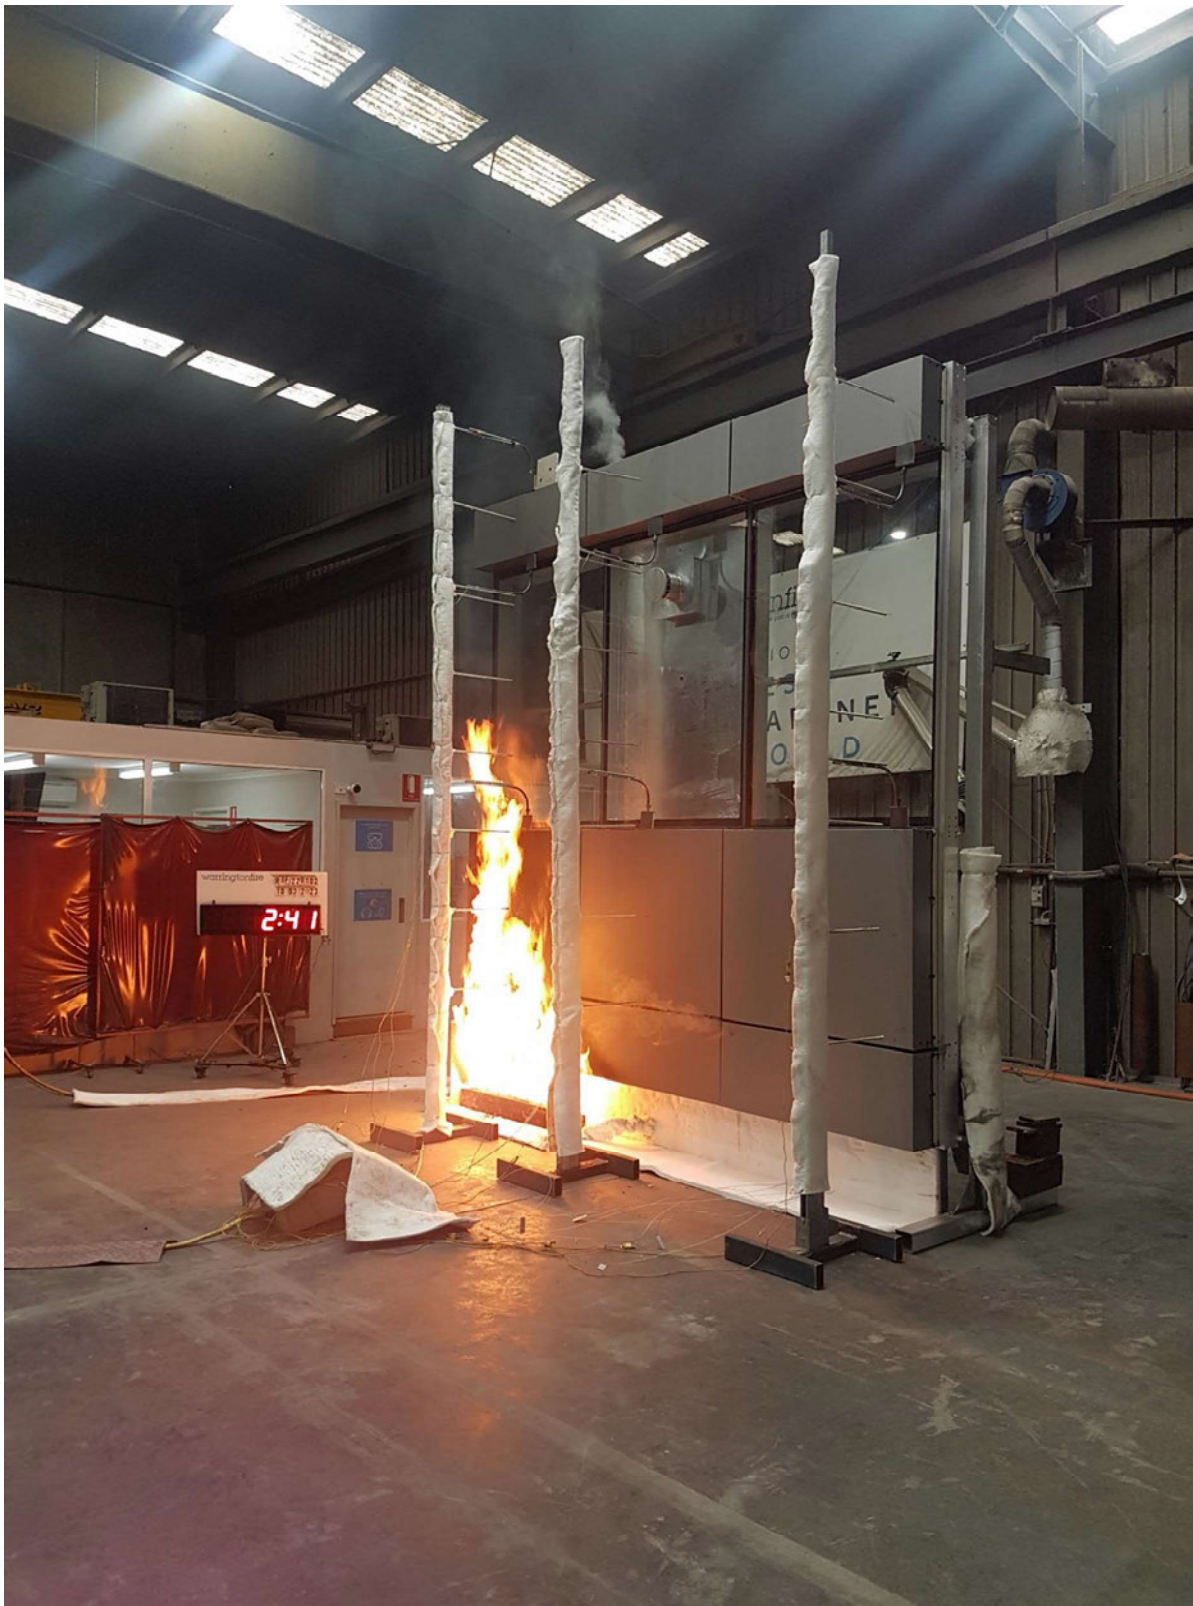
Figure 25 The specimen 2 minutes 41 seconds into the test (burner output at 300 kW)

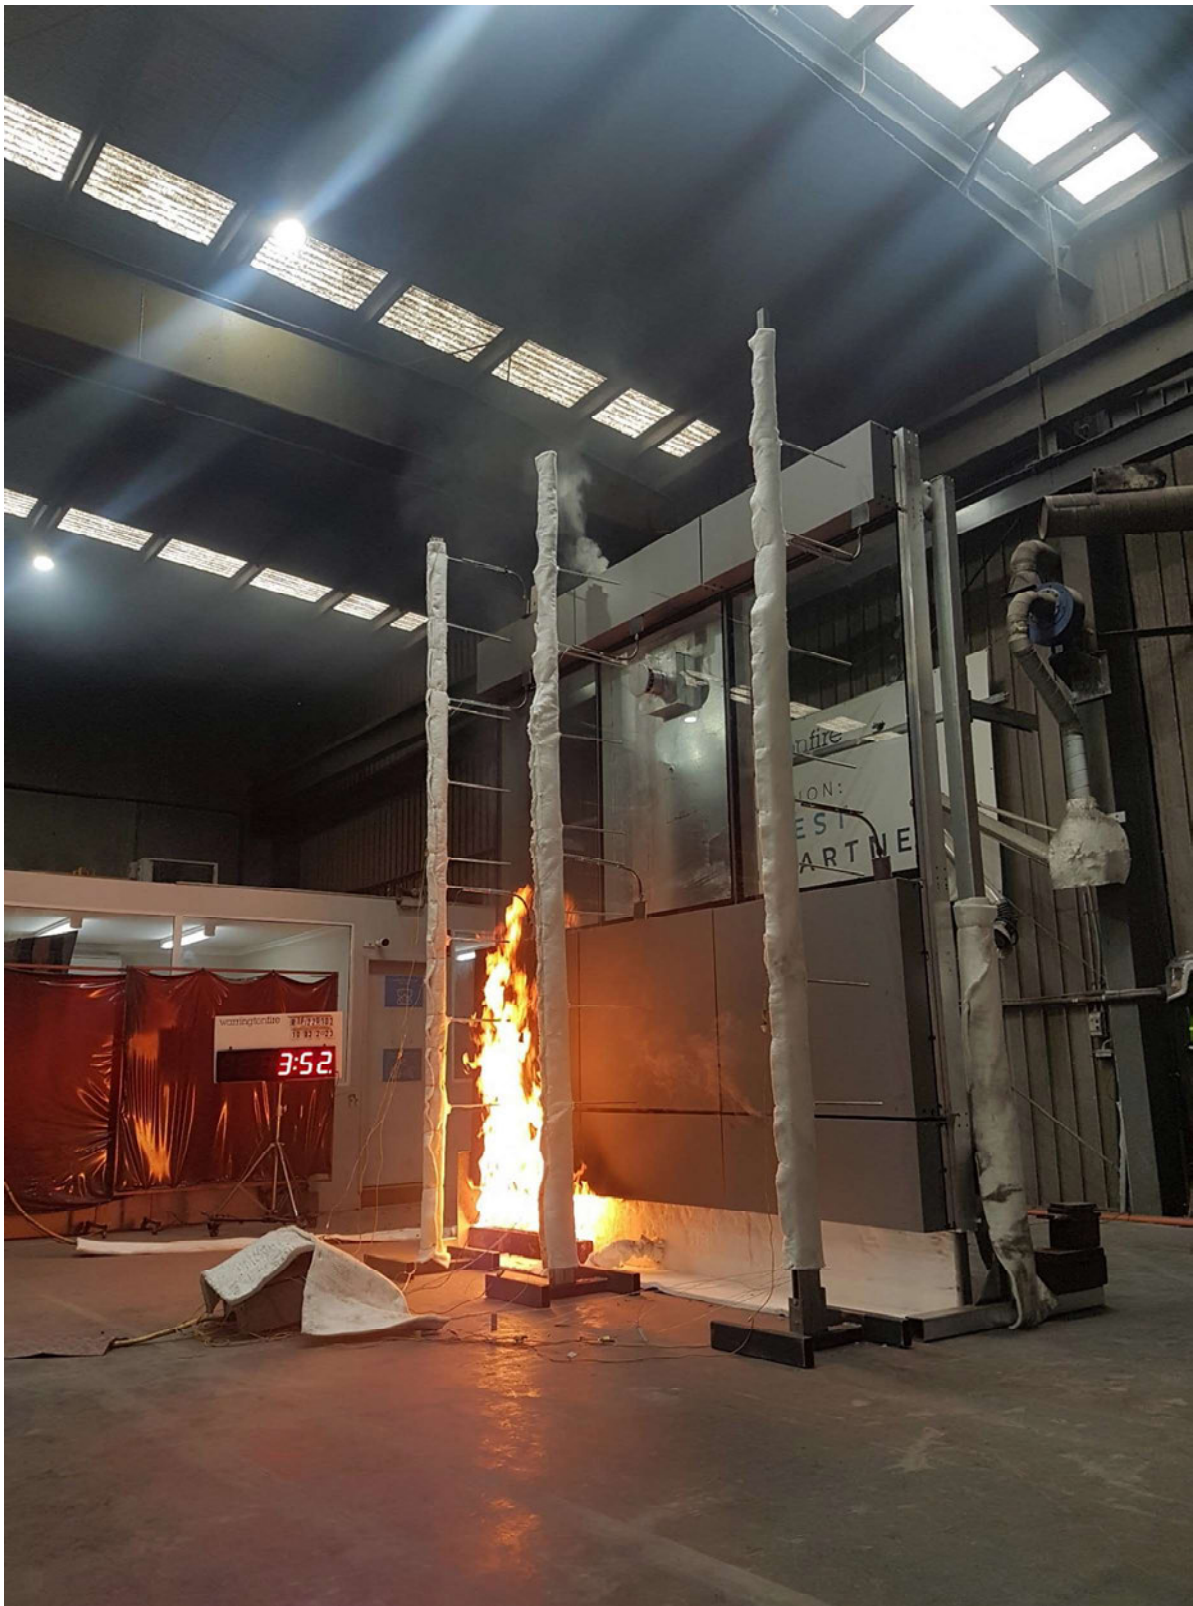
Figure 26 The specimen 3 minutes 52 seconds into the test (burner output at 300 kW)

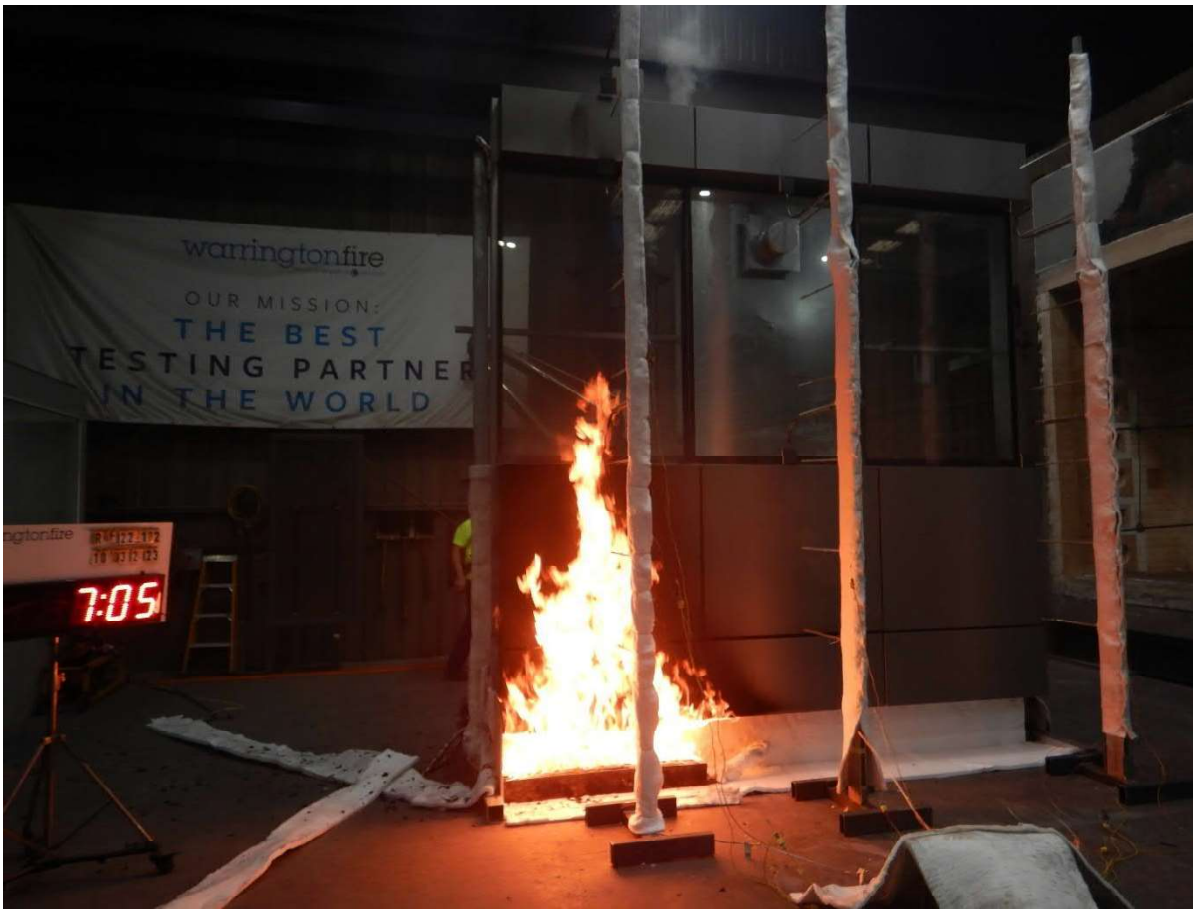
Figure 27 The specimen 7 minutes 5 seconds into the test (burner output at 300 kW)

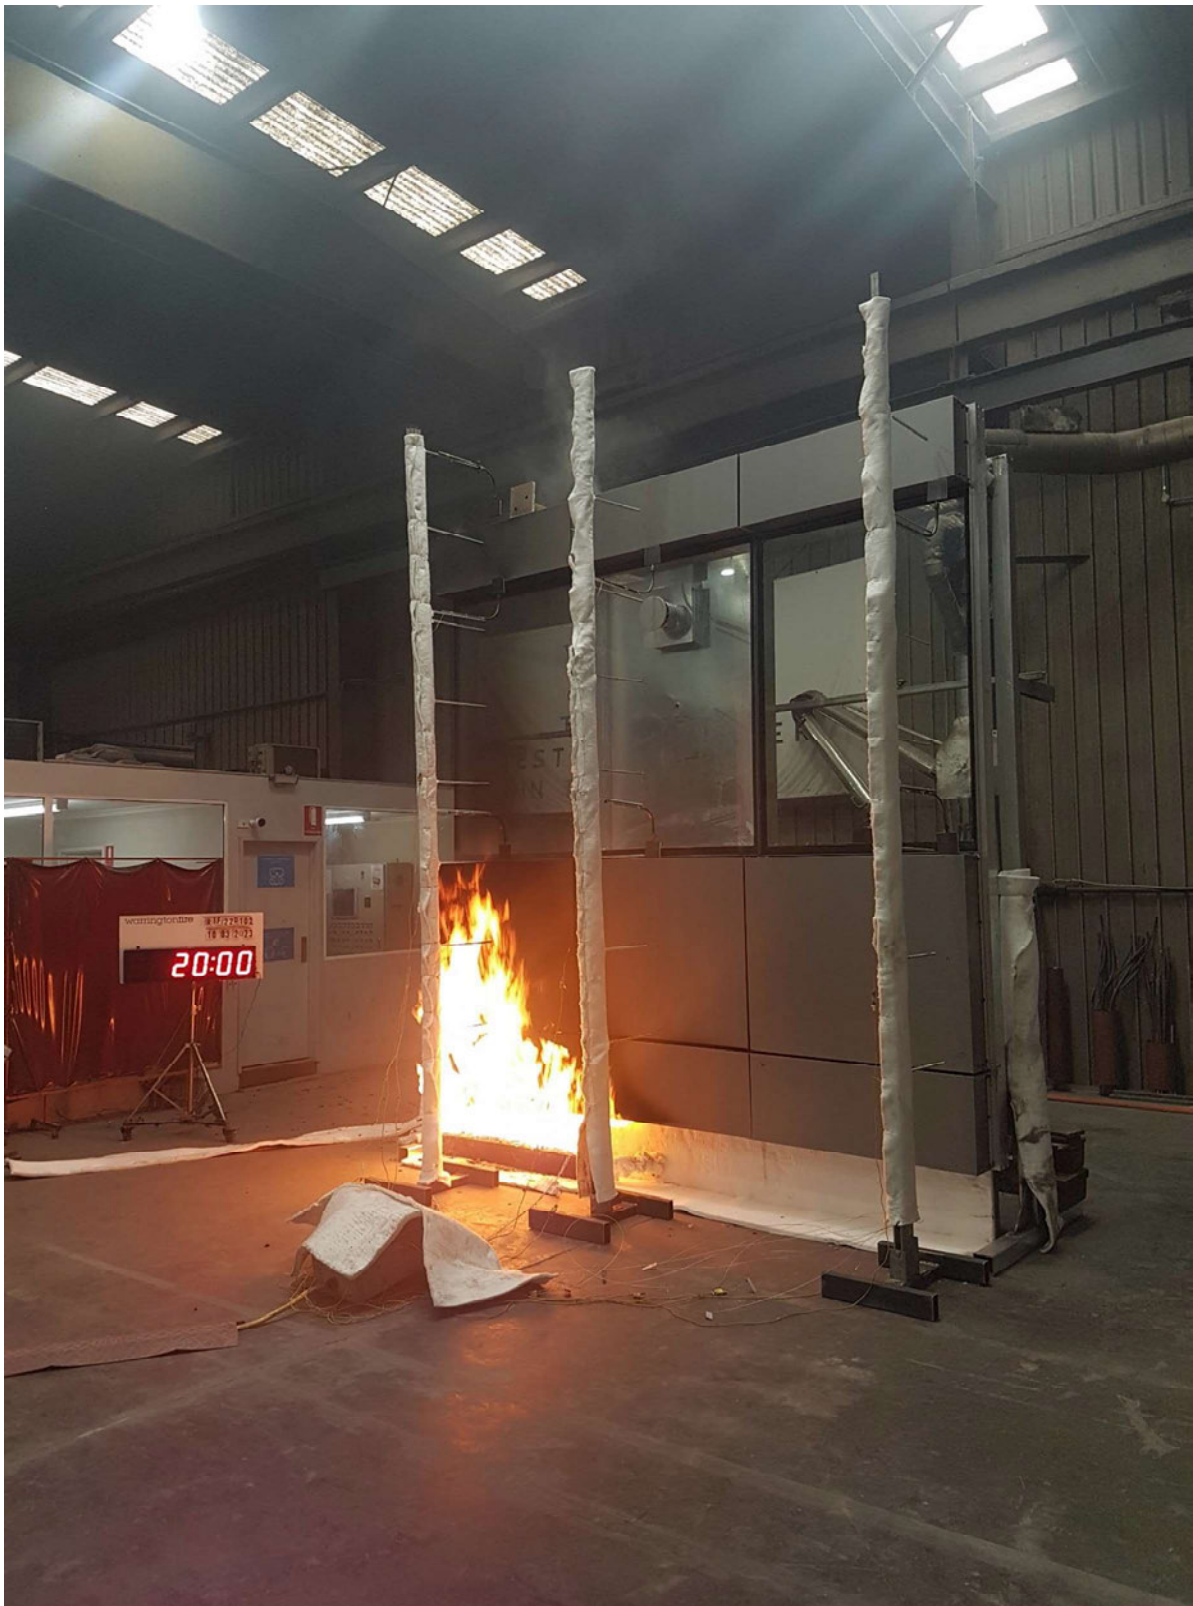
Figure 37 The specimen 20 minutes into the test (burner output at 300 kW)

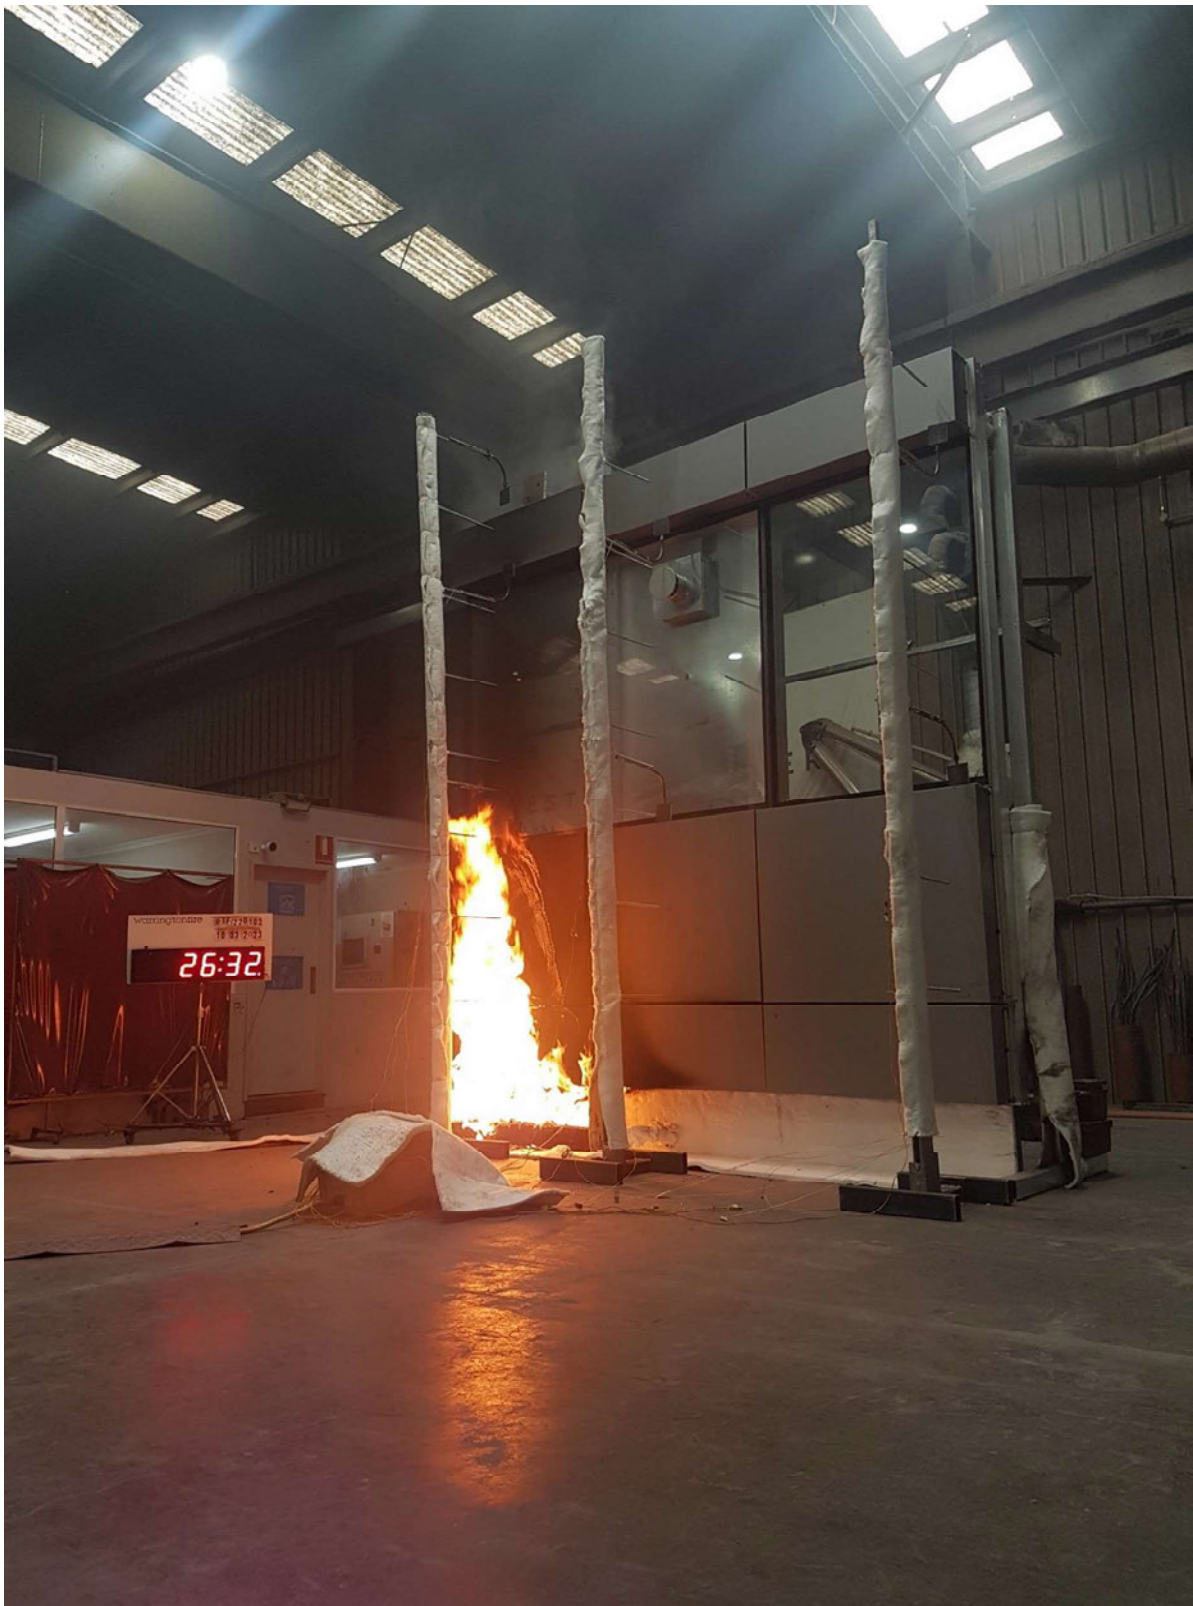
Figure 46 The specimen 26 minutes 32 seconds into the test (burner output at 300 kW)

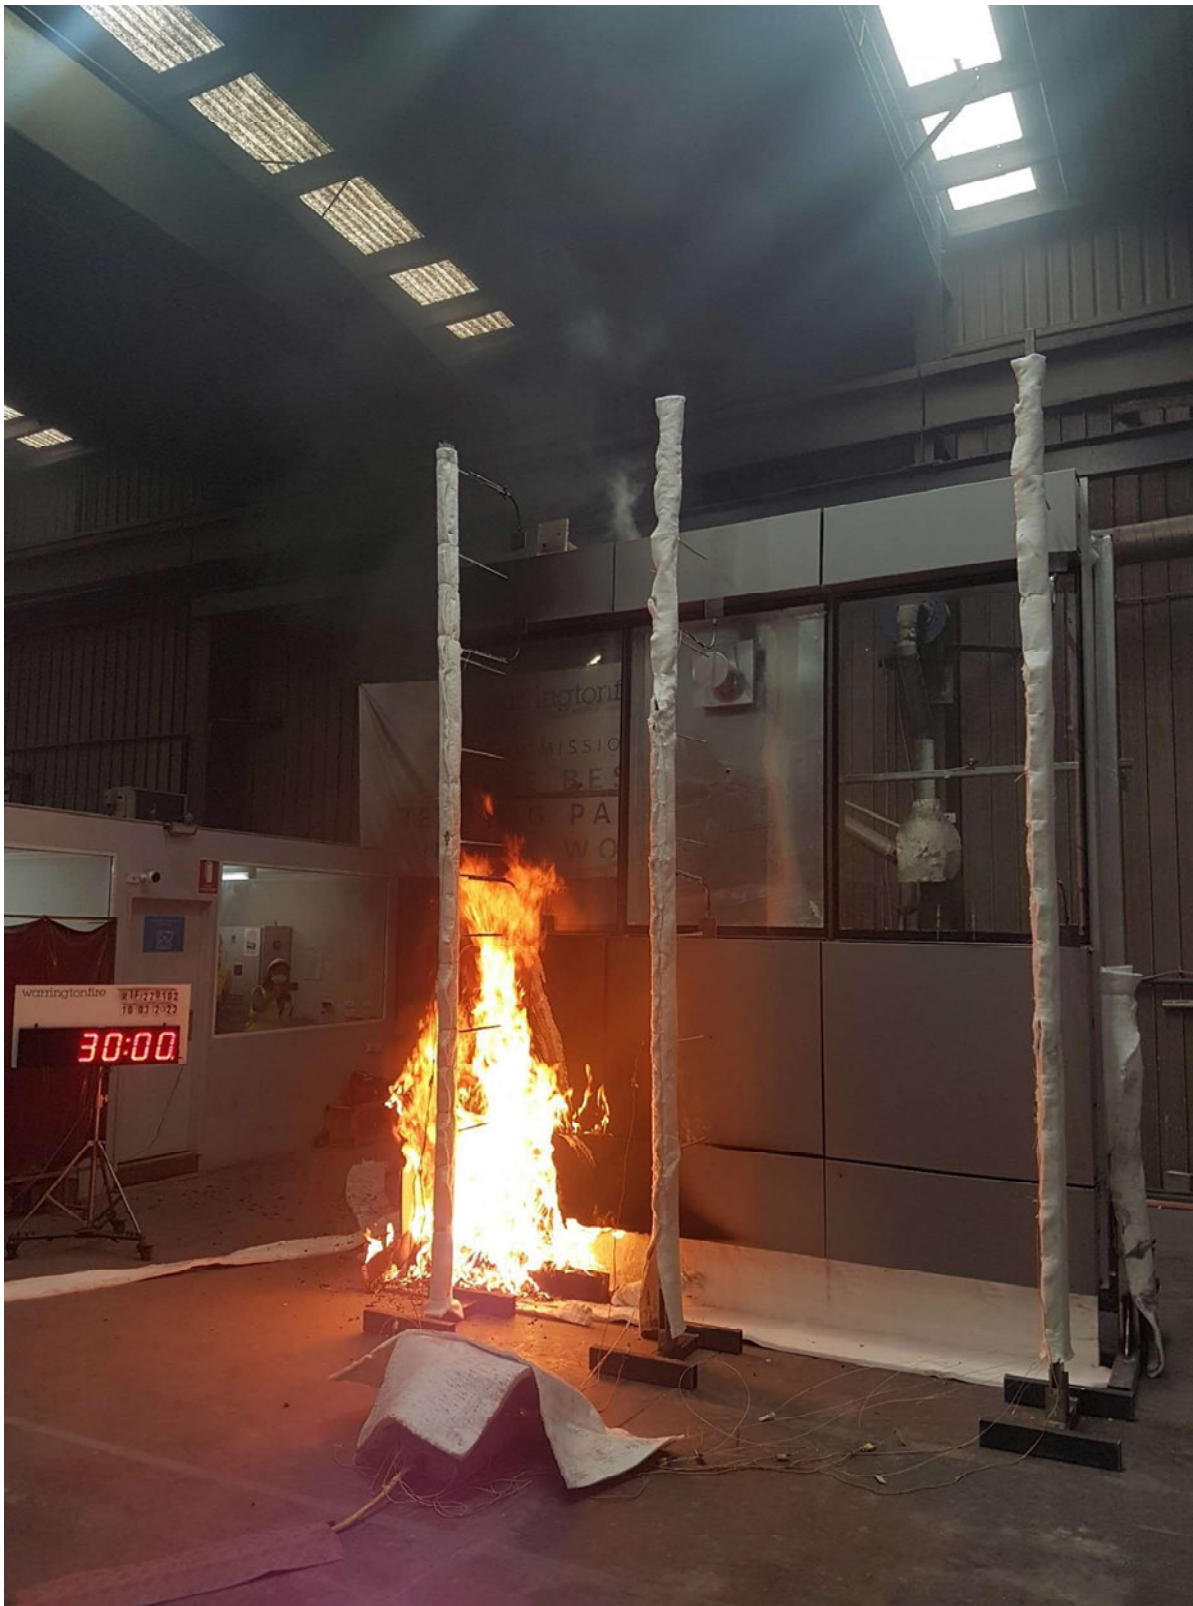
Figure 52 The specimen 30 minutes into the test - burner turned off.

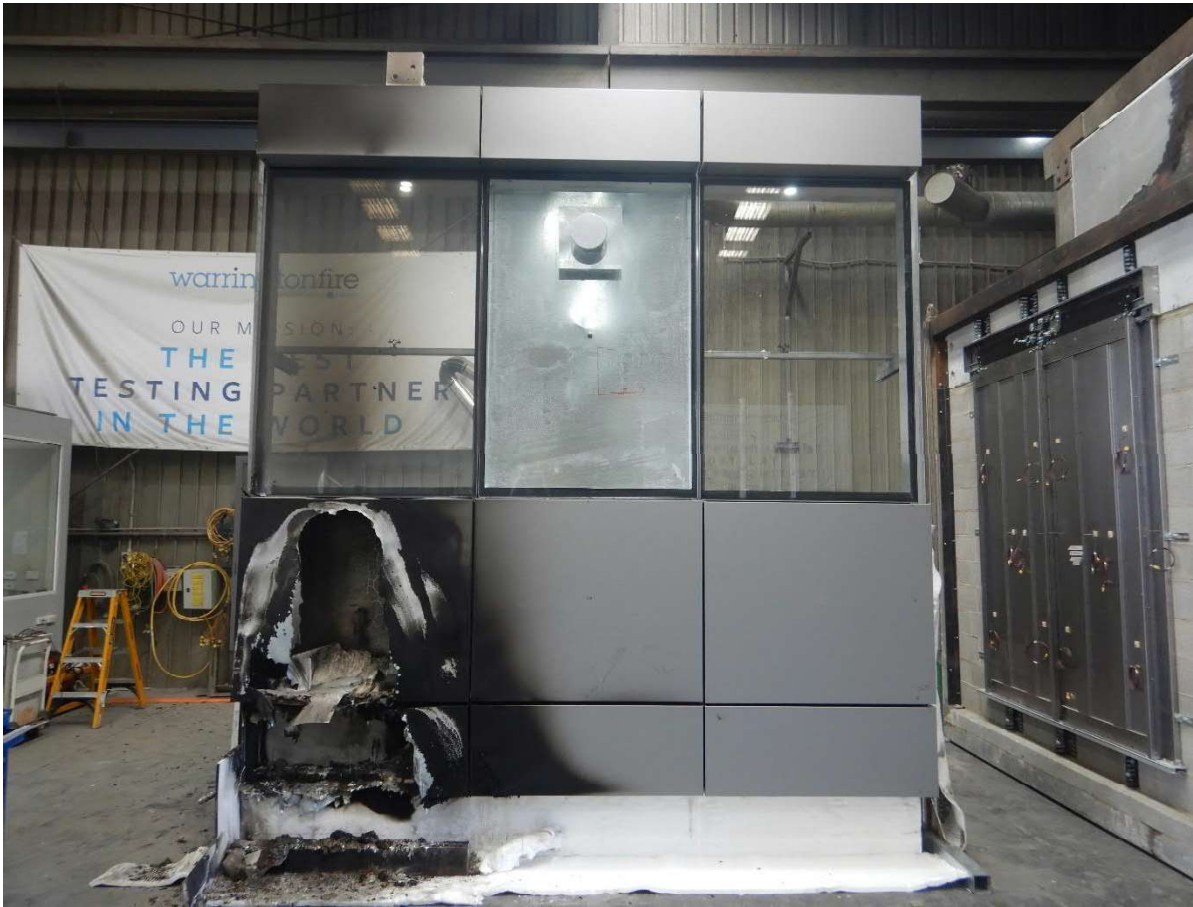
Figure 60 The specimen at end of test – exposed side.

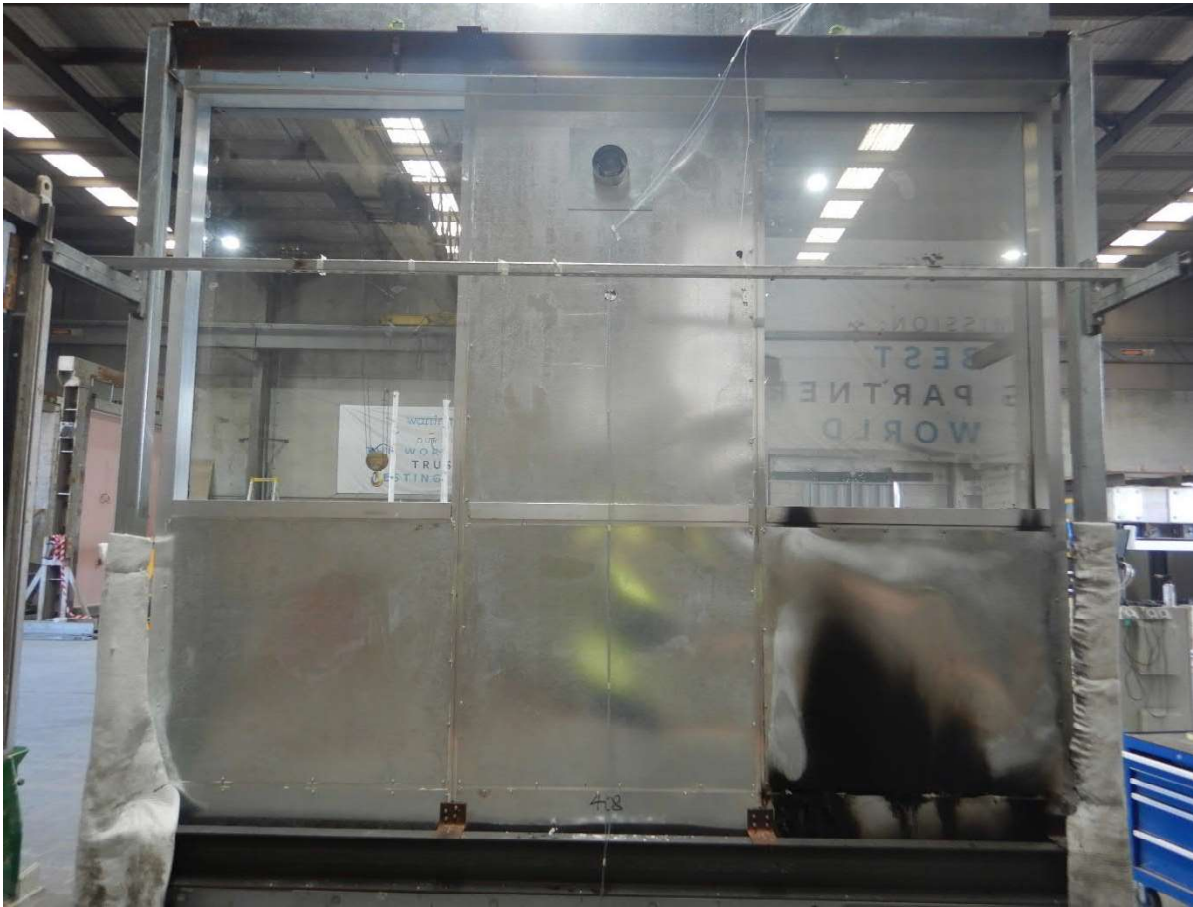
Figure 61 The specimen at end of test – unexposed side.
