# Grounding of pilot launch *PV Corsair*

Port Phillip Heads (near Point Lonsdale), Victoria, on 5 October 2023

MO-2023-003

Final – 27 February 2025

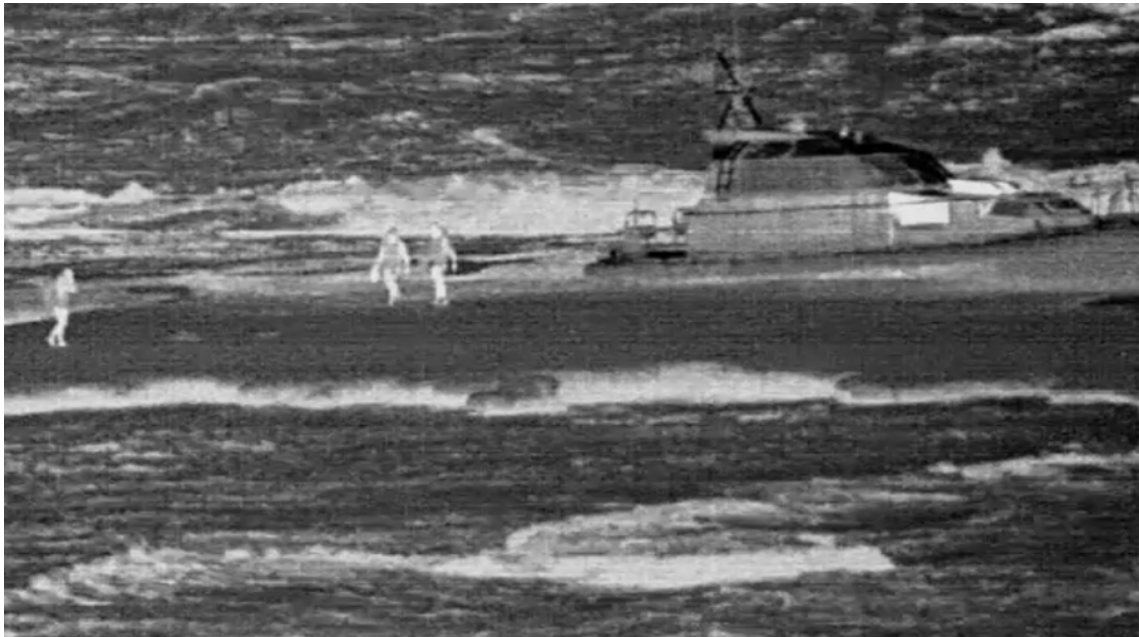
**Cover photo:** The disabled *PV Corsair* and its occupants following the grounding on Point Lonsdale Reef (source: Ports Victoria)

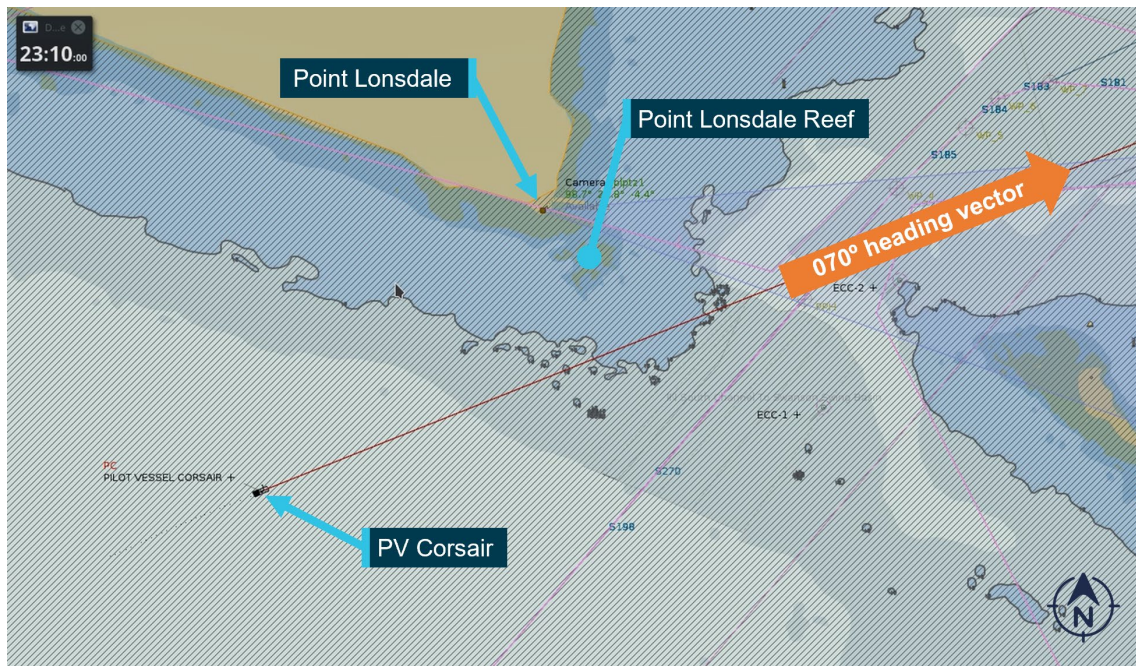
**Figure 2: The heading vector of PV Corsair at 2310 prior to course alteration to port**

For its return to Queenscliff, *Corsair* initially settled on a heading 067° and then 070° (Figure 2). On this course, *Corsair* would pass clear of Point Lonsdale Reef.

The figure shows the course vector of PV Corsair at 2310 when on a 070° heading and about 2.3 km from Point Lonsdale. Source: Ports Victoria, annotated by the Office of the Chief Investigator

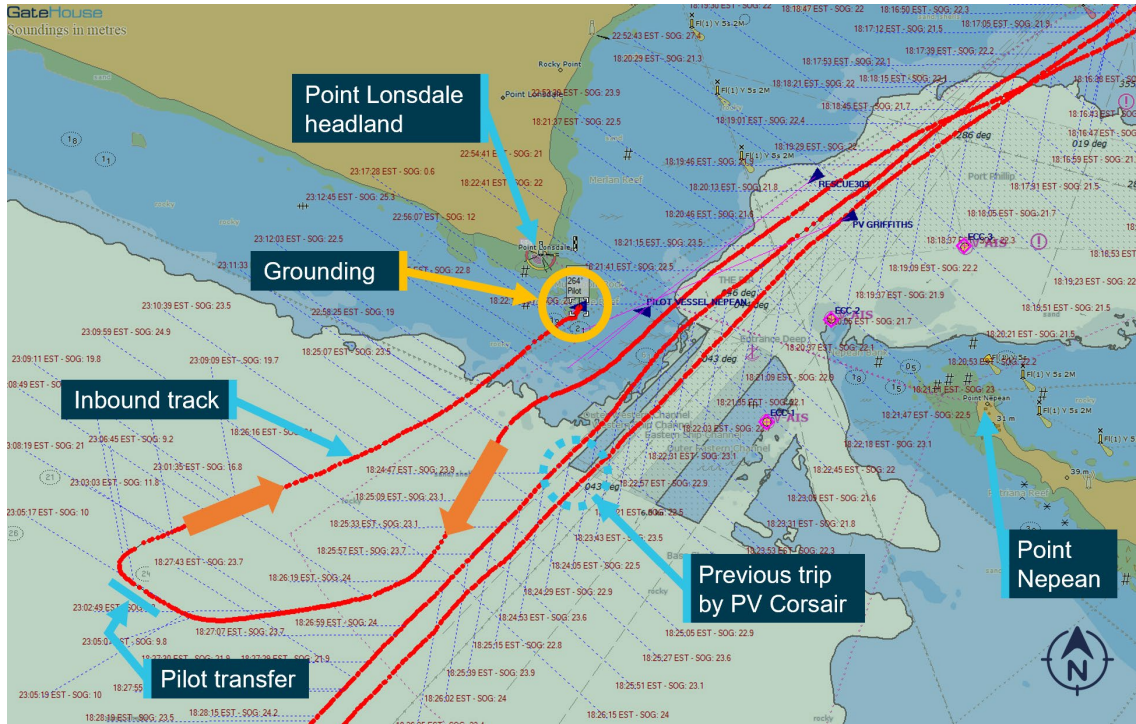
**Figure 3: The track of PV *Corsair* outbound and then inbound towards the reef**

The course alteration to port was completed and the launch steadied on a course of about 052° when *Corsair* was about 760 m from the reef. At about 2313 *Corsair* entered the shallowing water and ran aground travelling at about 24 knots (Figure 3).

The figure also shows the tracks of PV *Corsair* through the Heads on its previous trip. Source: Ports Victoria, annotated by the Office of the Chief Investigator

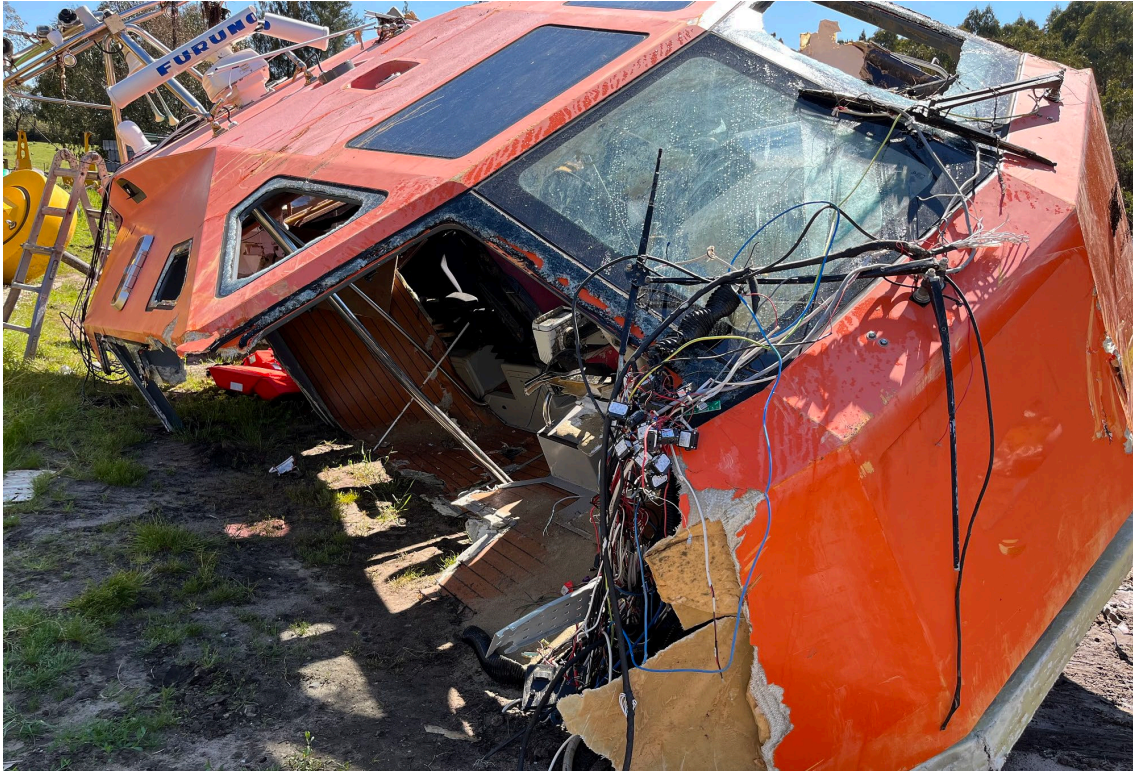
**Figure 5: Recovered wheelhouse from *PV Corsair***

The entrance to Port Phillip was closed to shipping from 0001 to 0210 on 6 October while the rescue was in operation, and again later that morning from 0525 to 1015 while debris from the *Corsair* was recovered. During the night, the pilot launch had been wrecked by the effect of the sea and reef (Figure 5).

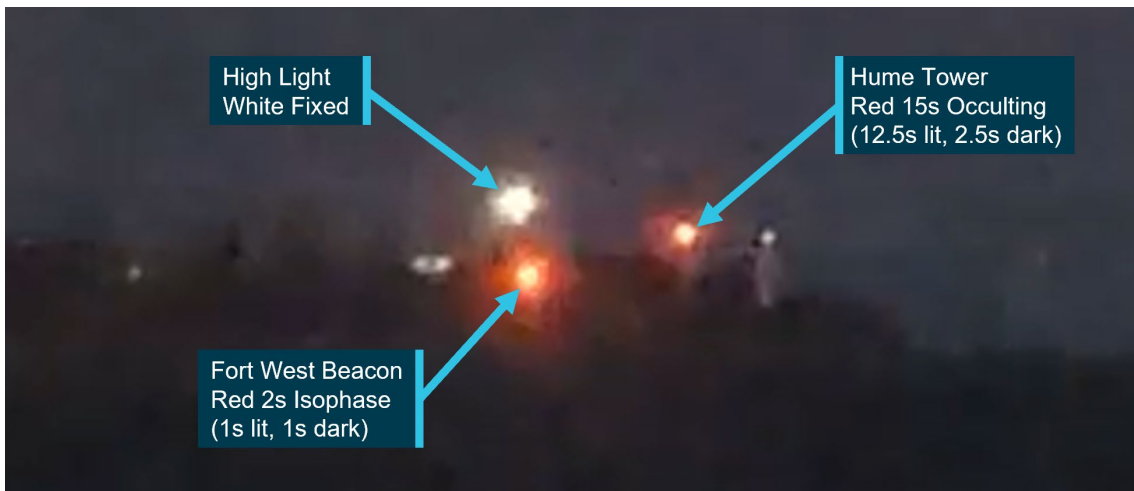
**Figure 12: Just west of Fisherman’s Channel in the red sector of Fort West Beacon**

When west of, and outside, Fisherman’s Channel, the High Light would be observed to the left of FWB which would now be in its red sector (Figure 12). Hume Tower would also still be visible in this part of the FWB red sector.

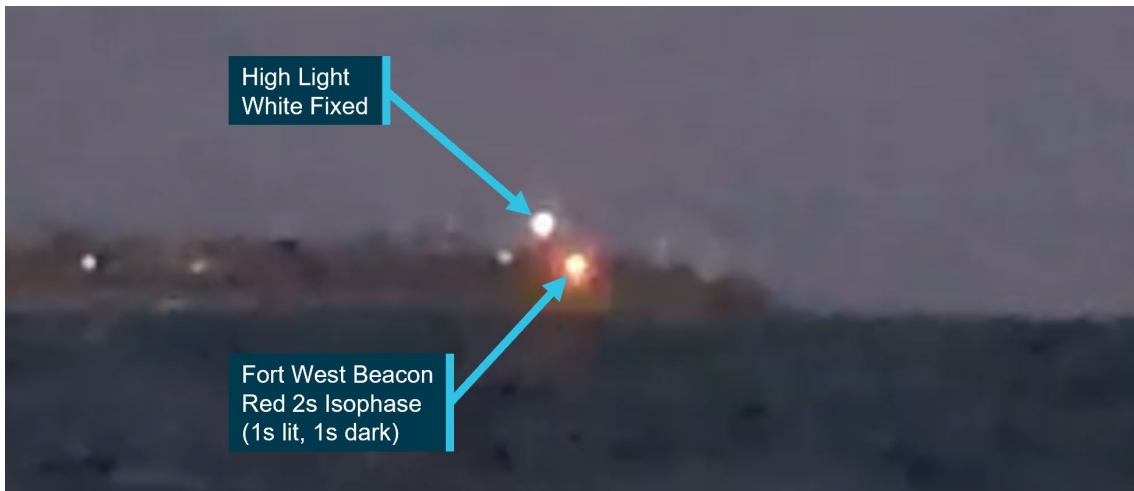
**Figure 14: Further west of Fisherman’s Channel outside the light sector of Hume Tower**

Further to the west, the limit of the Hume Tower red occulting light would be reached and no longer seen (Figure 14). Beyond this limit, the navigational aids visible on Shortland Bluff would be the white High Light above, and to the left of, the red sector light of the Fort West Beacon. *Corsair* was operating around the western limit of the Hume Tower light. Trials suggest that the Hume Tower light was probably not visible to the crew of *Corsair* during most of its approach.

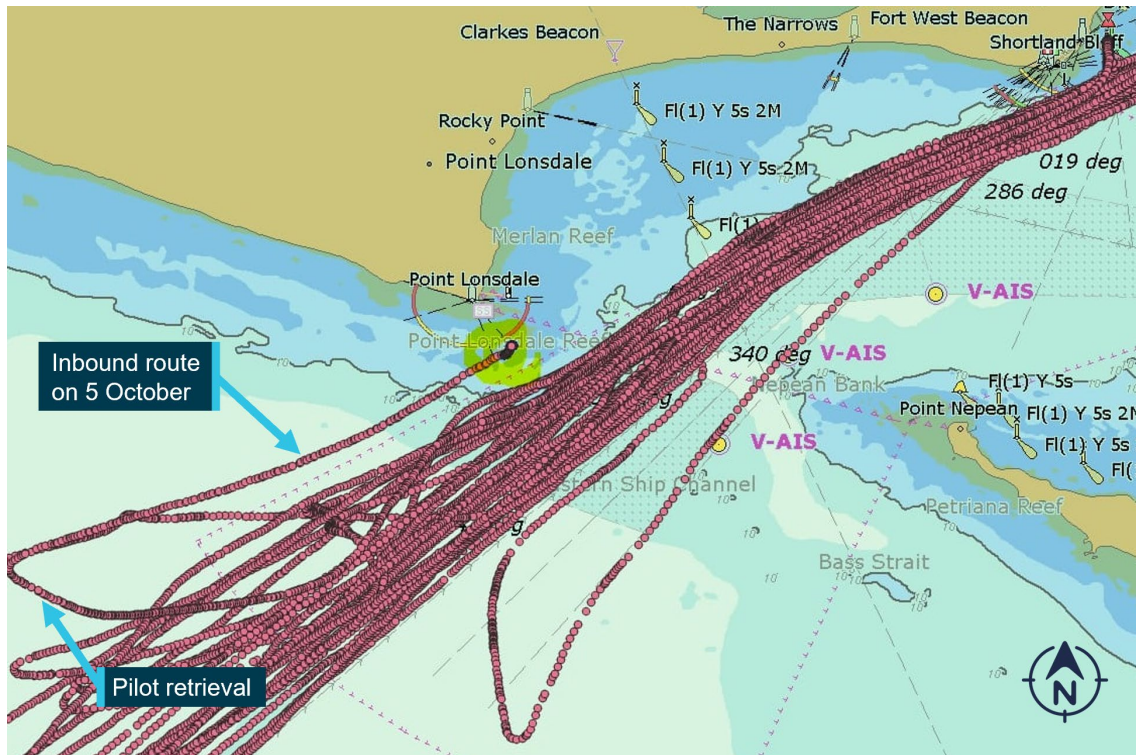
**Figure 20: Passages of *Corsair* in last 14 days including on the evening of grounding**

The operational parameters on the evening of the grounding were not unusual. However, on this night, pilot retrieval and the starting point for the return journey to the entrance was further west than most recent passages (Figure 20). This westerly position and the need to initially navigate east for an extended duration for a more central approach to the entrance may not have been recognised by the launch coxswain.
