Reaction to fire test report

Test standard: Ad-hoc test based off ISO 13785-1:2002

System: Aluminium composite panel (ACP) and glazing external wall cladding system

Job number: RTF230140

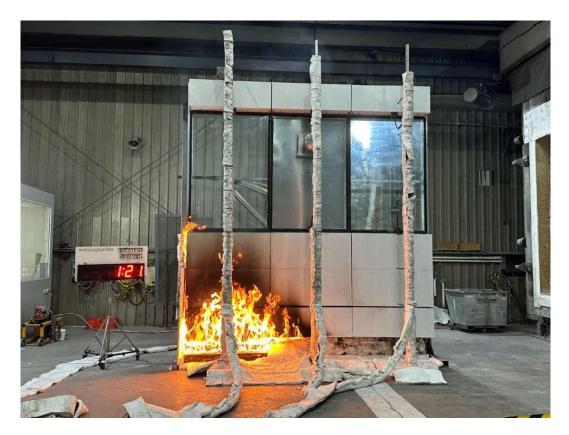
Figure 30 The specimen 1 minute 21 seconds into the test (burner output at 300 kW)

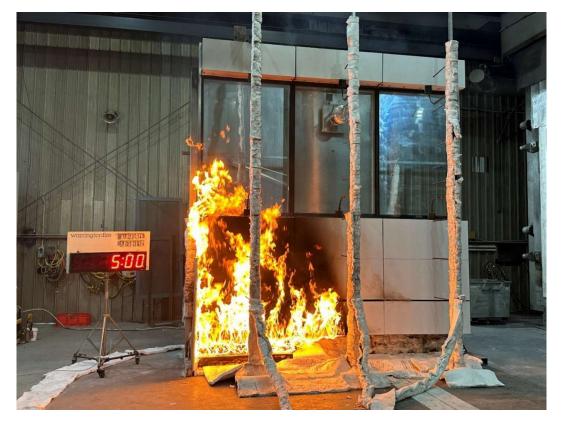
Figure 31 The specimen 5 minutes into the test (burner output at 300 kW)

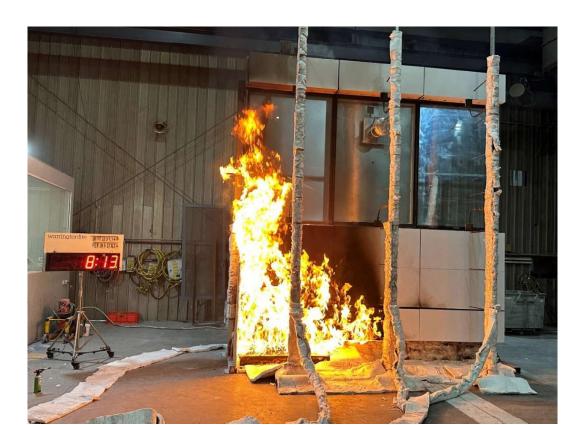
Figure 32 The specimen 8 minutes 13 seconds into the test (burner output at 300 kW)

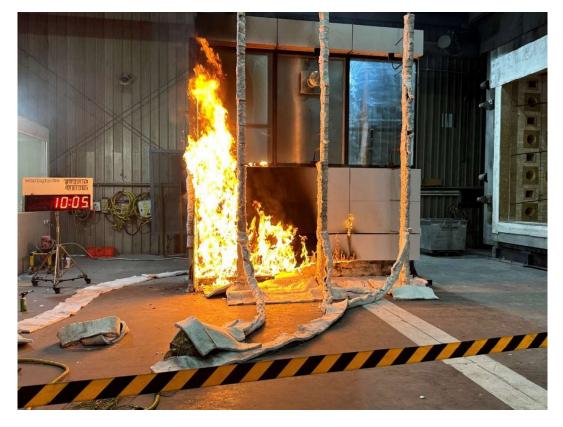
Figure 33 The specimen 10 minutes 5 seconds into the test (burner output at 300 kW)

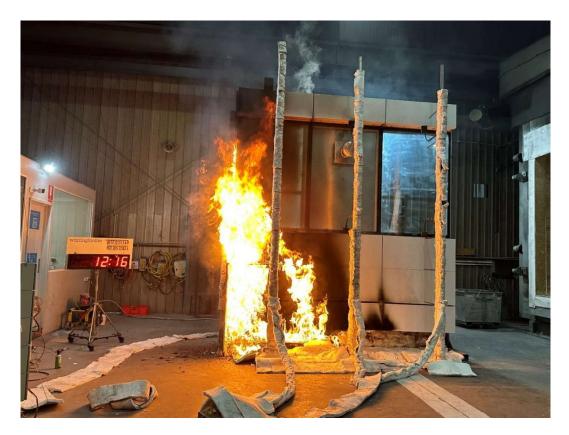
Figure 34 The specimen 12 minutes 16 seconds into the test (burner output at 300 kW)

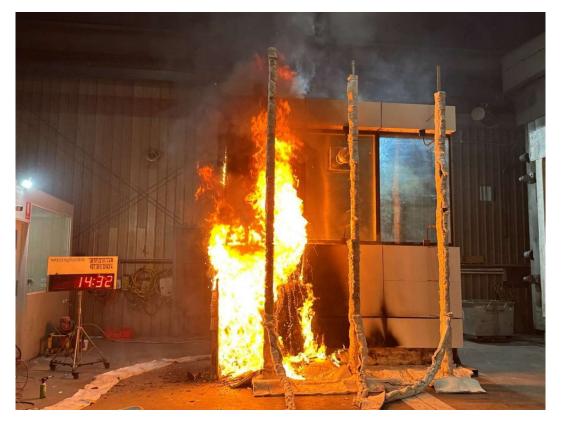
Figure 35 The specimen 14 minutes 32 seconds into the test (burner output at 300 kW)

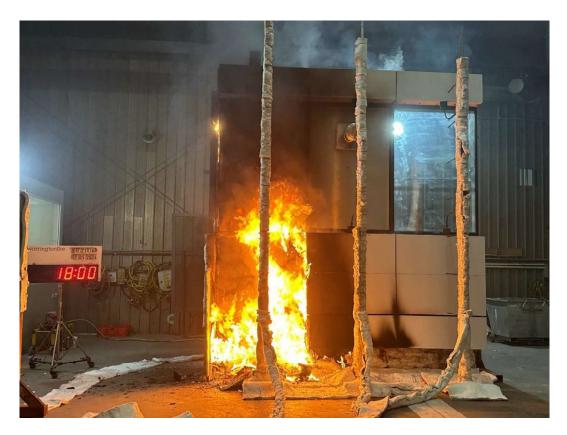
The specimen 18 minutes into the test (burner output at 300 kW) Figure 36

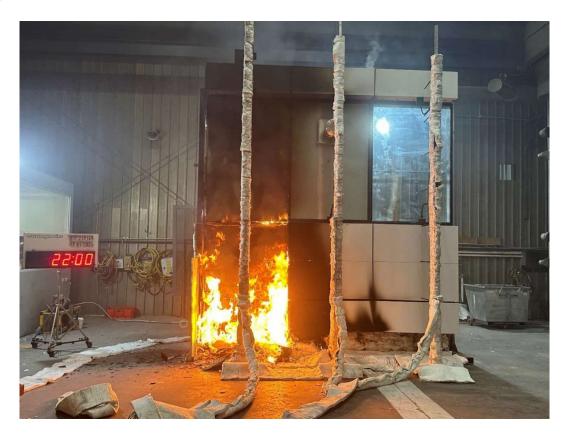
Figure 37 The specimen 22 minutes into the test (burner output at 300 kW)

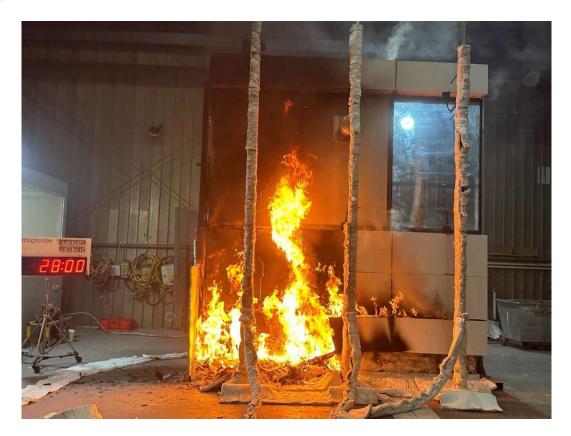
Figure 39 The specimen 28 minutes into the test (burner output at 300 kW)

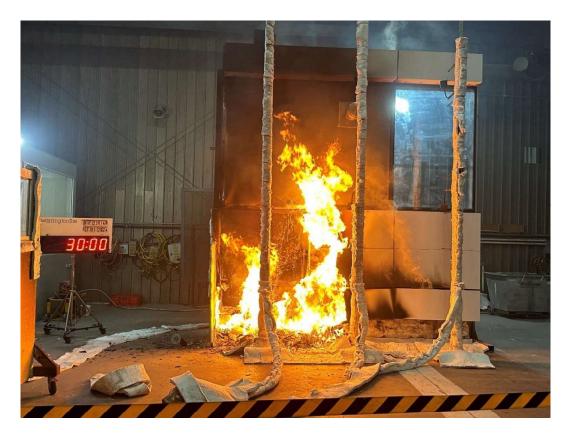
Figure 40 The specimen 30 minutes into the test (burner output at 300 kW)

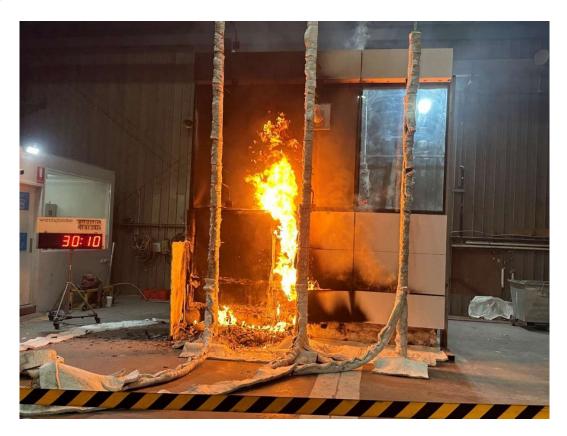
Figure 41 The specimen 30 minutes 10 seconds into the test (burner off)

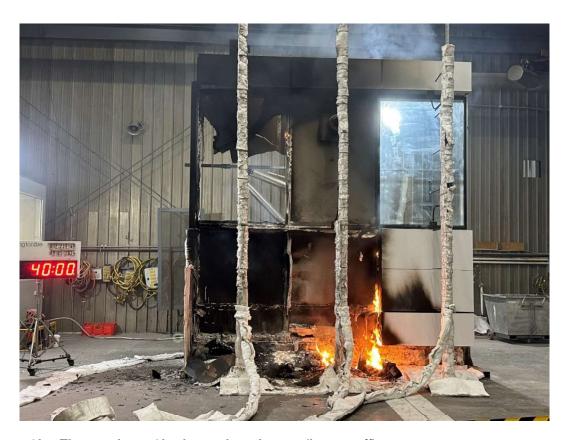
Figure 42 The specimen 40 minutes into the test (burner off)

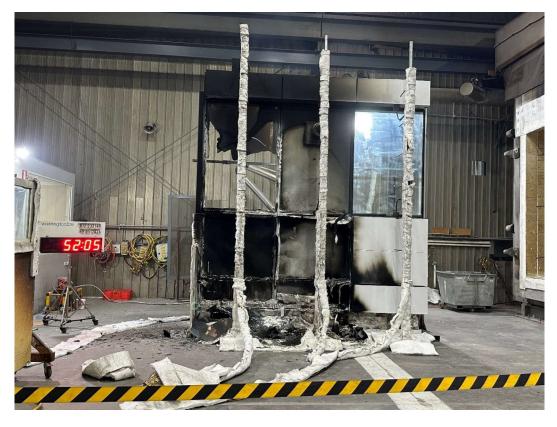
Figure 43 The specimen 52 minutes 5 seconds into the test (burner off)

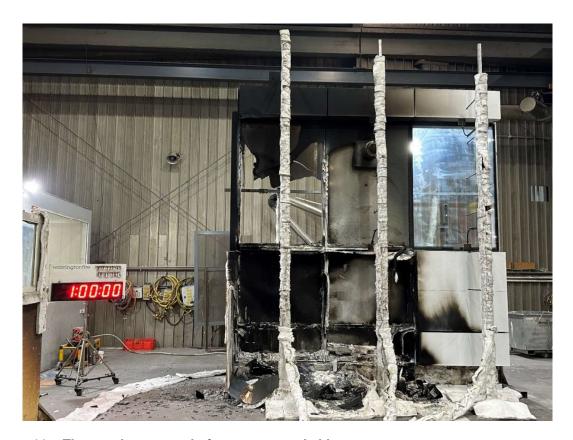
The specimen at end of test - exposed side Figure 44

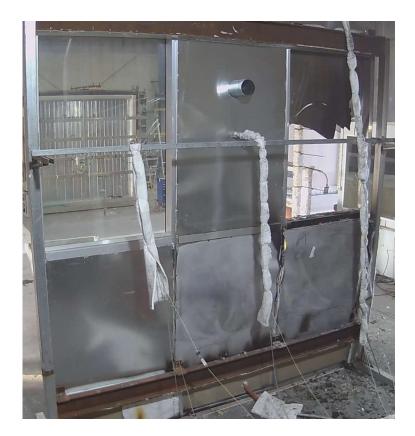
Figure 45 The specimen at end of test - unexposed side
