RESEARCH ANALYSIS NO. 2

Non-cladding building defects

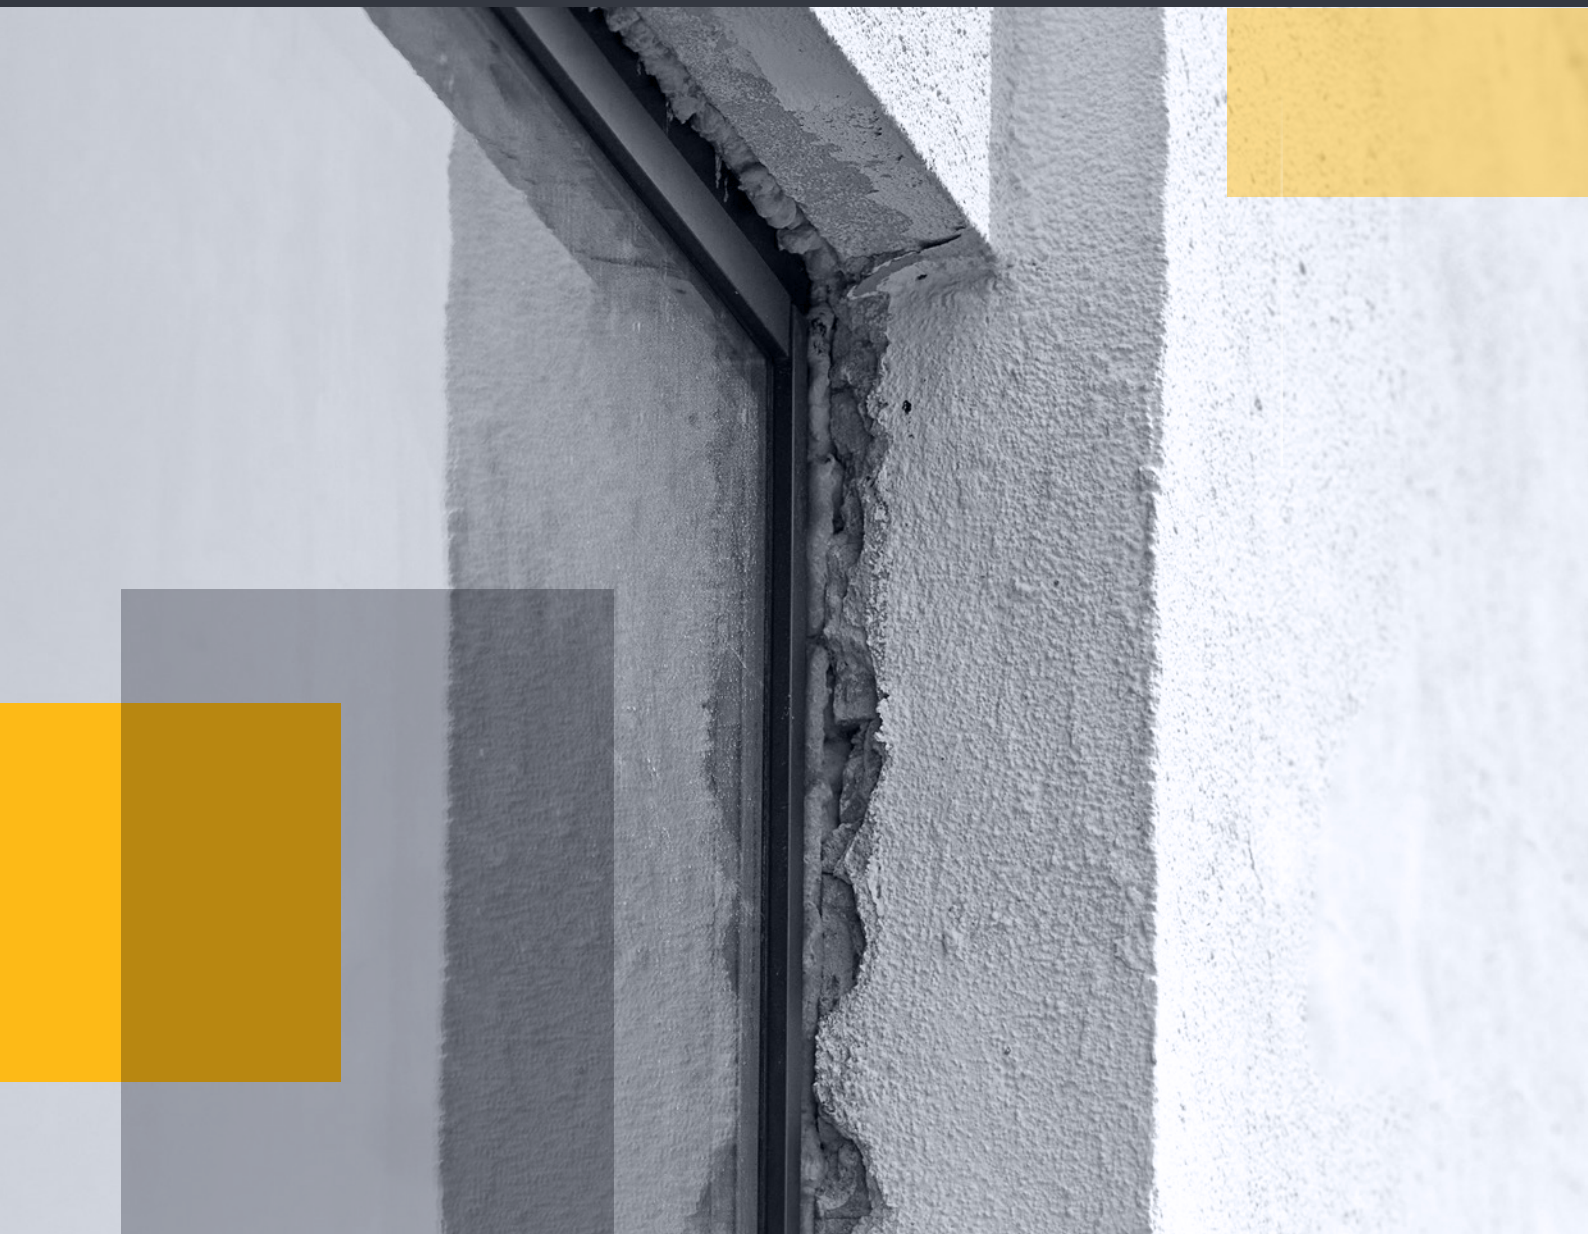
Aboriginal acknowledgement

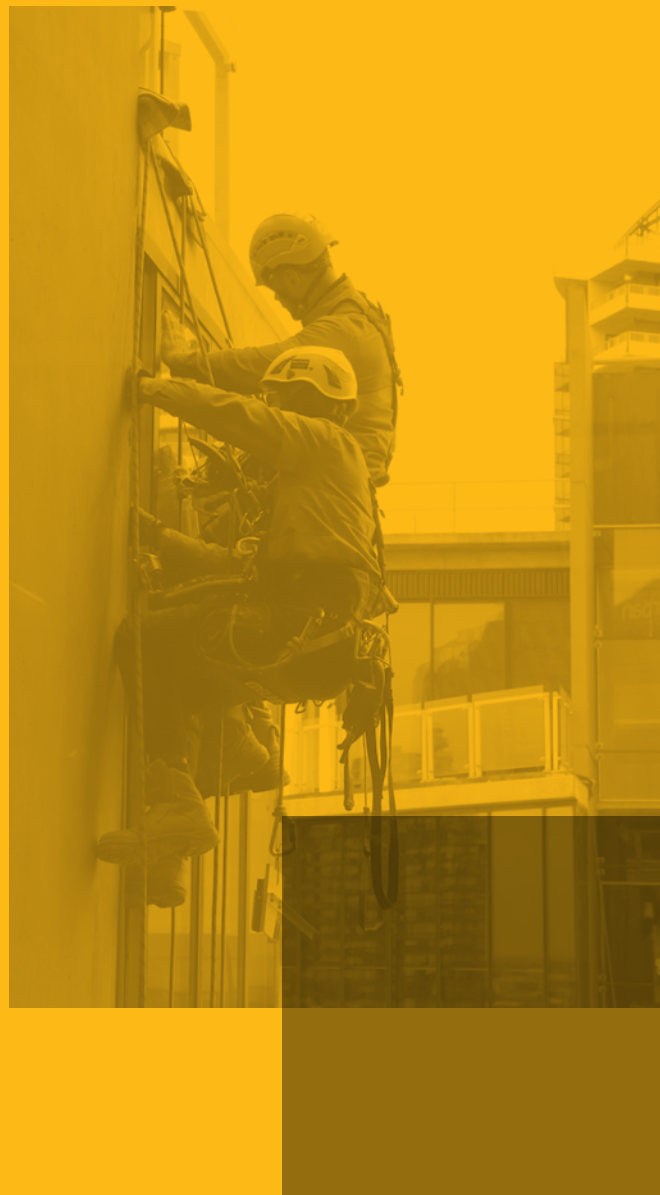
2. Methodology, limitations and assumptions

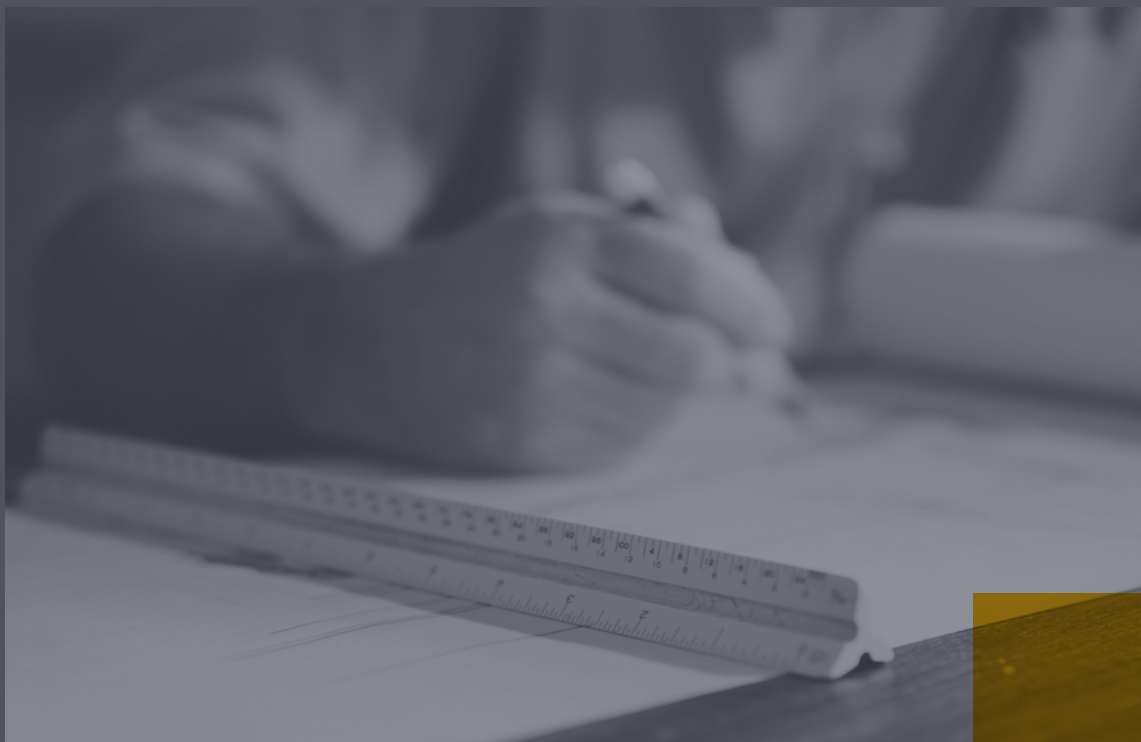
Defects arise from poor architectural design, defective construction by poor workmanship by trades under the supervision of builders or maintenance issues and have the potential to present serious safety risks to residents if not addressed promptly.

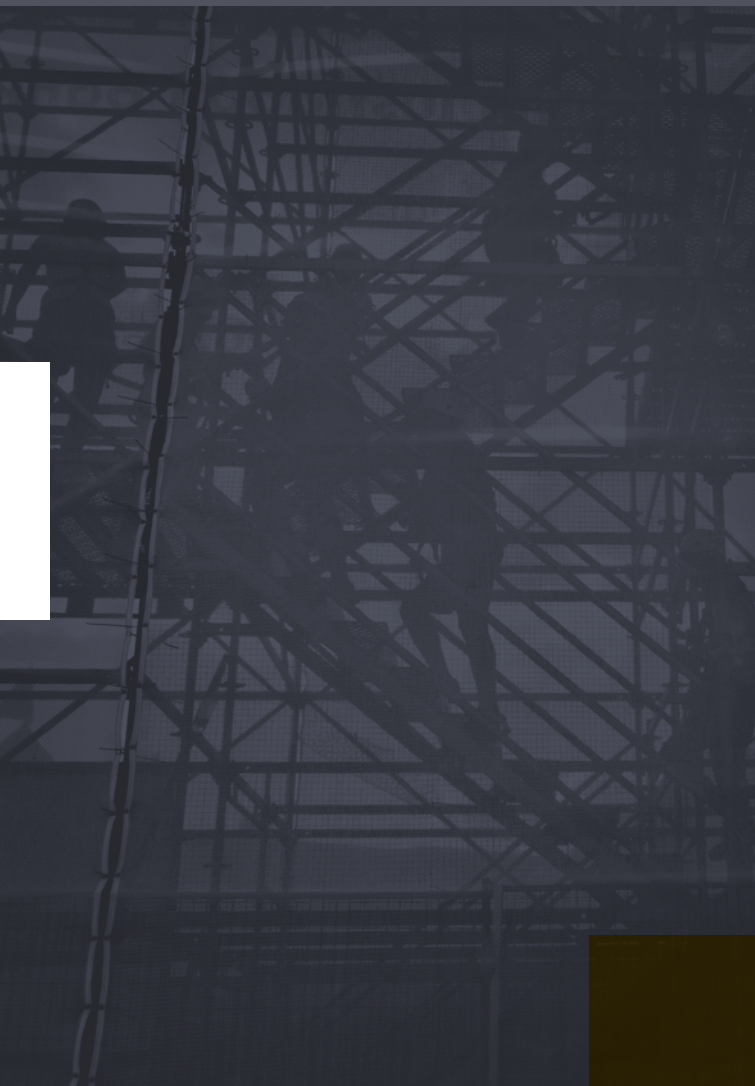
CSV has identified considerable and widespread serious non-cladding building defects on buildings designated to be funded for cladding rectification through CSV's program. These defects include pervasive black mould, framing non-compliance, leaking roof and gutters, balconies, rotten framing and water proofing issues.

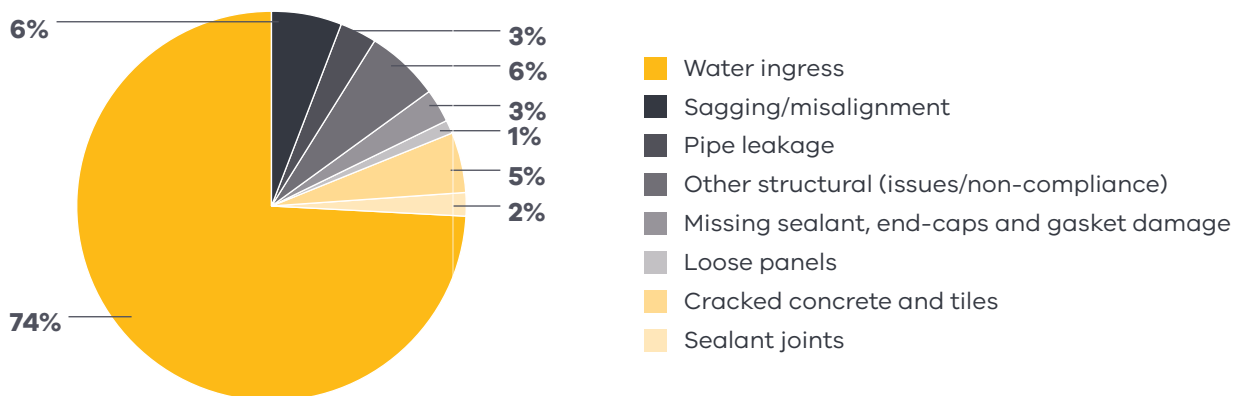
Figure 2 reveals that of the 175 buildings where CSV has been able to assess the cause of the defects (172 in total), a significant number of buildings have balcony defects related to insufficient water proofing and improper drainage systems leading to water ingress issues.

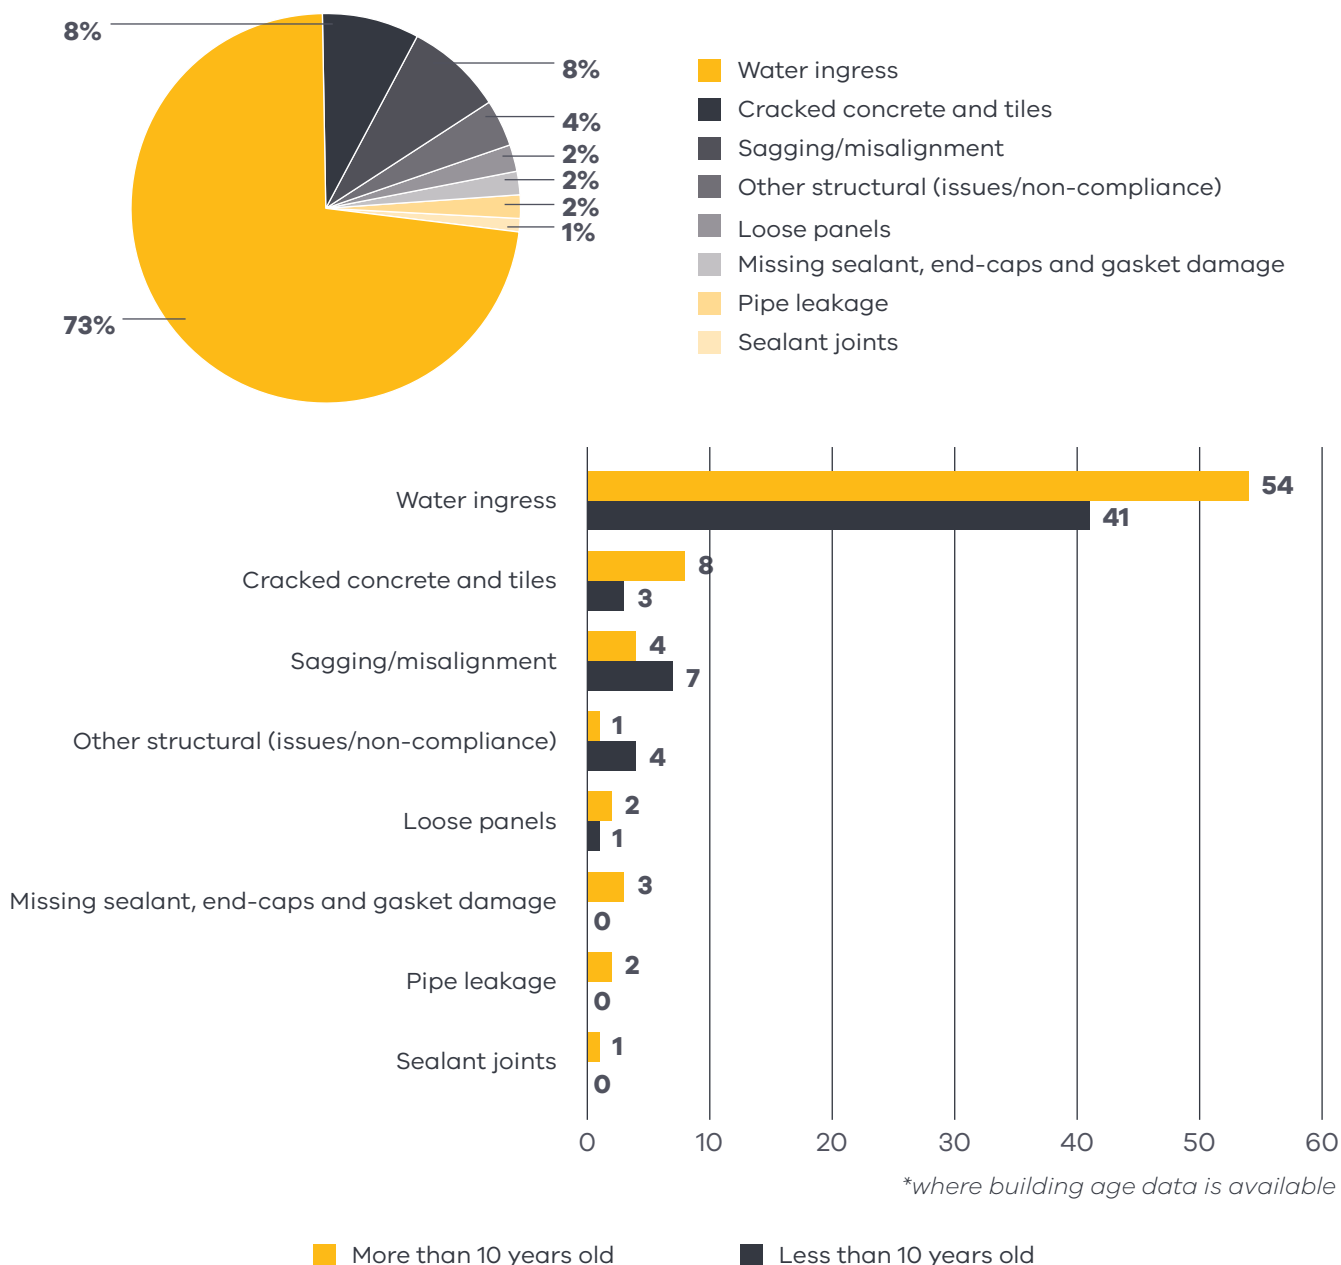
Figure 3. Example of water ingress affecting a balcony on a funded building in CSV's program (comprising 26 sole occupancy units)

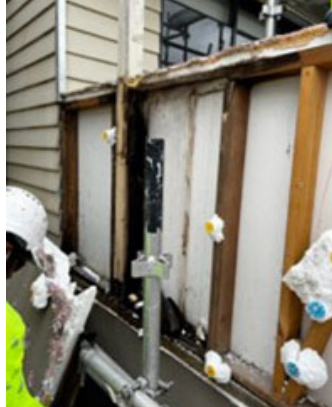
Timber framed balustrade showing water damage coming through capping.

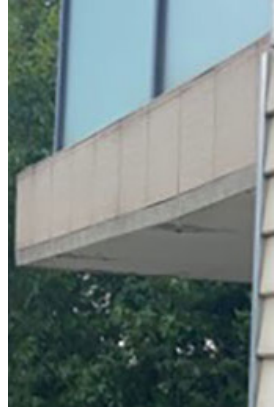
Water damage to soffit evident from balcony above.

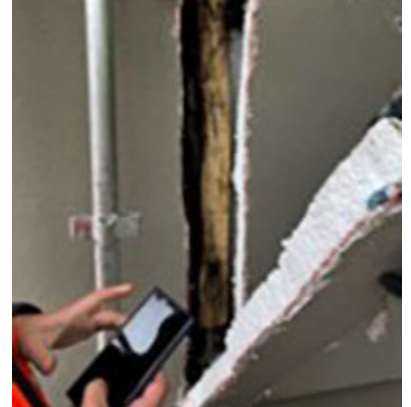
Timber framing to balustrade rotten from water ingress. No sarking sitting behind EPS cladding.

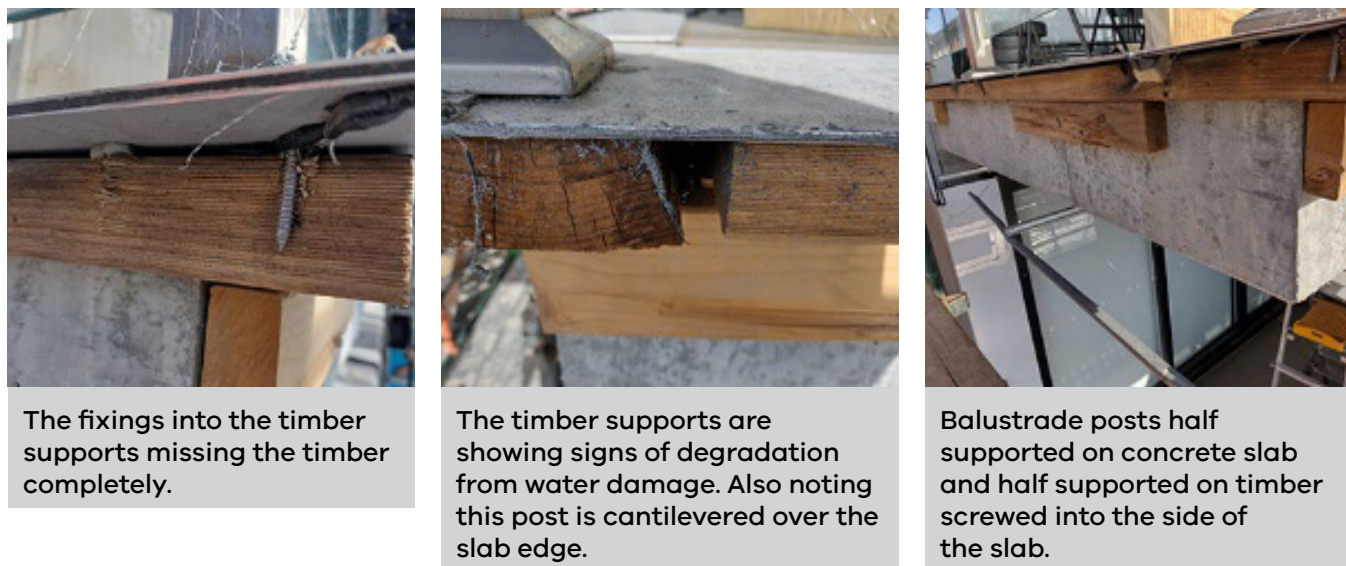
The fixings into the timber supports missing the timber completely.

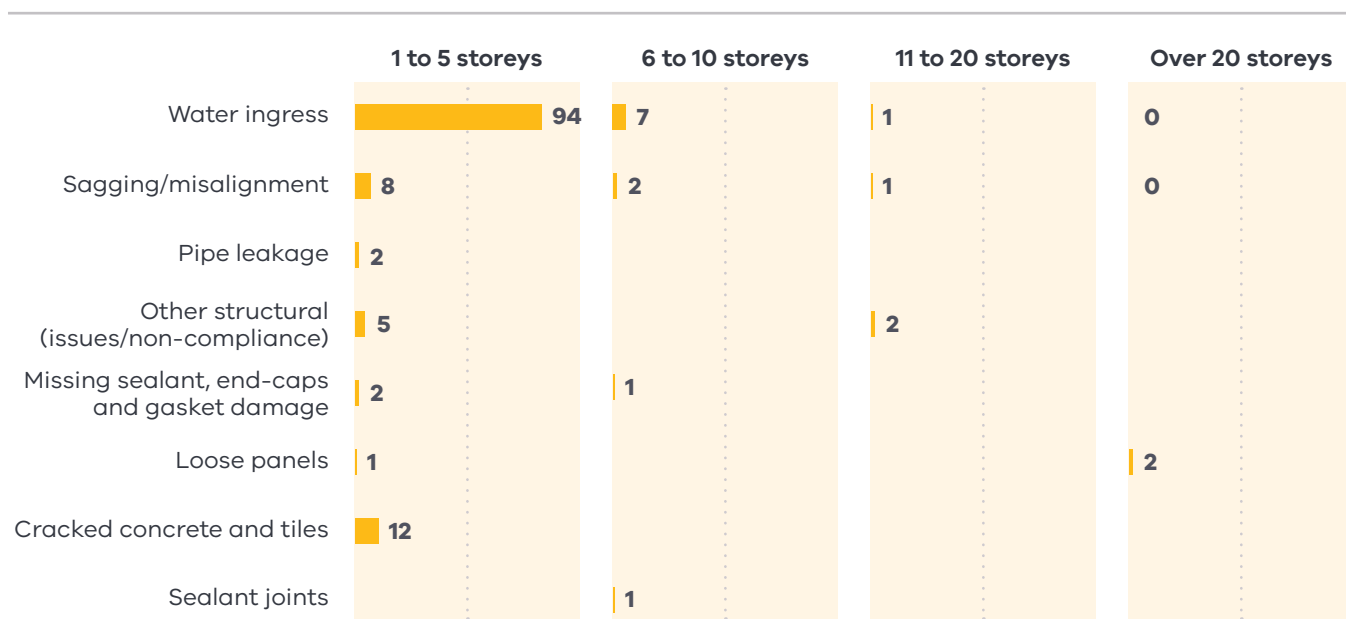
Figure 6. Example of insufficient or no waterproofing affecting a balustrade on a funded building in CSV's program (comprising 12 sole occupancy units)

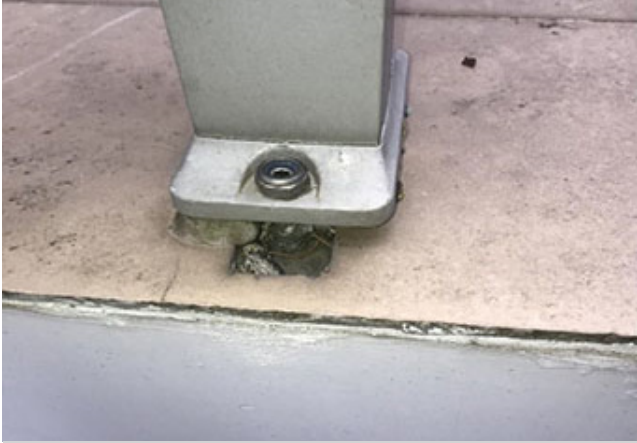
Improper water proofing around balustrade fixing providing areas for water ingress to structural elements.

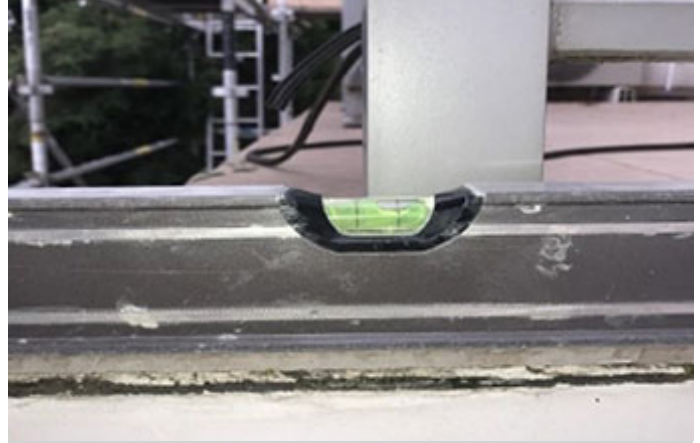
Balcony falling steeply away at edge.

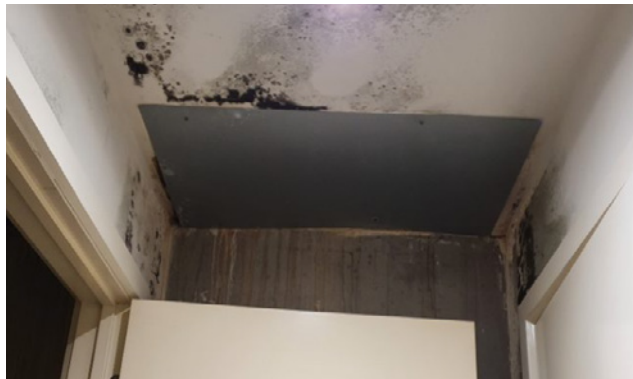
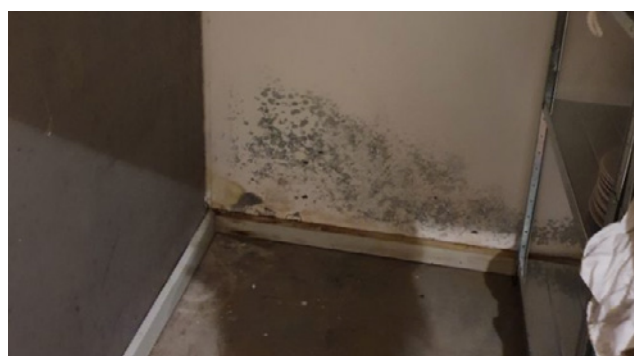
The presence of black mould on parts of the ceiling and walls in this apartment is extensive and widespread.

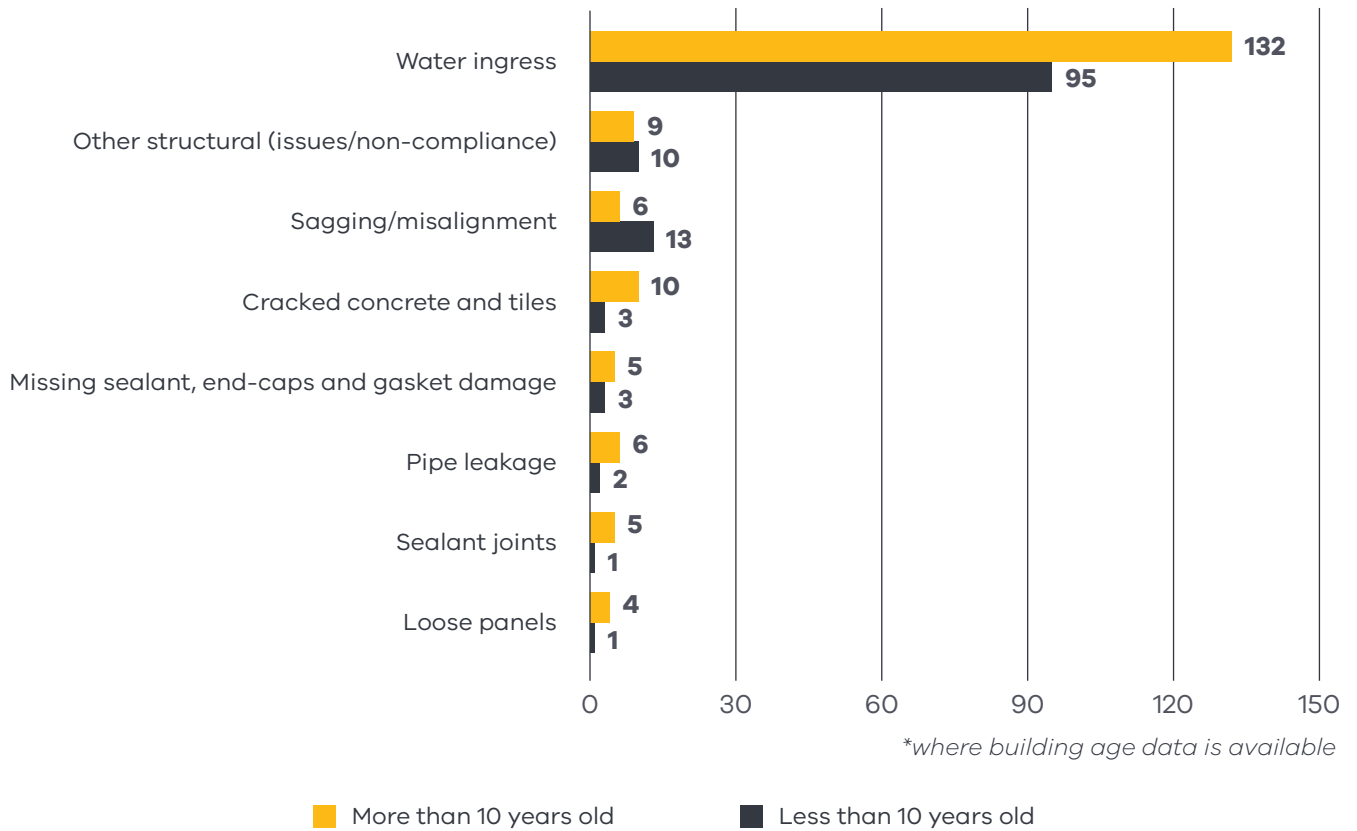
Figure 10 shows that buildings over ten storeys in height have fewer defects than low or medium-sized buildings (between four and ten storeys in height). This is unexpected because taller buildings are more complex, so theoretically should have more defects.

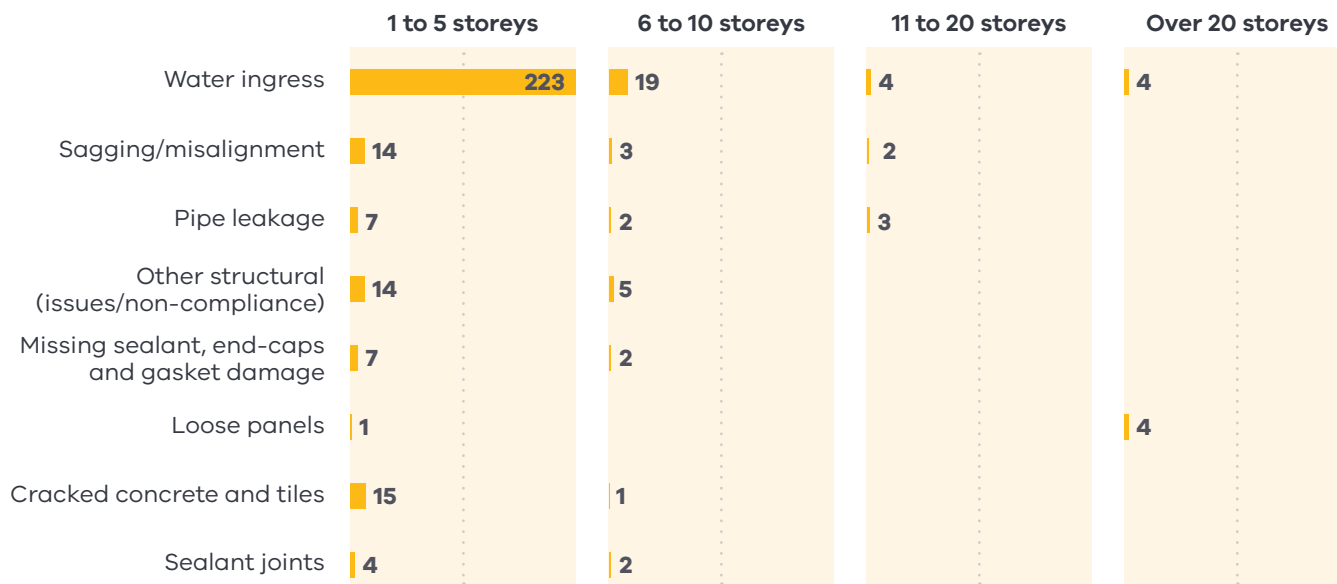
Figure 11 shows the location and number of defects for all buildings in the sample data. Balconies are, by far, the more common defect locations.

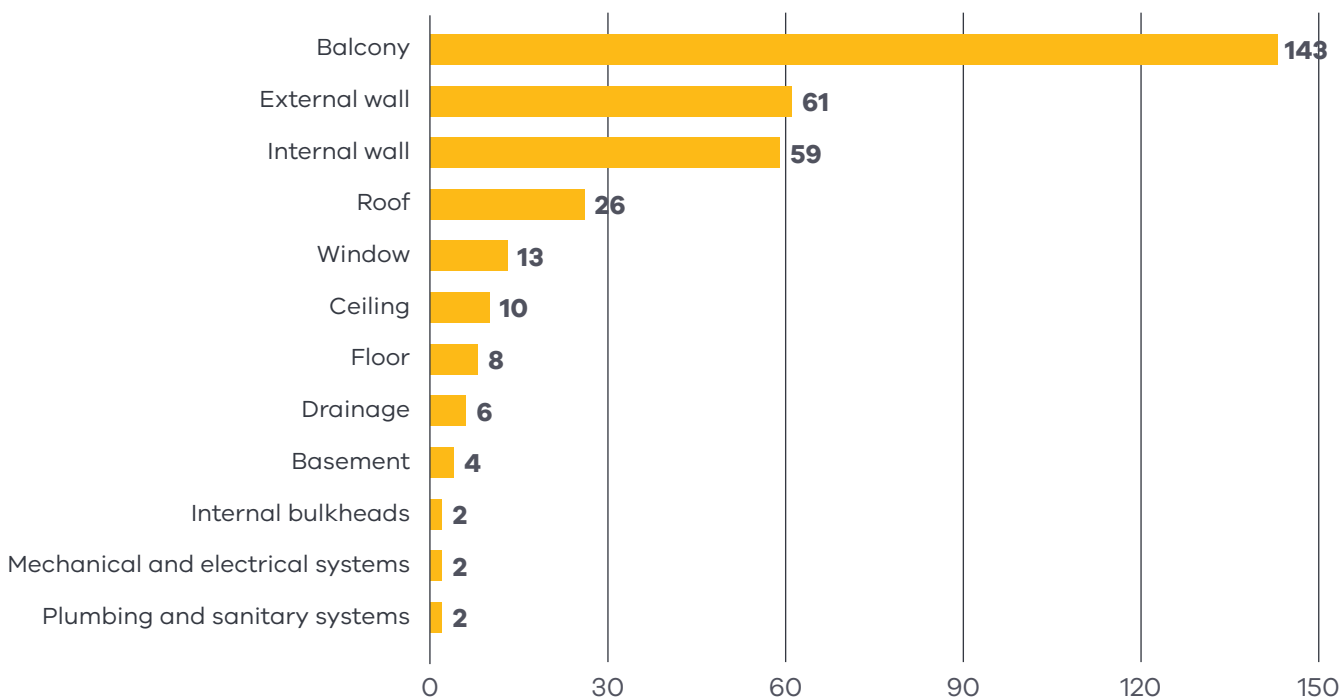
Figure 12. Examples of water ingress in a building in CSV's program

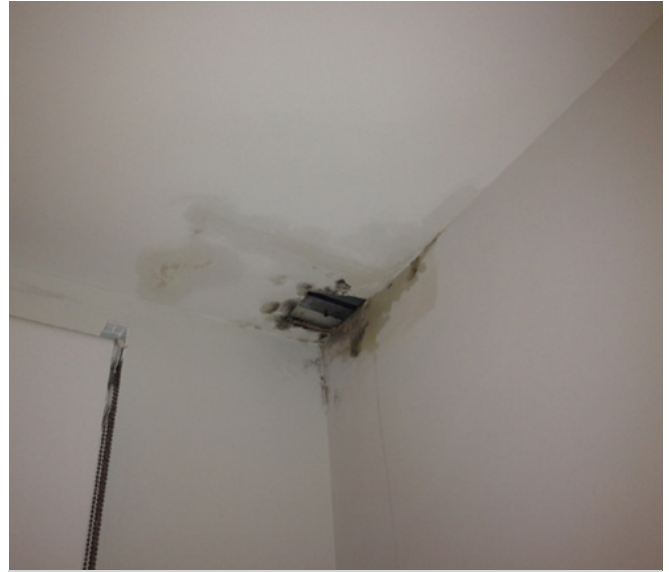
Moisture seeping through plaster walls.

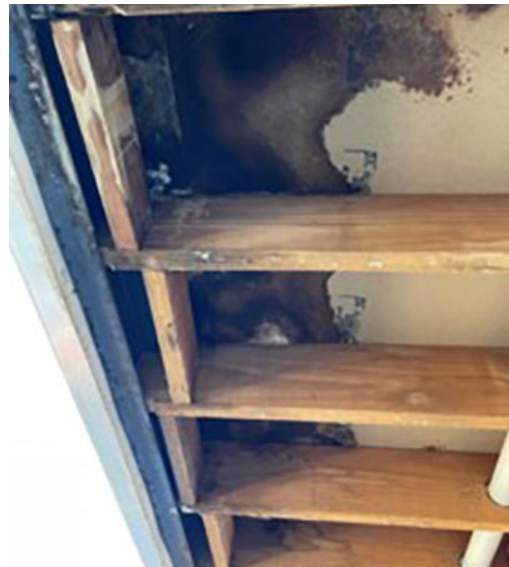
Underside of balcony; substrate with significant rot from water and timber joists showing rot.

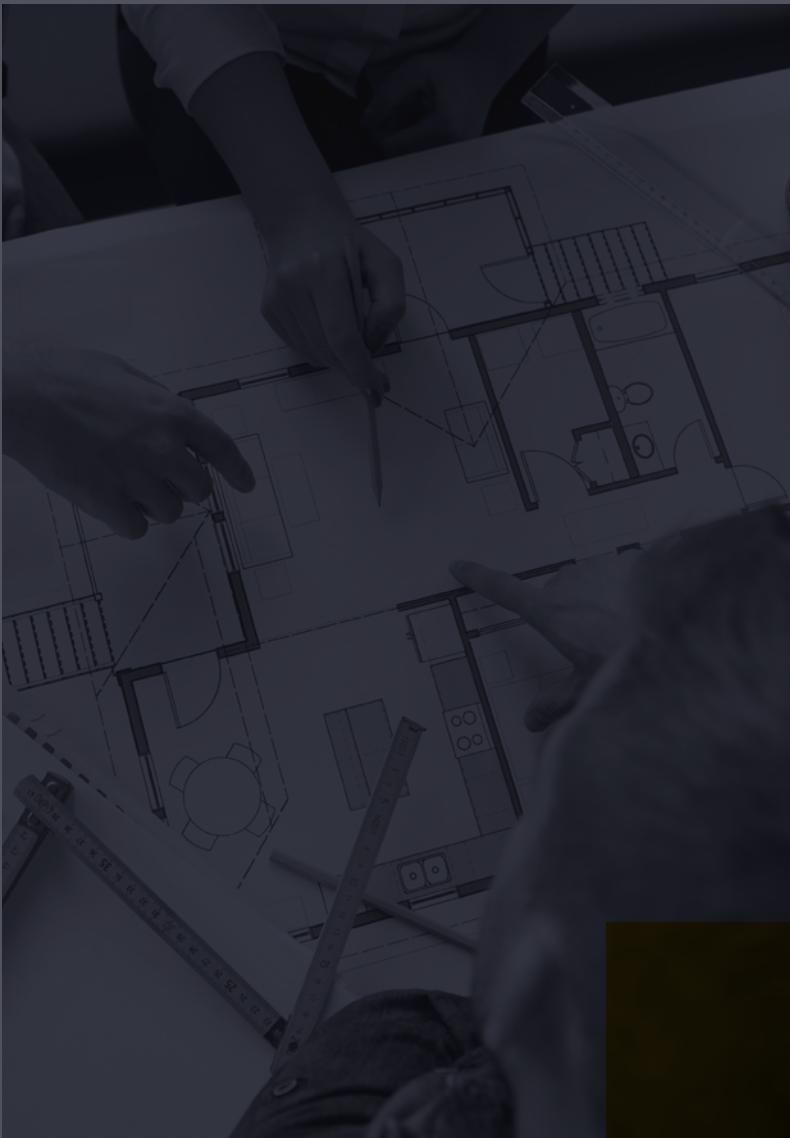
The safety risks to the community posed by building defects caused through poor design, construction or maintenance are considered as unacceptable and have led to fatal outcomes.

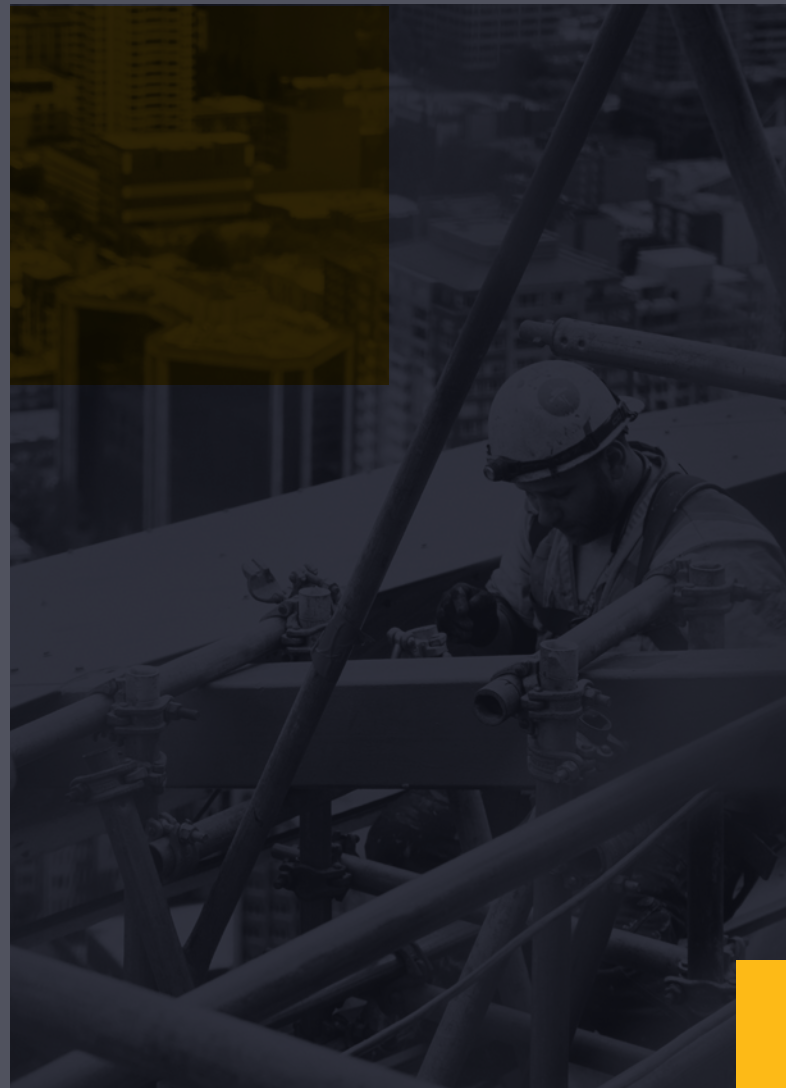
The following two case studies are derived from buildings referred to CSV's Cladding Rectification Program and provide indicative examples of the kinds of issues faced by CSV in addressing cladding on buildings where there are non-cladding defects identified.

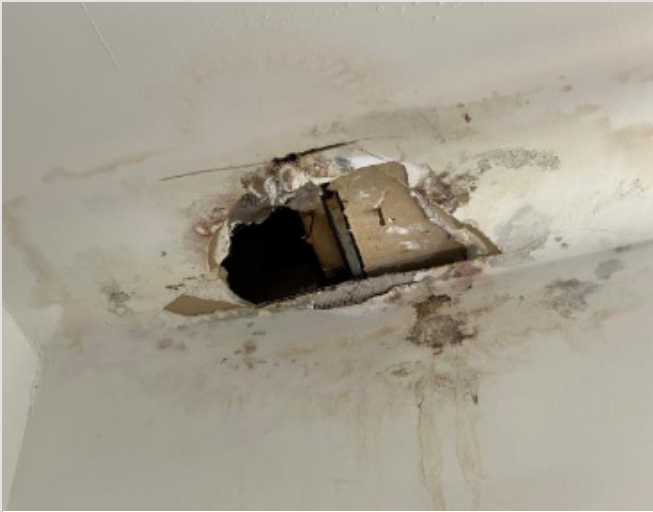
Mould and staining on apartment ceiling.

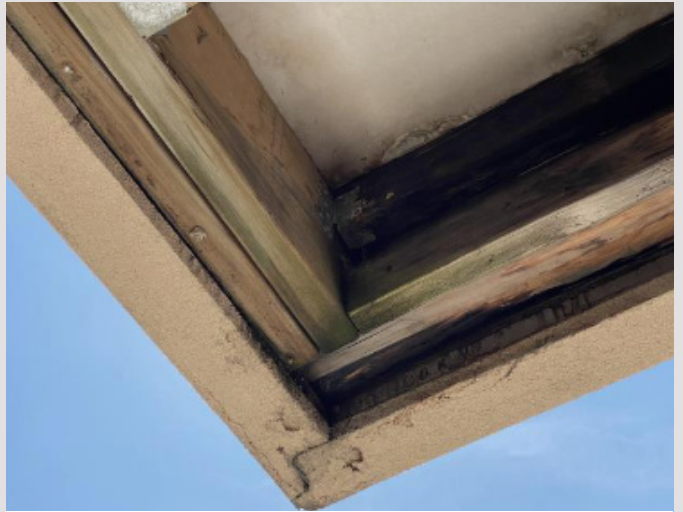
Deterioration of timber balcony.

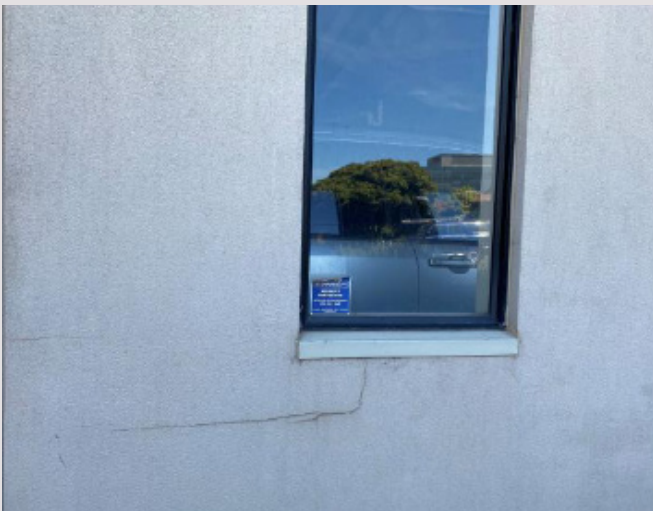
Cracking along blockwork joints.

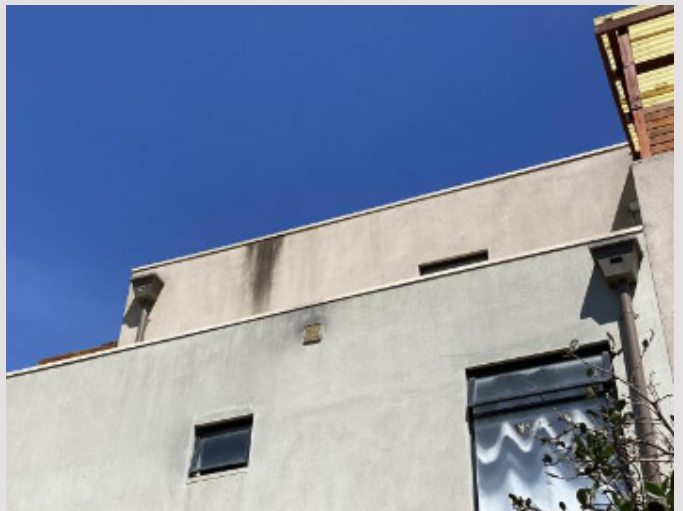
Widespread staining of rendered surfaces.

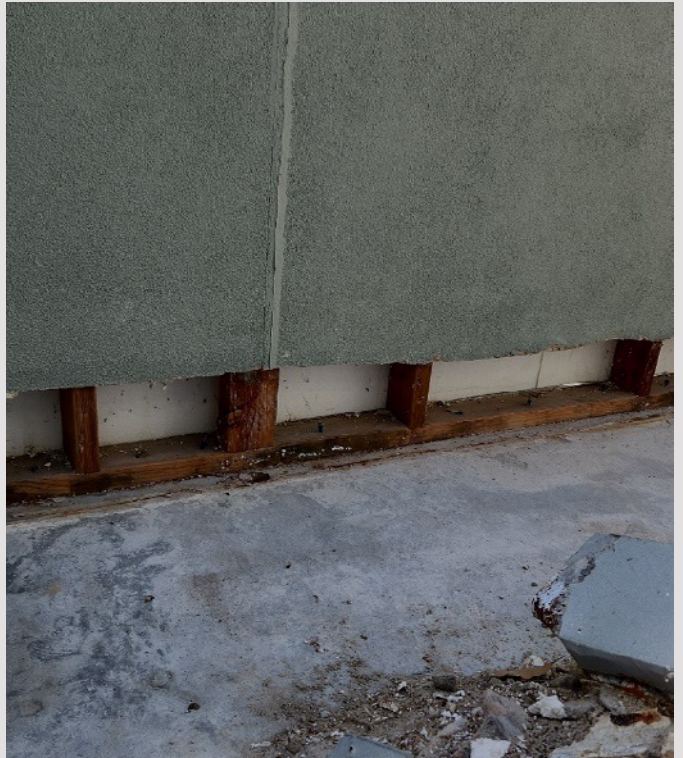
Example of waterproofing damage that is being replaced.

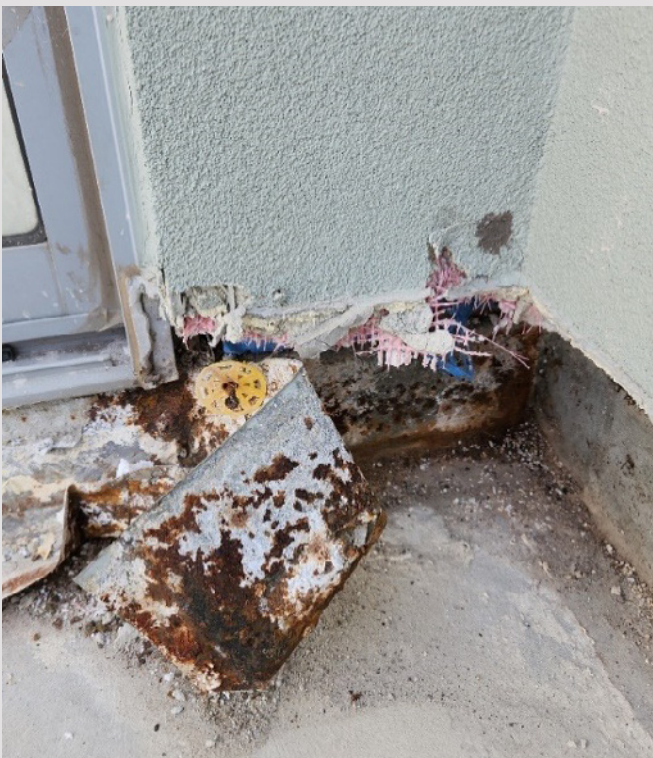
Corroded steel frames caused by water leakage.
