Exceedance of temporary speed restriction by XPT passenger train ST21

Moreland, Victoria on 24 May 2022

ATSB Transport Safety Report

RO-2022-005

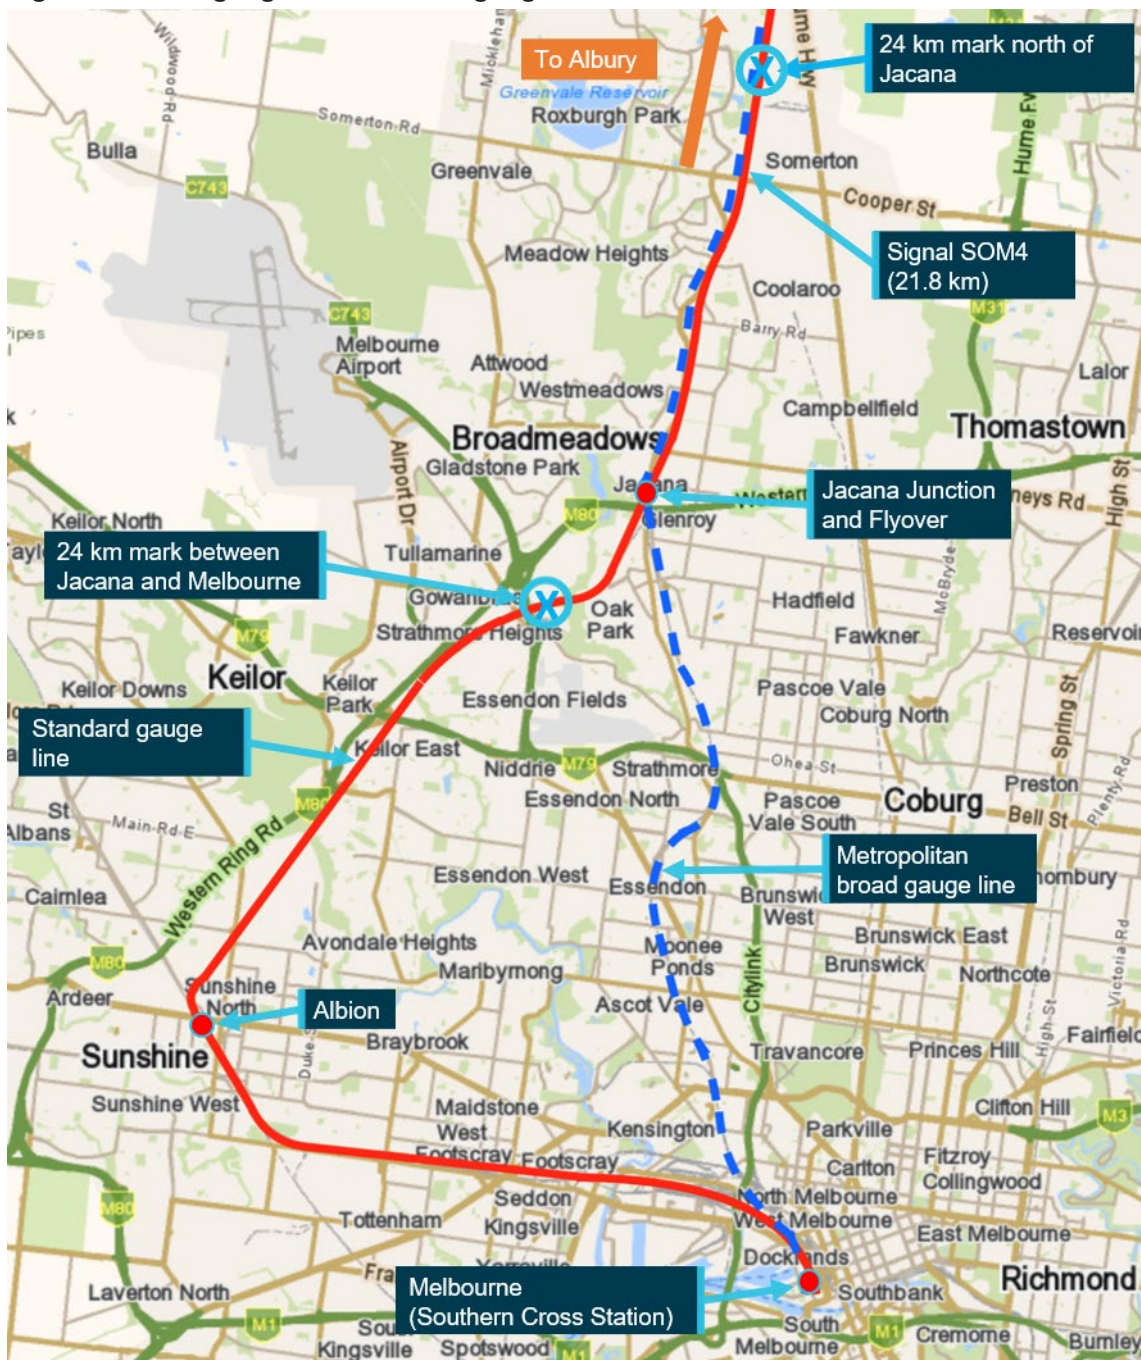
Figure 5: Broad gauge and standard gauge routes to and from Melbourne

For trains travelling toward Melbourne, the standard and broad gauge tracks ran parallel approaching Jacana before taking divergent routes. The standard gauge track crossed over the broad gauge at the Jacana Flyover and was routed via western Melbourne, whereas the broad gauge lines continued in a more direct route towards Melbourne (Figure 5). The standard gauge route between Jacana and Melbourne was about 27 km and the broad gauge route about 16 km.
