# Grounding of pilot launch *PV Corsair*

Port Phillip Heads (near Point Lonsdale) Victoria, on 5 October 2023

MO-2023-003

Preliminary – 22 December 2023

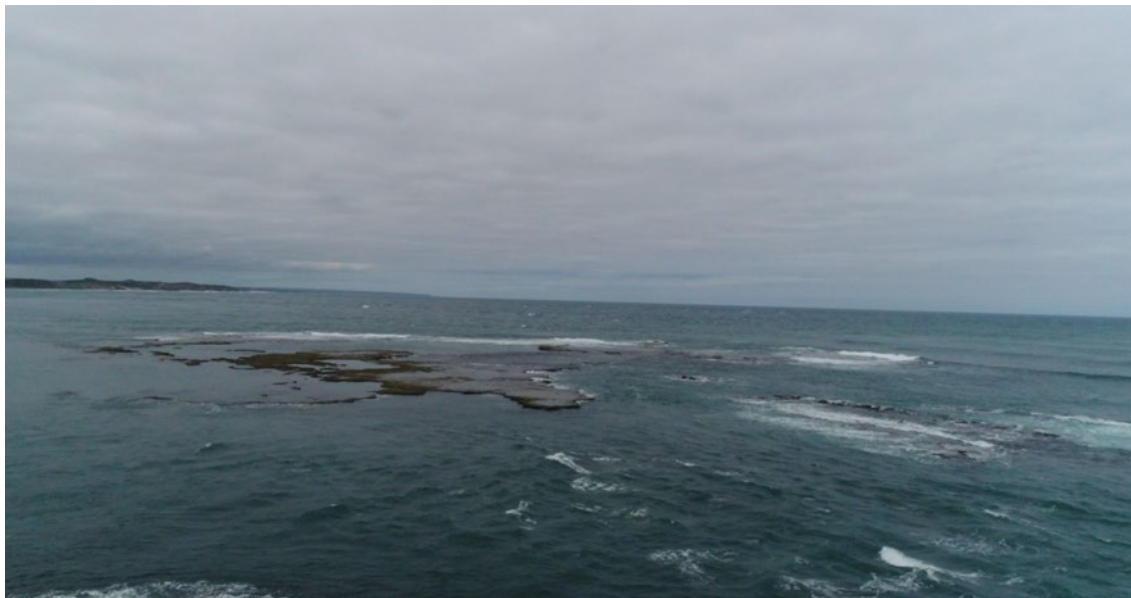
**Figure 3: Point Lonsdale Reef**

*Point Lonsdale Reef photographed from Point Lonsdale the day after the grounding.*  
Source: Elstone Diving Services Pty Ltd

Point Lonsdale Reef is an outcrop of flat-topped rocks extending up to about 540 m south-east of Point Lonsdale (Figure 3). The extent of the reef's exposure and its visibility varies with tide and sea conditions.
