Reaction to fire test report

Test standard: Ad-hoc test based off ISO 13785-1:2002

System: Aluminium composite panel (ACP) and glazing external wall cladding system

Job number: RTF230148

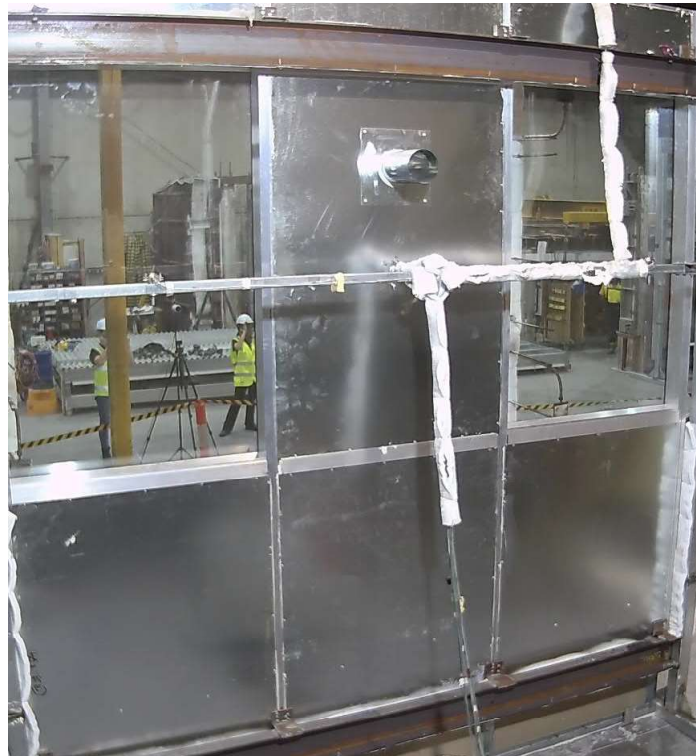
Figure 28 The specimen (unexposed side) before the reaction to fire test

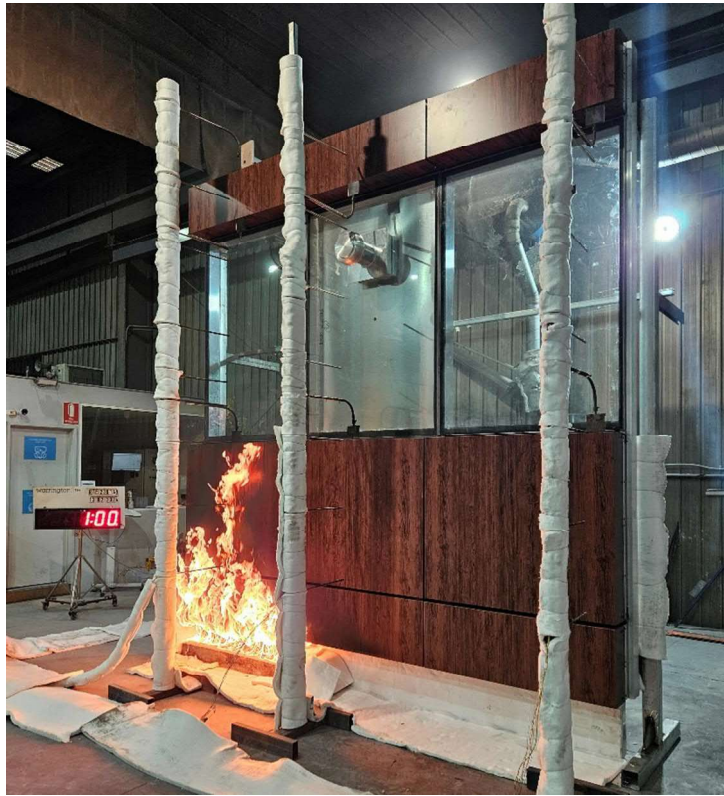
Figure 29 The specimen 1 minute into the test (burner output at 300 kW)

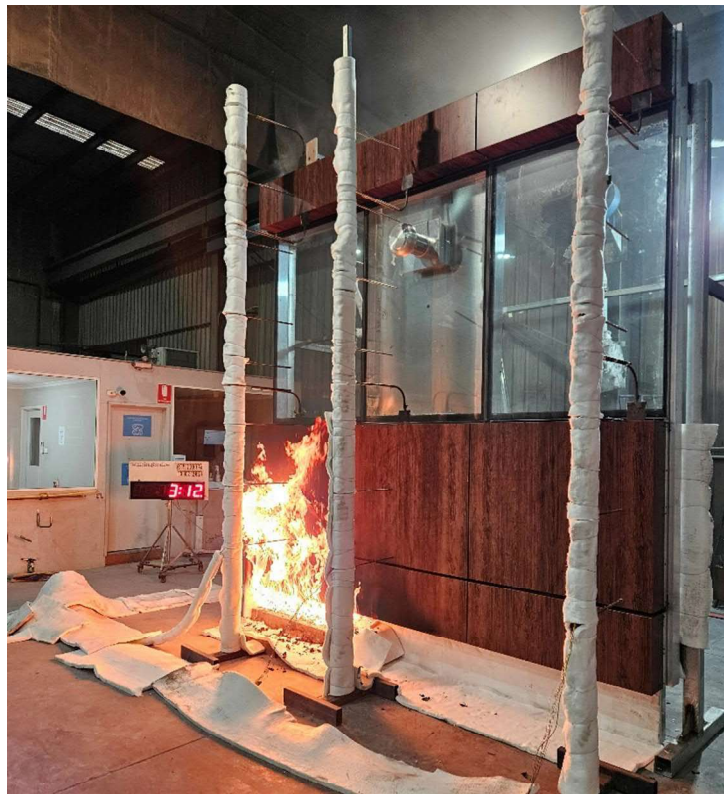
Figure 30 The specimen 3 minutes 12 seconds into the test (burner output at 300 kW)

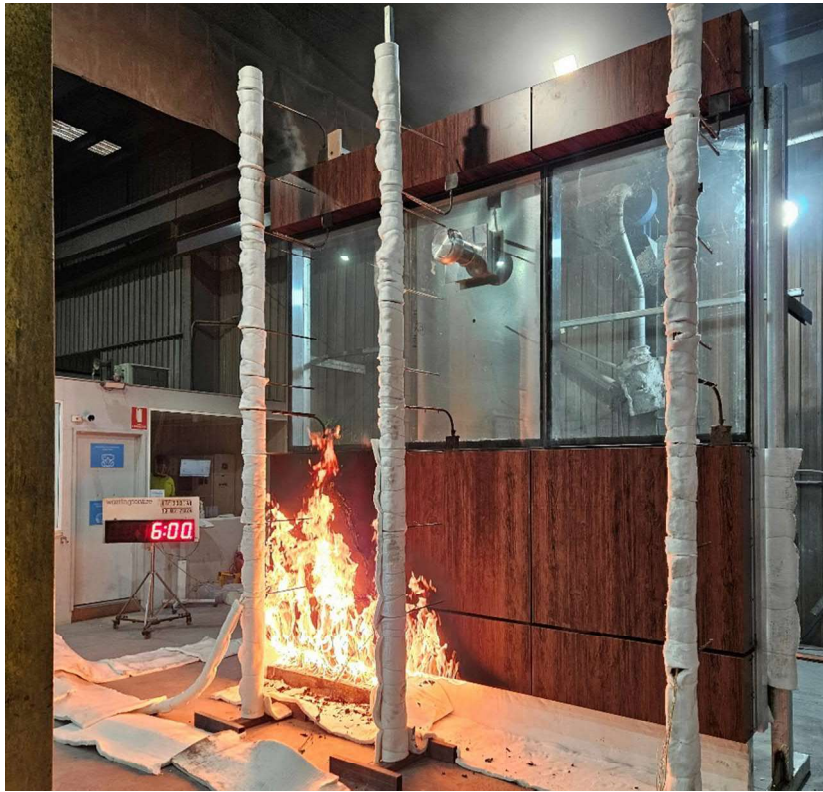
Figure 31 The specimen 6 minutes into the test (burner output at 300 kW)

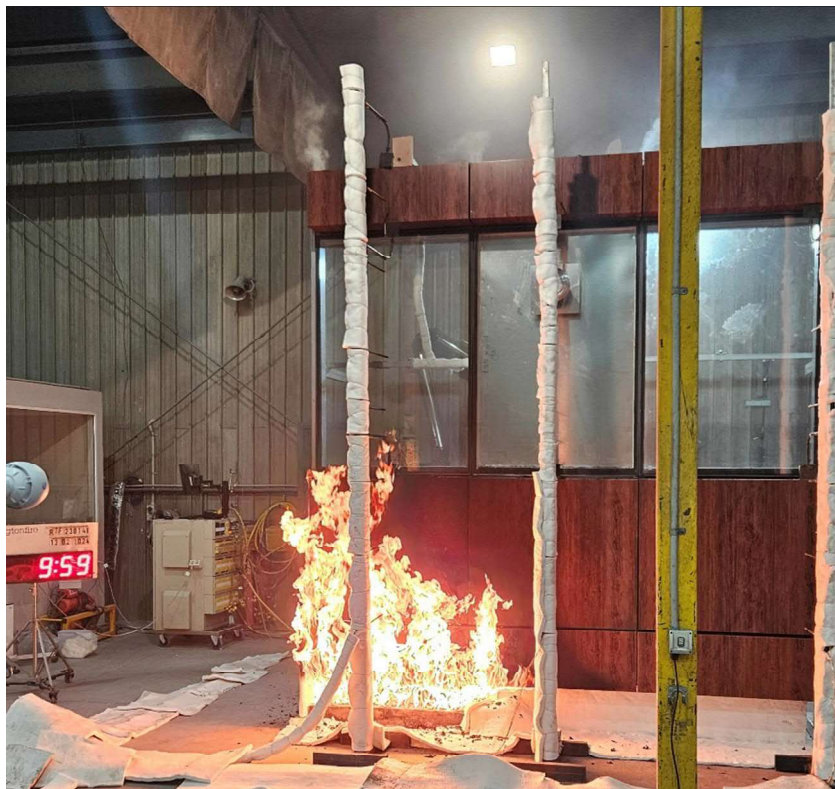
Figure 32 The specimen 9 minutes 59 seconds into the test (burner output at 300 kW)

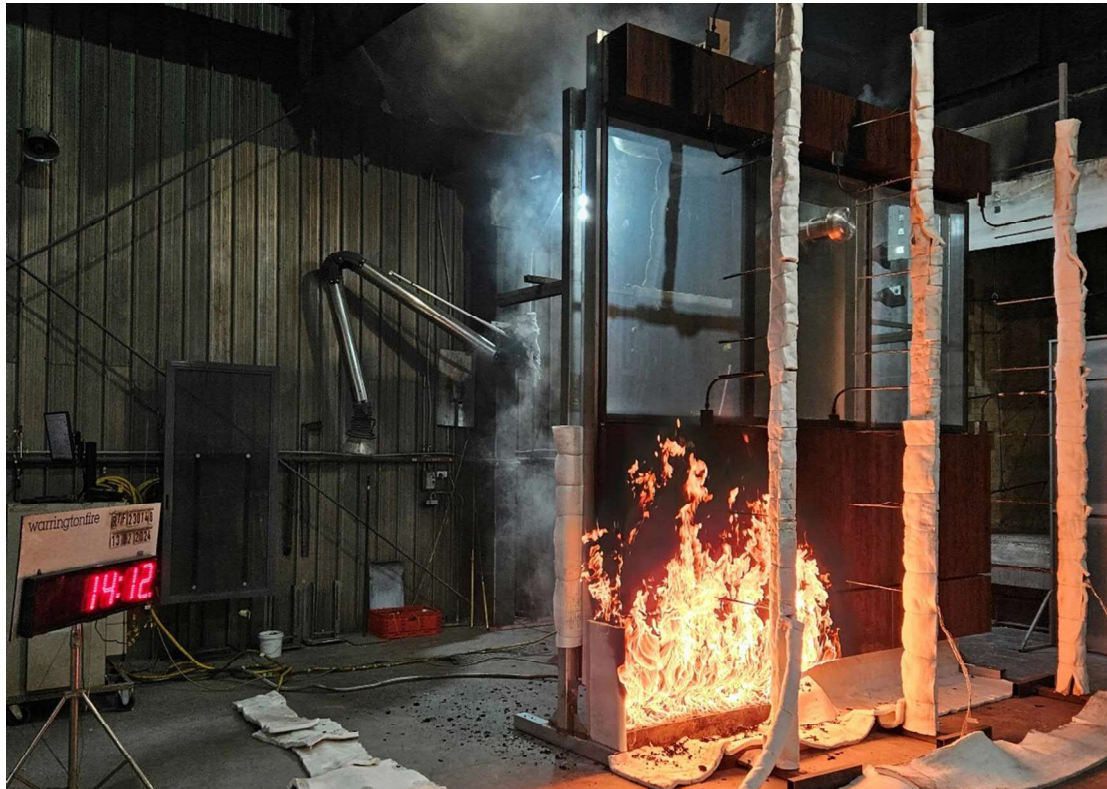
Figure 33 The specimen 14 minutes 12 seconds into the test (burner output at 300 kW)

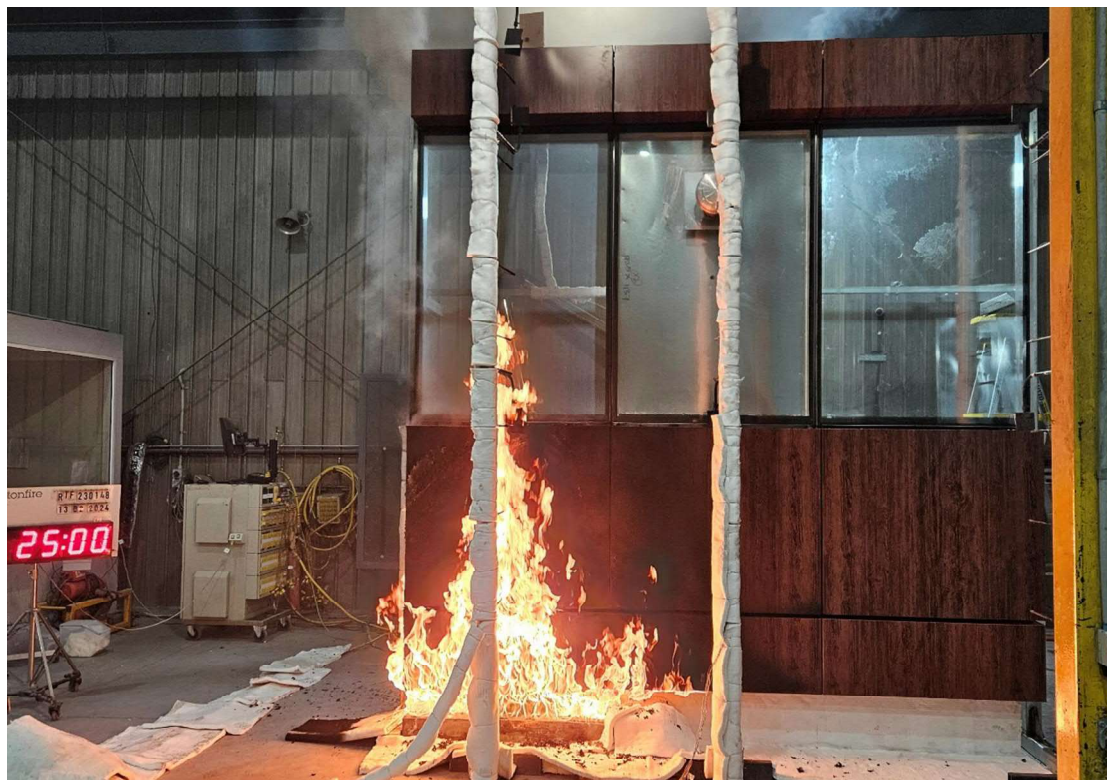
Figure 34 The specimen 25 minutes into the test (burner output at 300 kW)

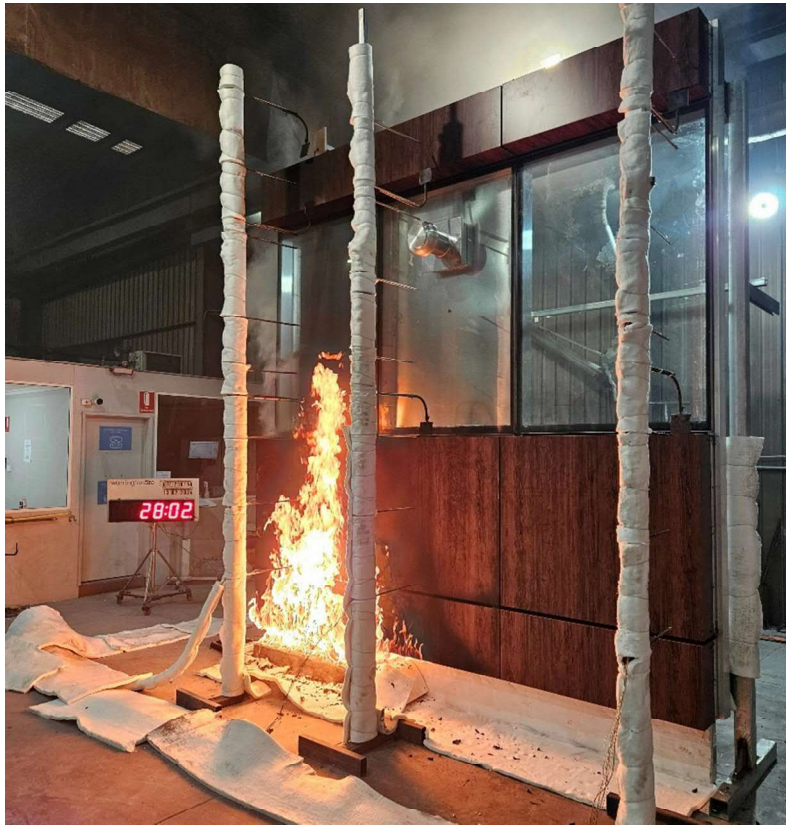
Figure 35 The specimen 28 minutes 2 seconds into the test (burner output at 300 kW)

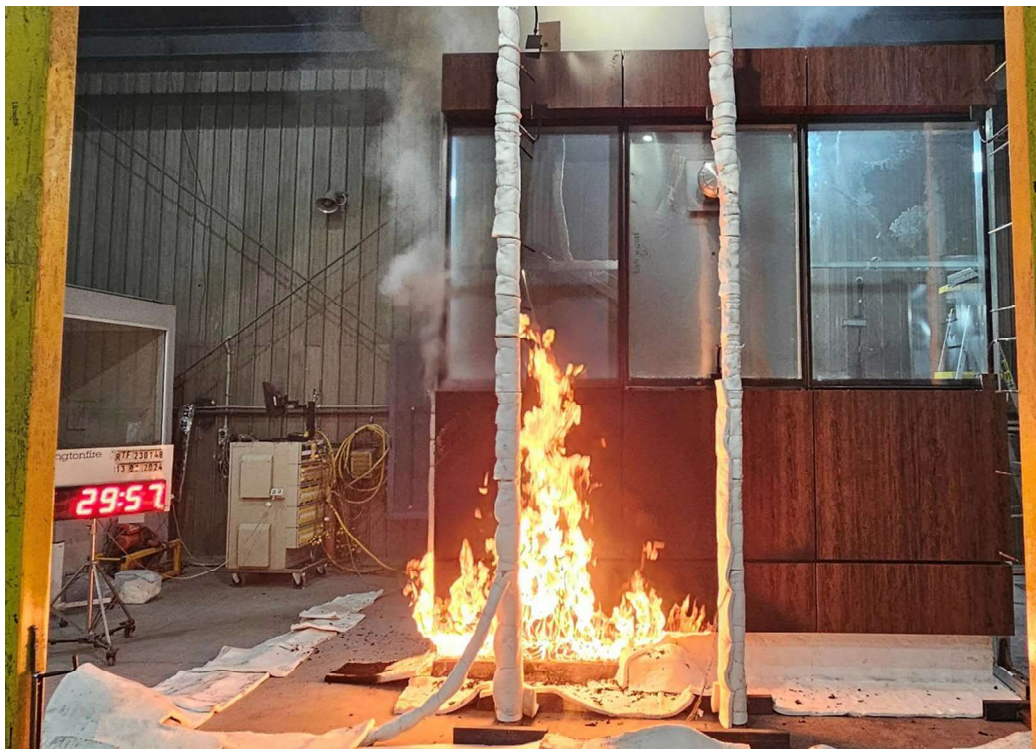
Figure 36 The specimen 29 minutes 57 seconds into the test (burner output at 300 kW)

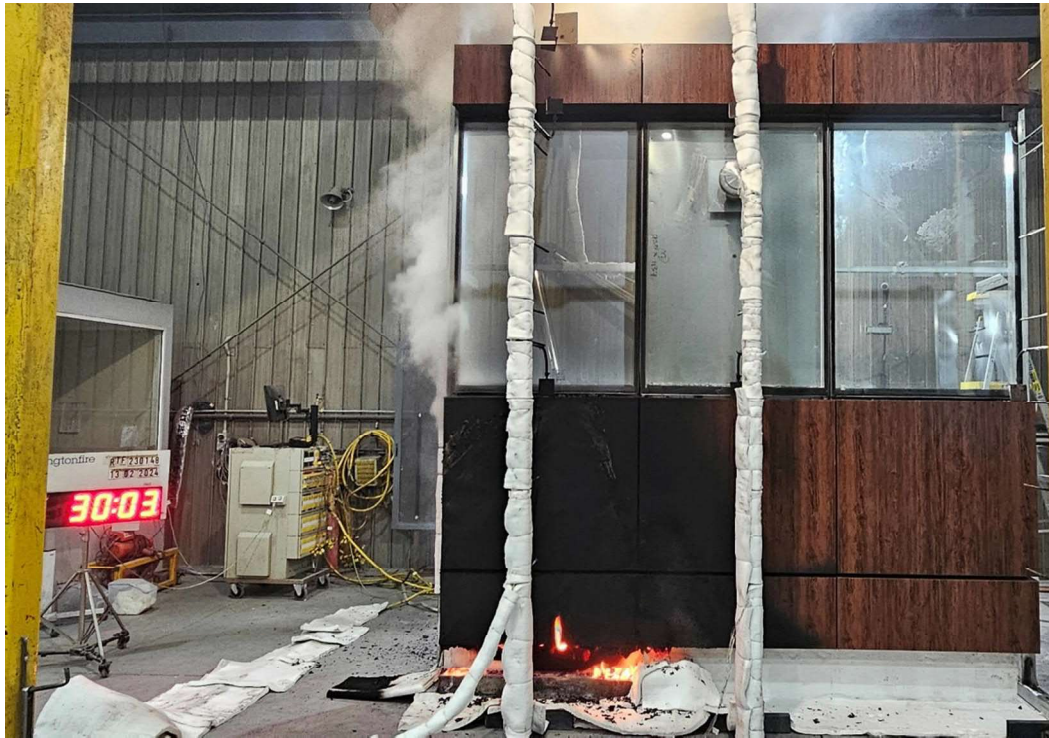
Figure 37 The specimen 30 minutes 3 seconds into the test (burner off)

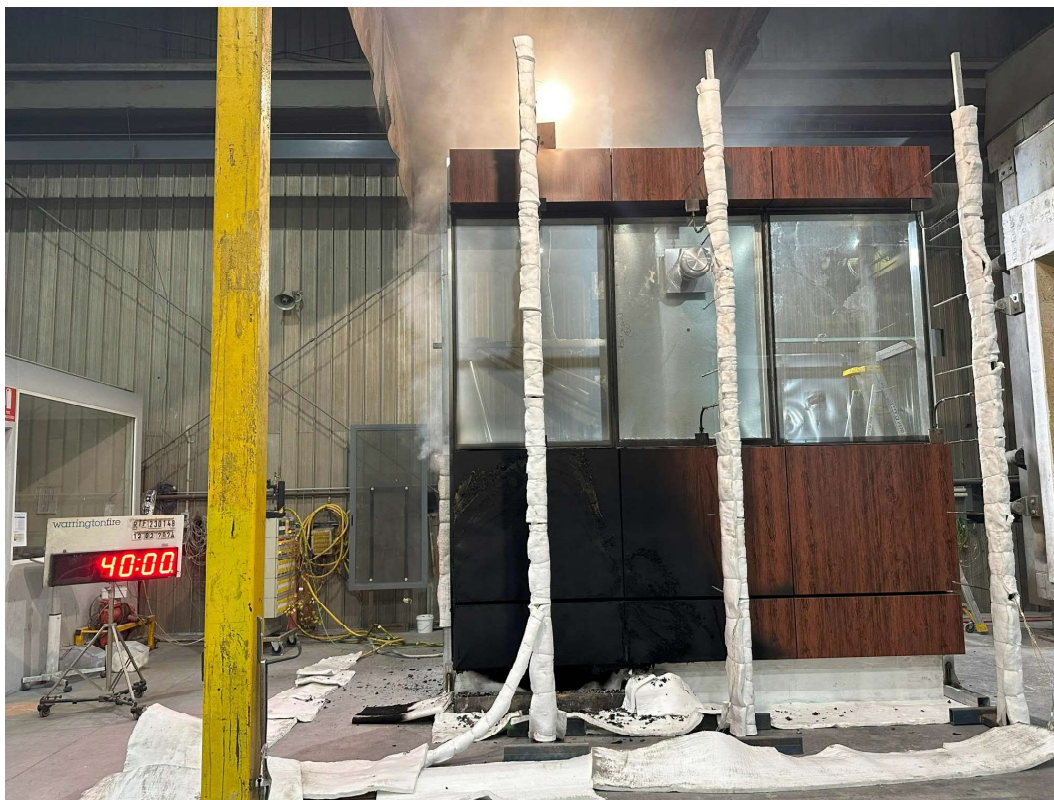
Figure 38 The specimen 40 minutes into the test (burner off)

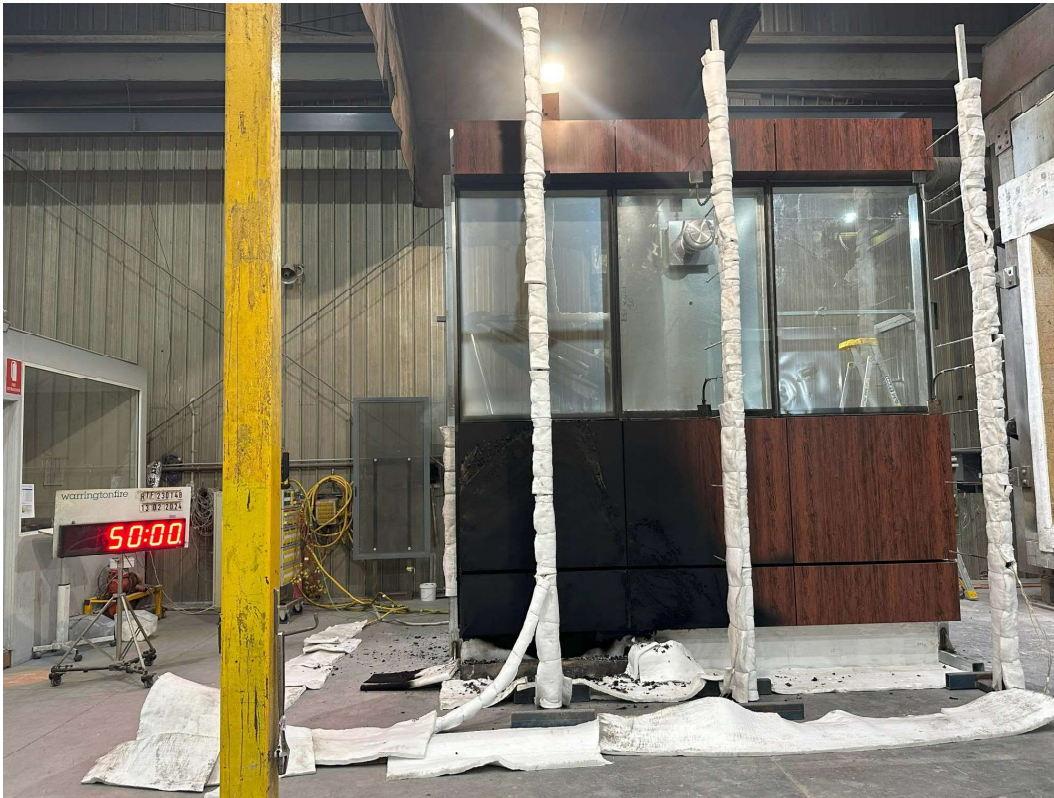
Figure 39 The specimen 50 minutes into the test (burner off)

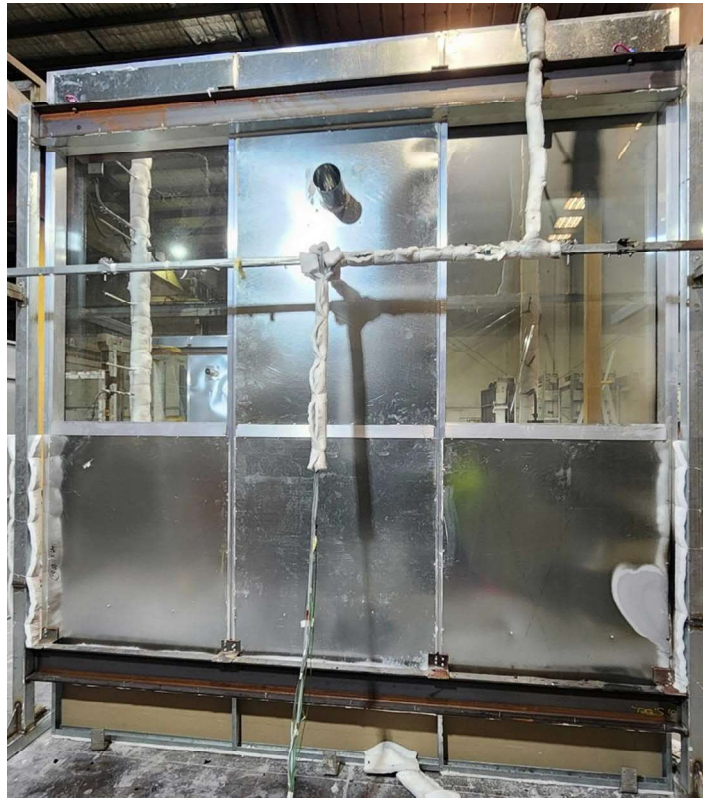
Figure 41 The specimen at end of test – unexposed side
