Reaction to fire test report

Test standard: Ad-hoc test based off ISO 13785-1:2002 with an additional wind component

System: Aluminium composite panel (ACP) and glazing external wall cladding system

Job number: RTF230150

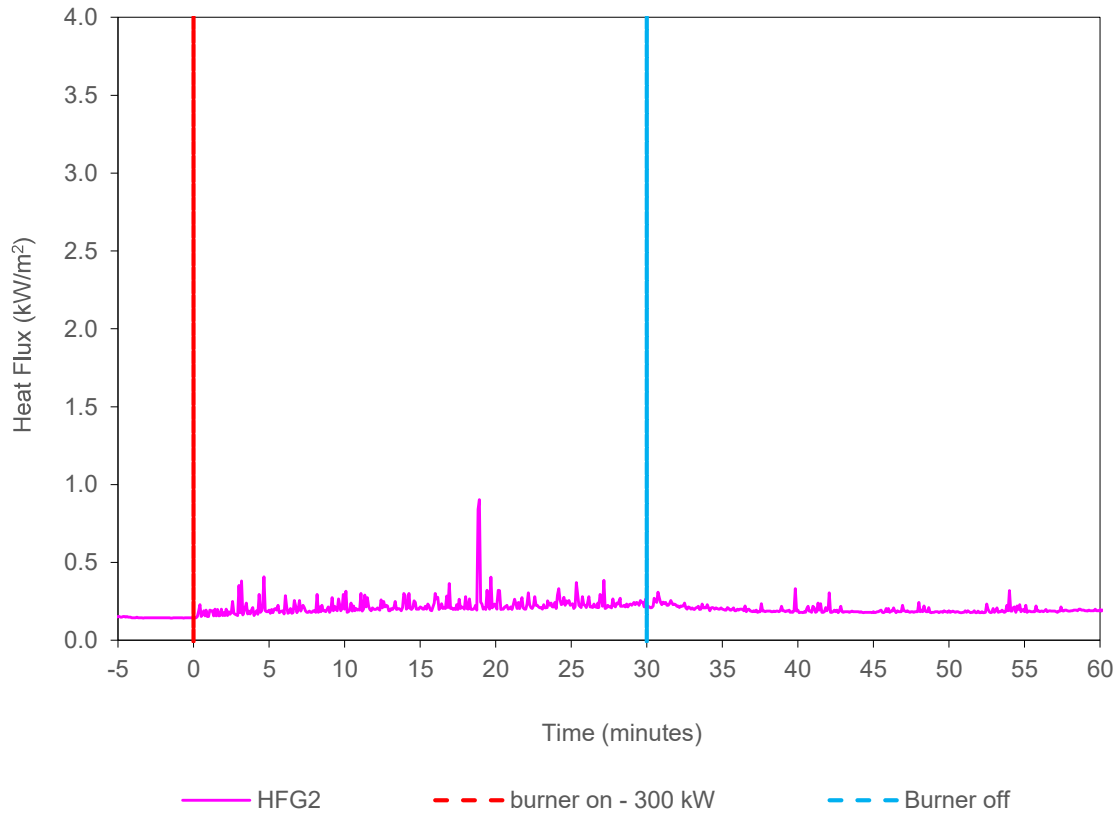
Figure 11 Heat flux data collected by heat flux gauge at the top of the specimen above the burner.

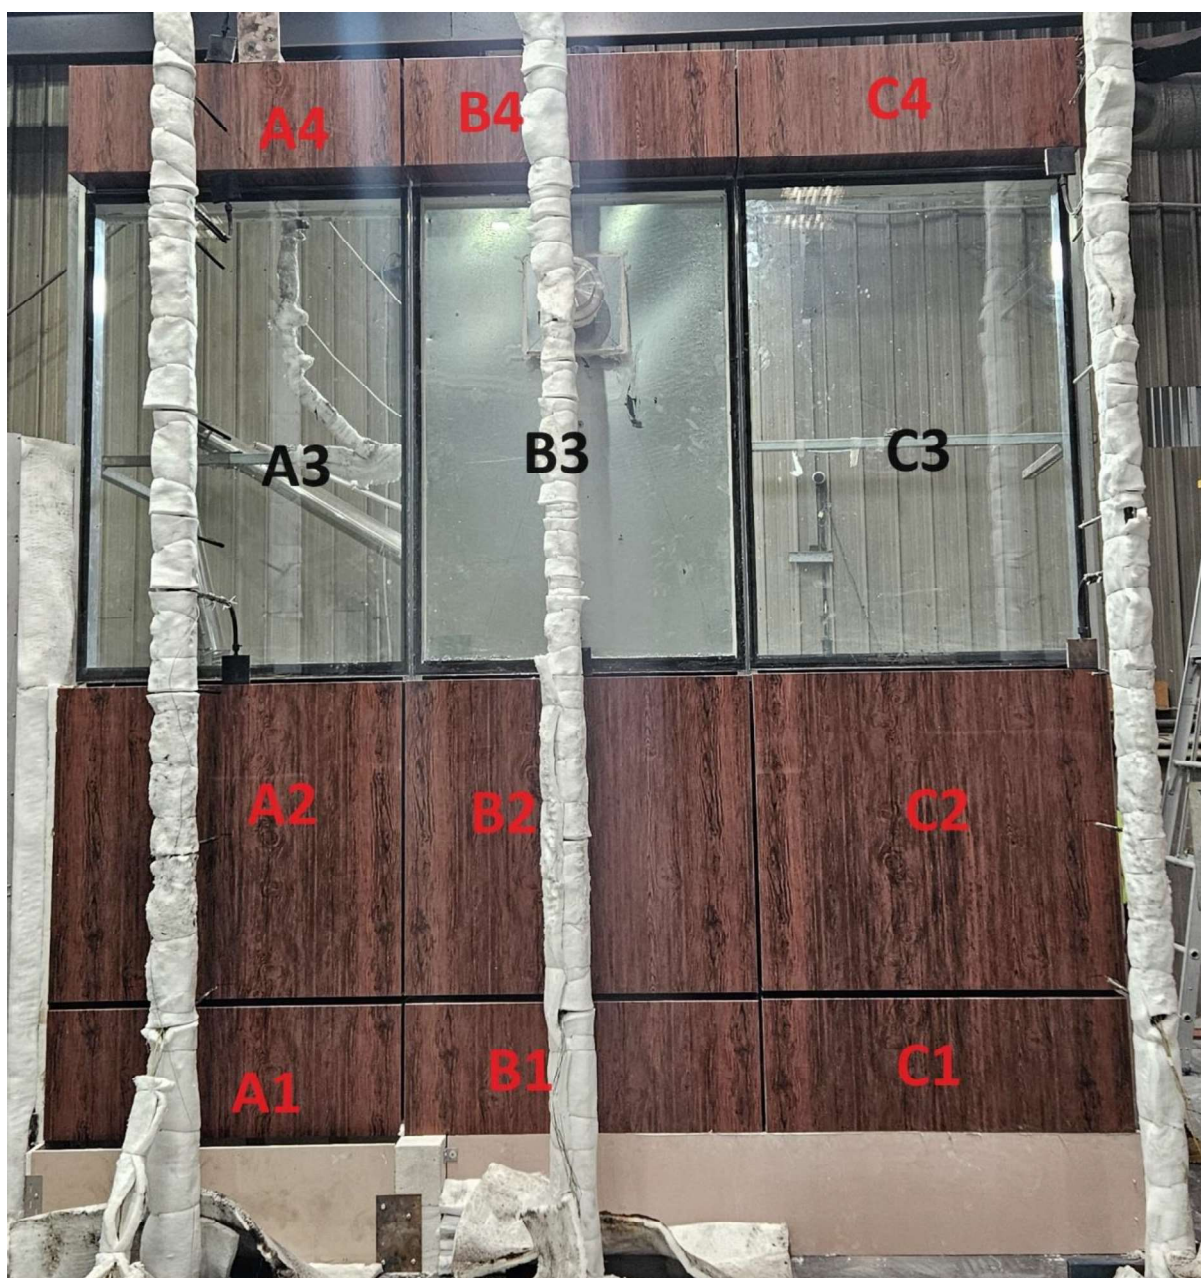
Figure 13 Designation of section for the test observations.

Table 4 shows the observations of any significant behaviour of the specimen during the test. Figure 13 shows the panel and glazing designations sighted in the observations.

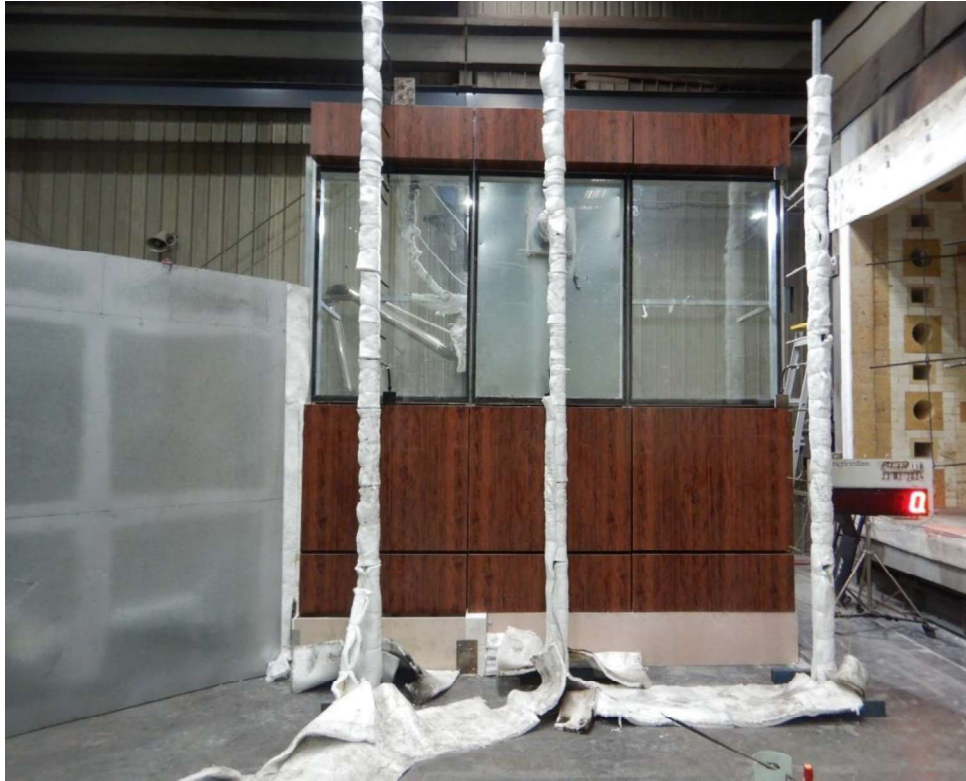
Figure 22 The specimen and test setup (angled - exposed side) before the reaction to fire test

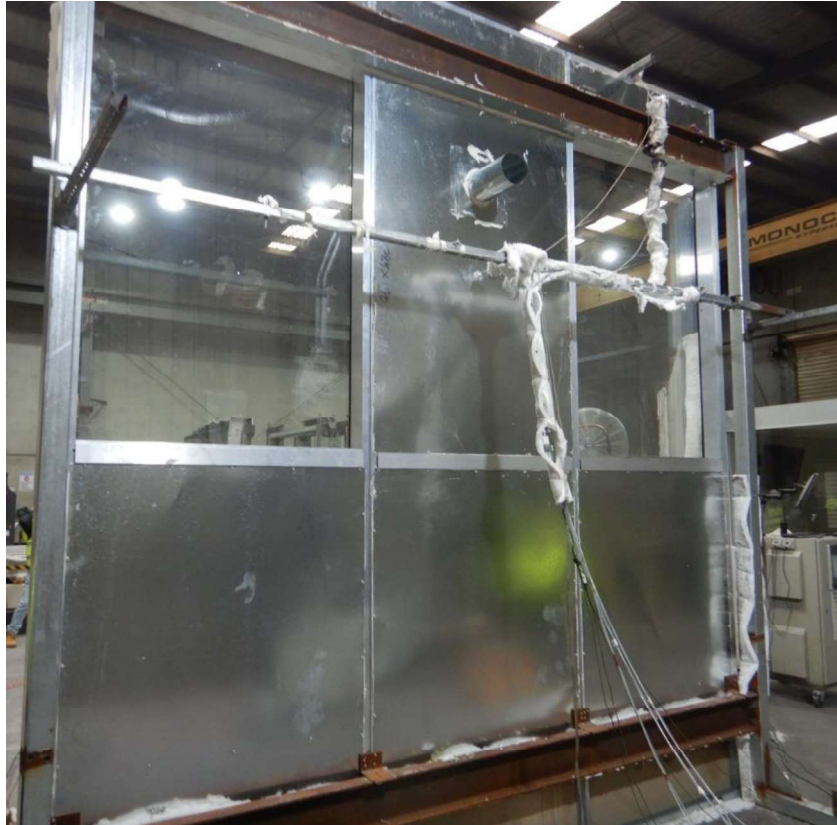
Figure 24 The specimen before the reaction to fire test - unexposed side.

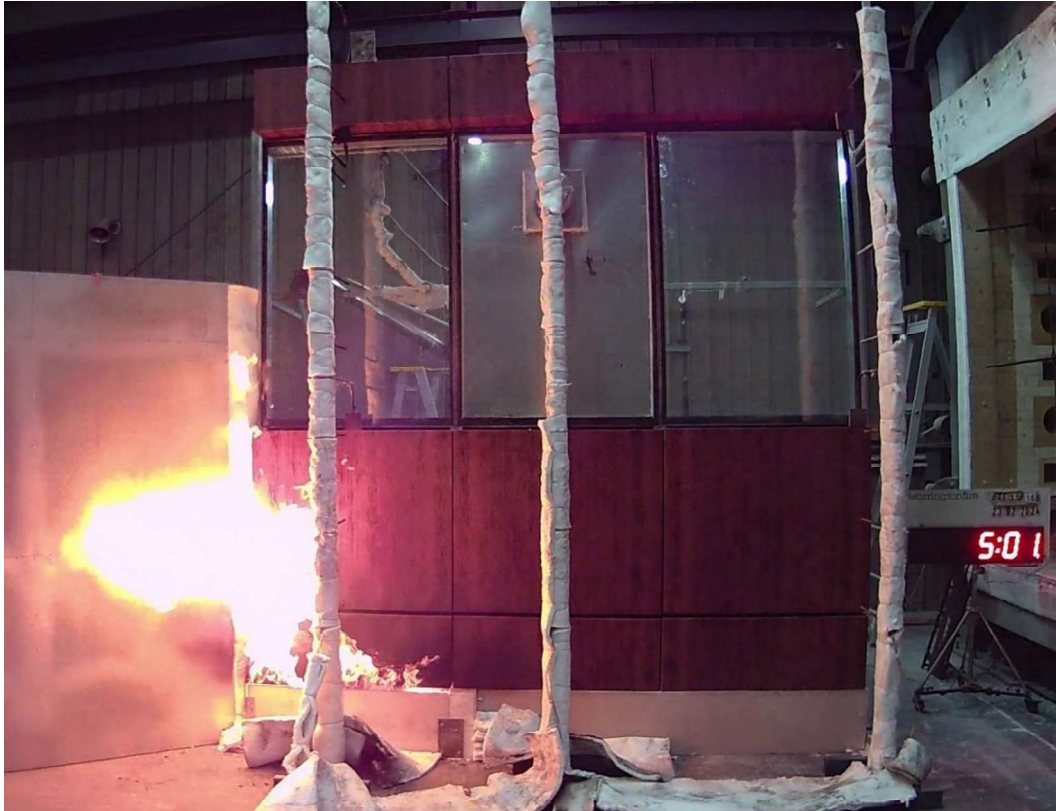
Figure 26 The specimen 5 minutes 1 second into the test (burner output at 300 kW and wind on)

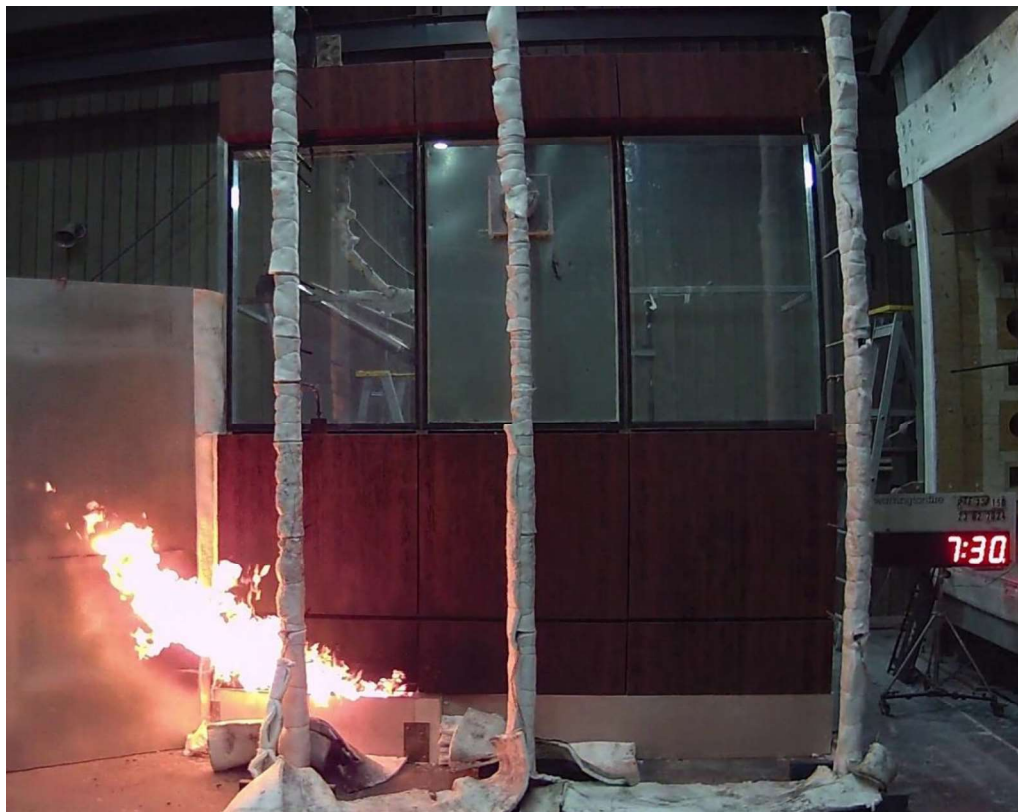
Figure 27 The specimen 7 minutes 30 seconds into the test (burner output at 300 kW and wind on)

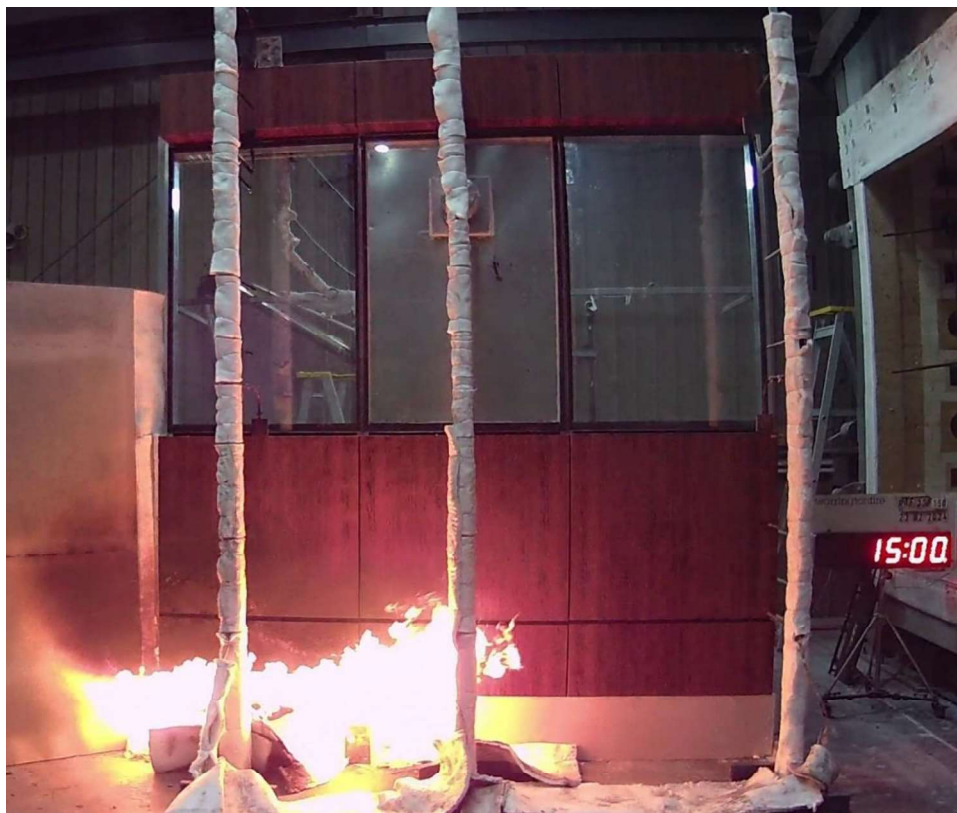
Figure 29 The specimen 15 minutes into the test (burner output at 300 kW and wind on).

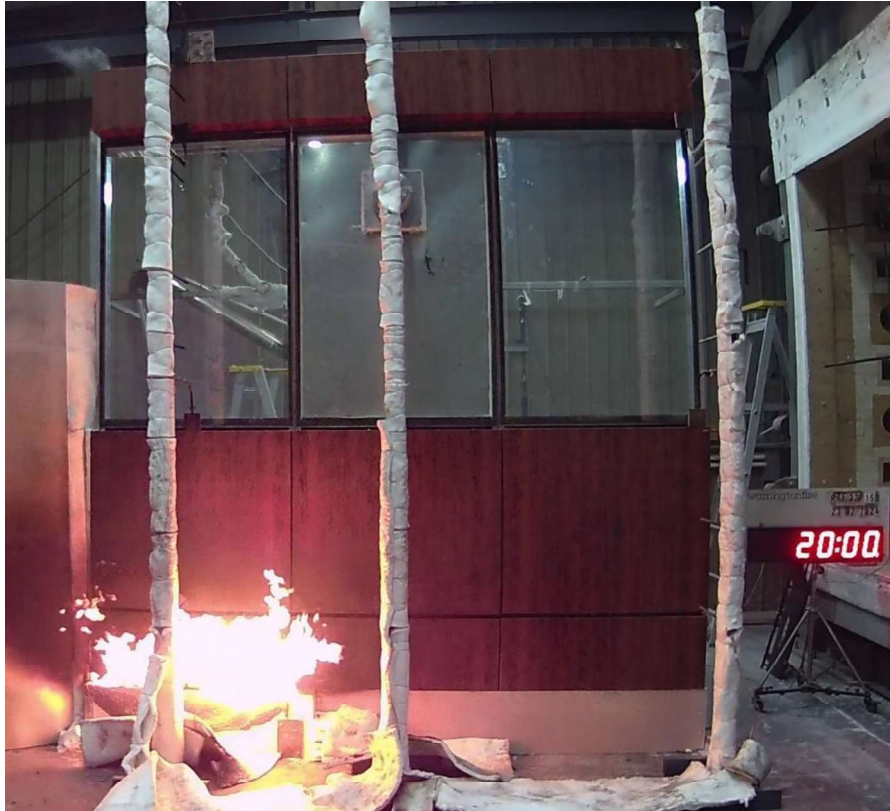
Figure 30 The specimen 20 minutes into the test (burner output at 300 kW and wind on).

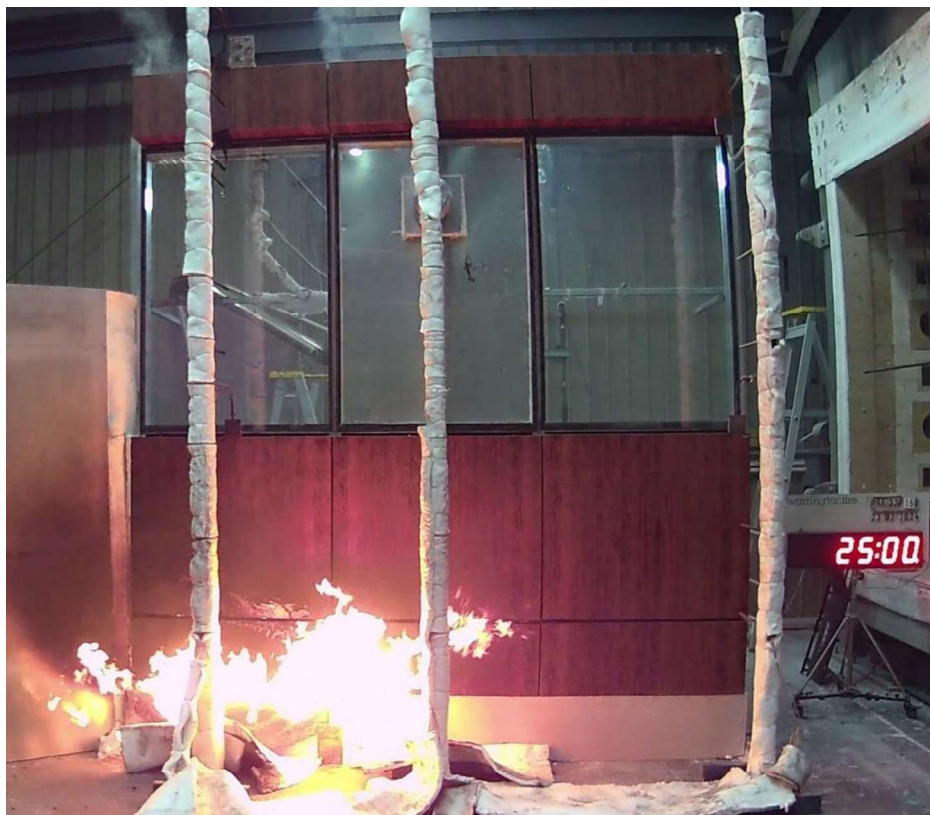
Figure 31 The specimen 25 minutes into the test (burner output at 300 kW and wind on).

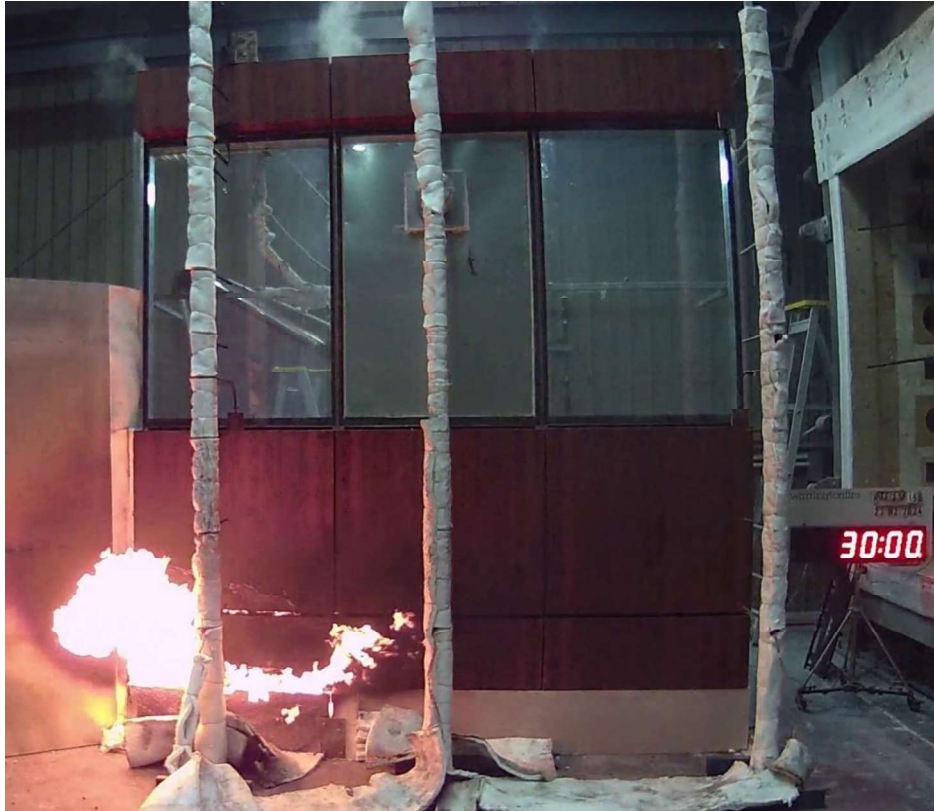
Figure 32 The specimen 30 minutes into the test (burner off and wind on).

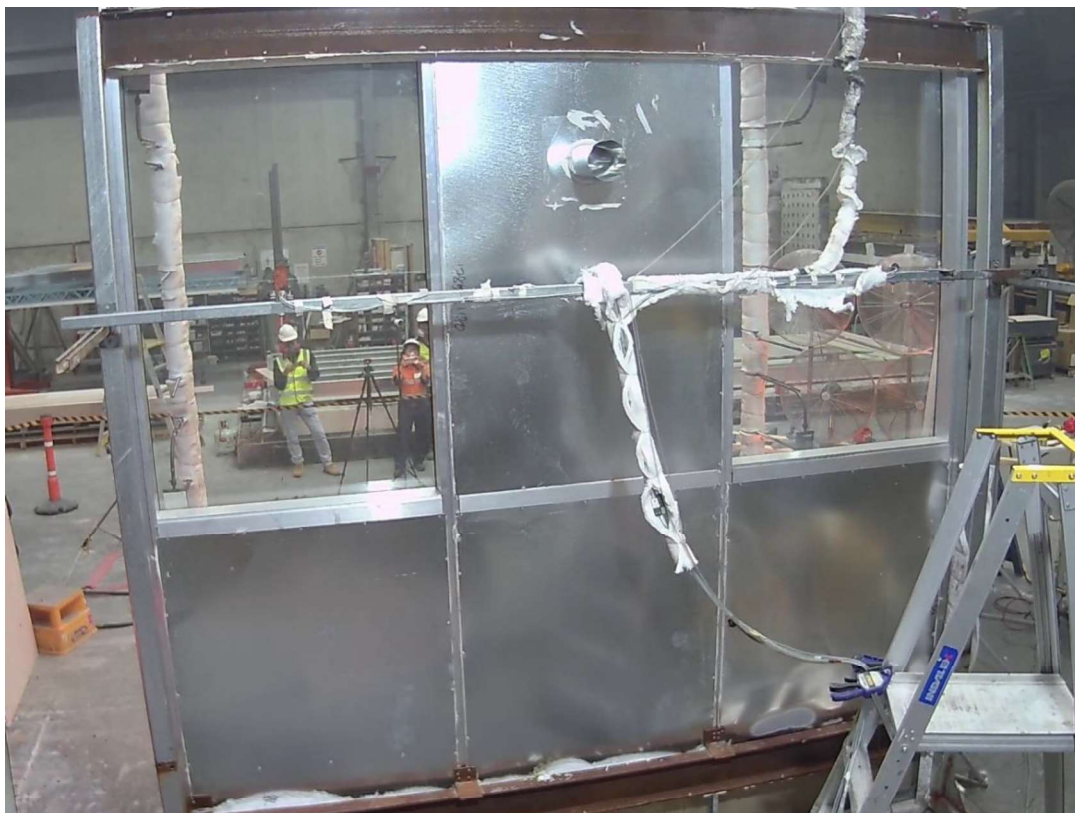
Figure 33 The unexposed side of the specimen 30 minutes into the test (burner off and wind on).

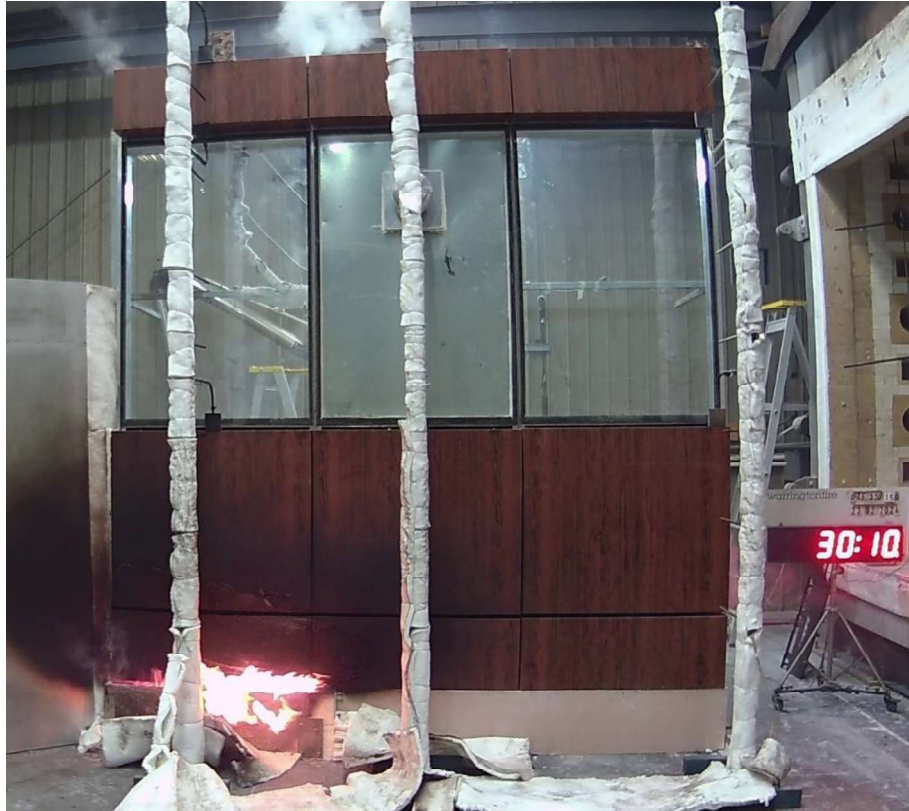
Figure 34 The specimen 30 minutes 10 seconds into the test (10 seconds after burner off and wind on).

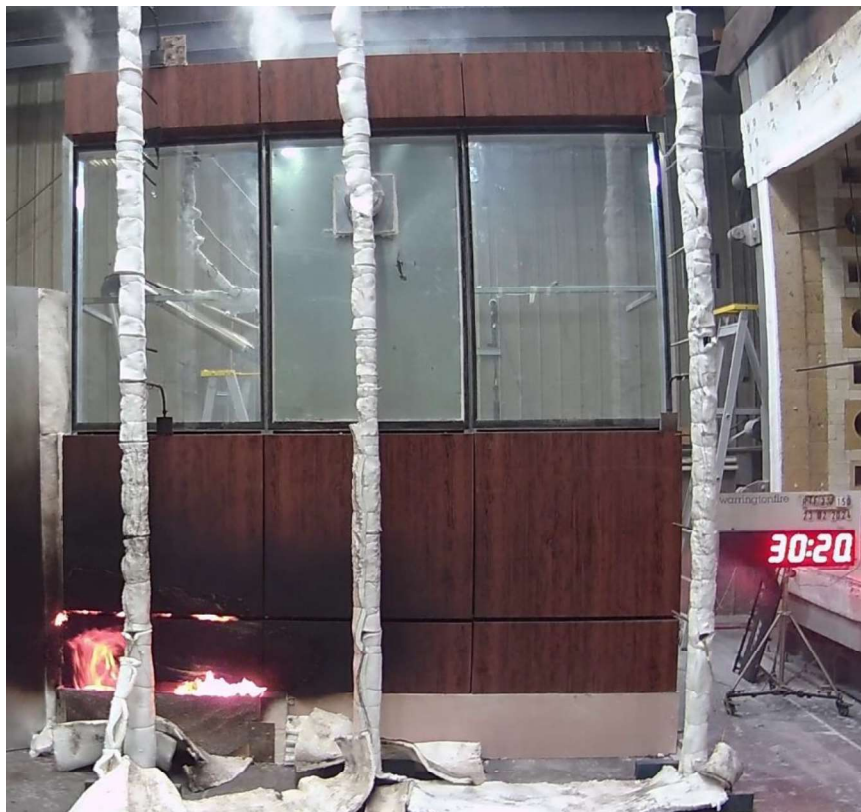
Figure 35 The specimen 30 minutes 20 seconds into the test (20 seconds after burner off and wind on).

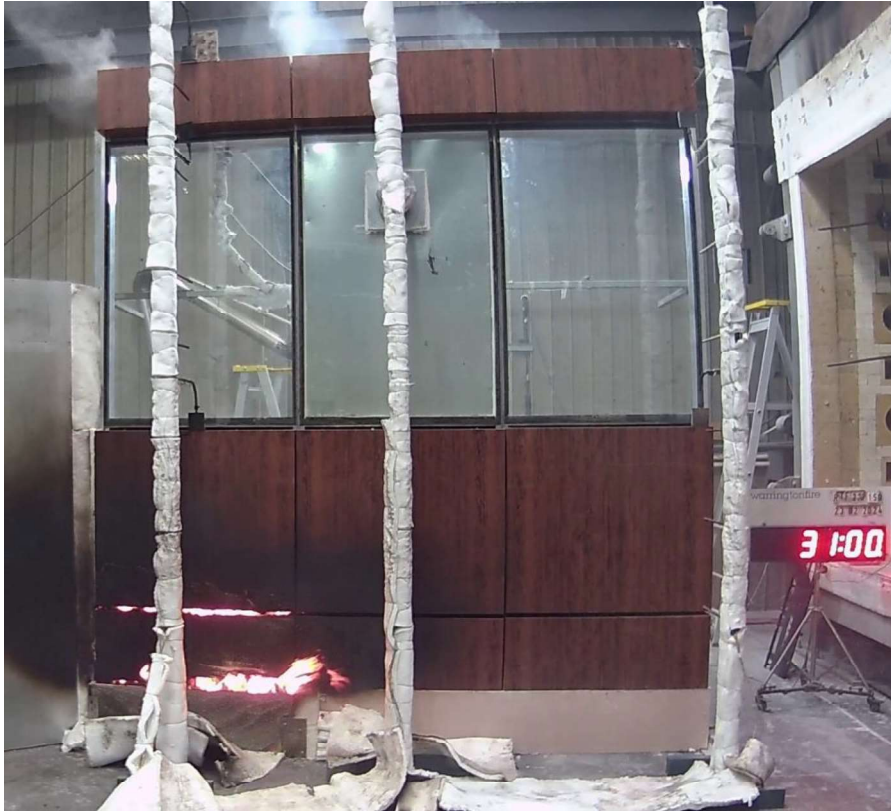
Figure 36 The specimen 31 minutes into the test (1minute after burner off and wind on).

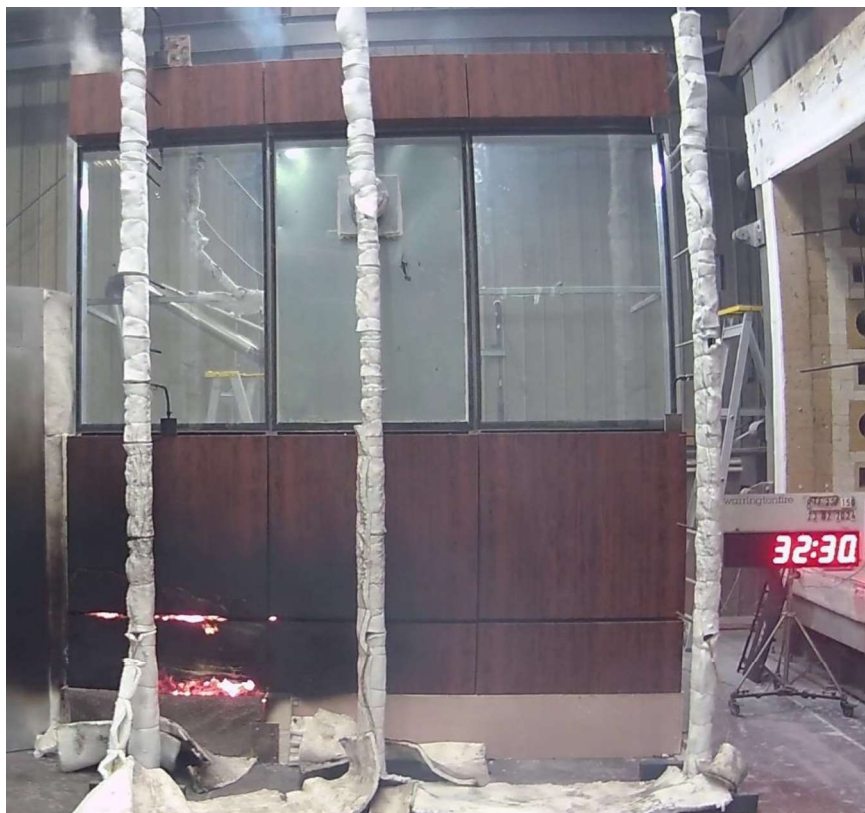
Figure 37 The specimen 32 minutes 30 seconds into the test (2 minutes 30 seconds after burner off and wind on).

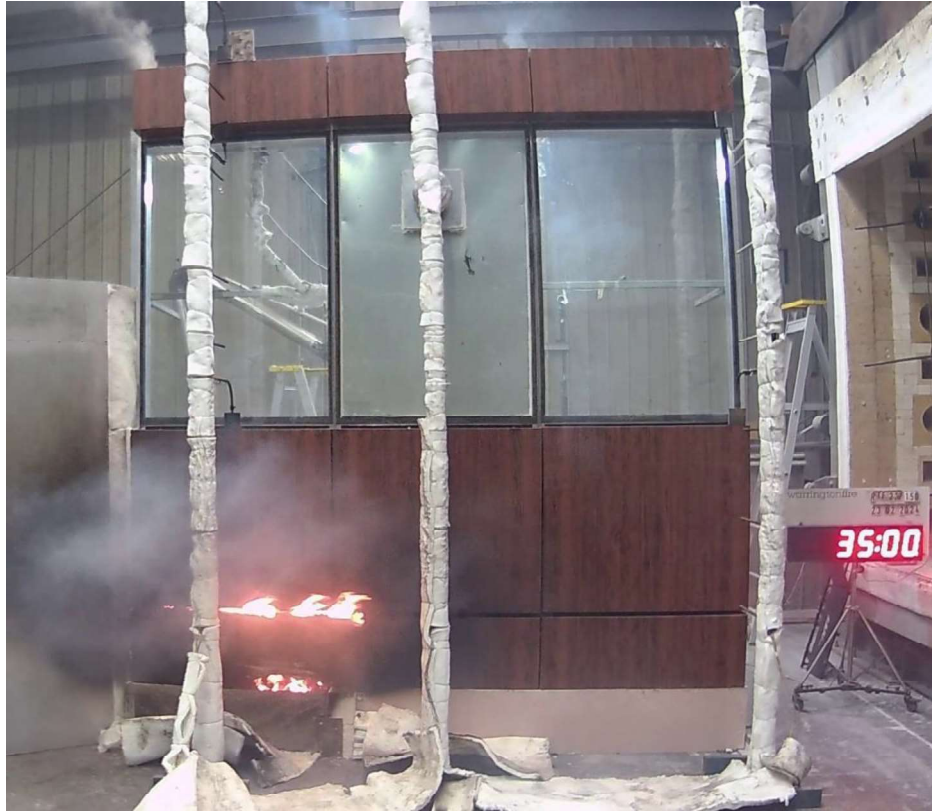
Figure 38 The specimen 35 minutes into the test (5 minutes after burner off and wind on).

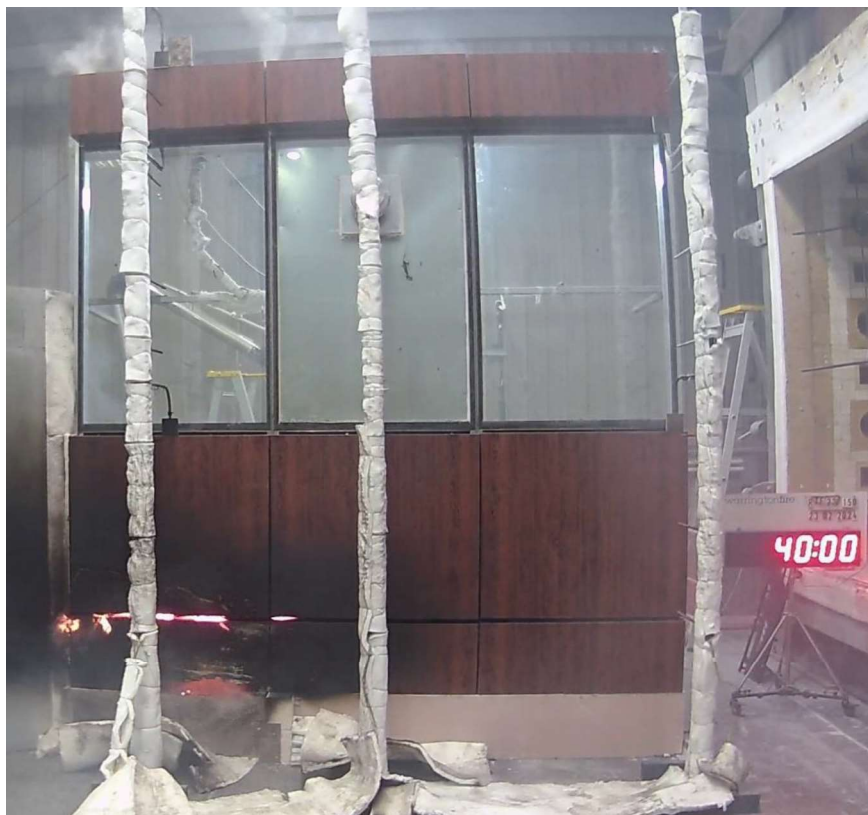
Figure 39 The specimen 40 minutes into the test (10 minutes after burner off and wind on).

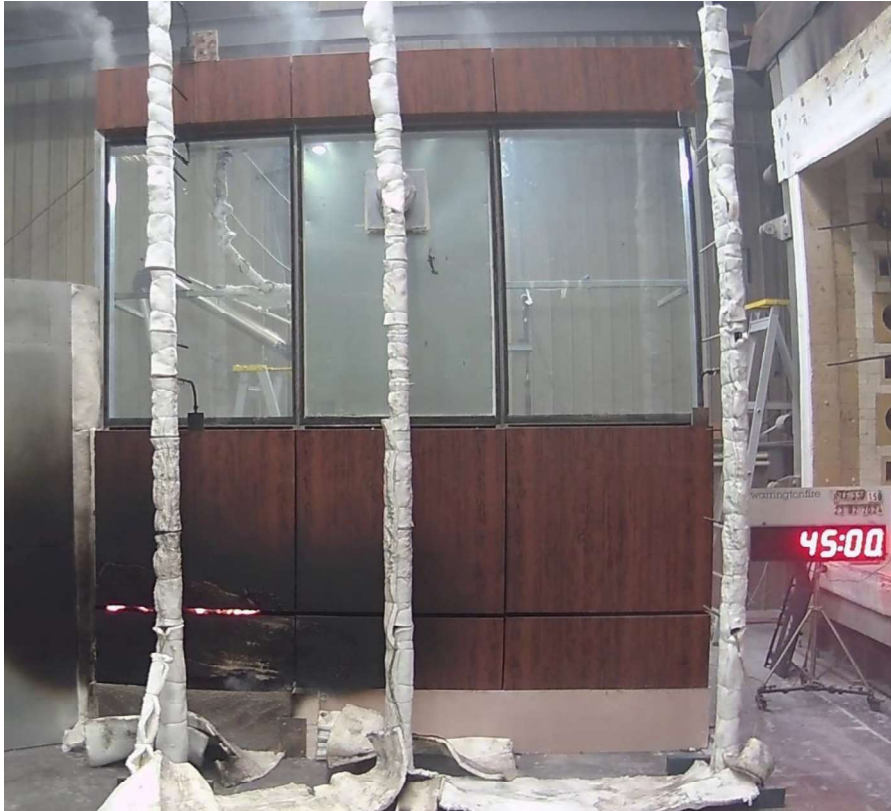
Figure 40 The specimen 45 minutes into the test (15 minutes after burner off and wind on).

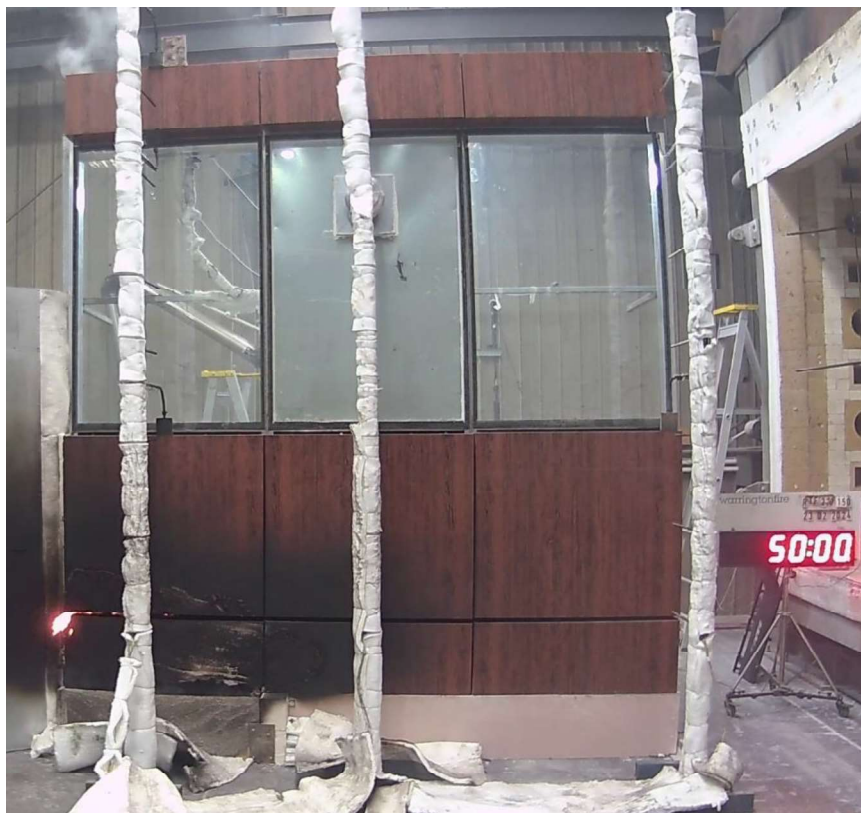
Figure 41 The specimen 50 minutes into the test (20 minutes after burner off and wind on).

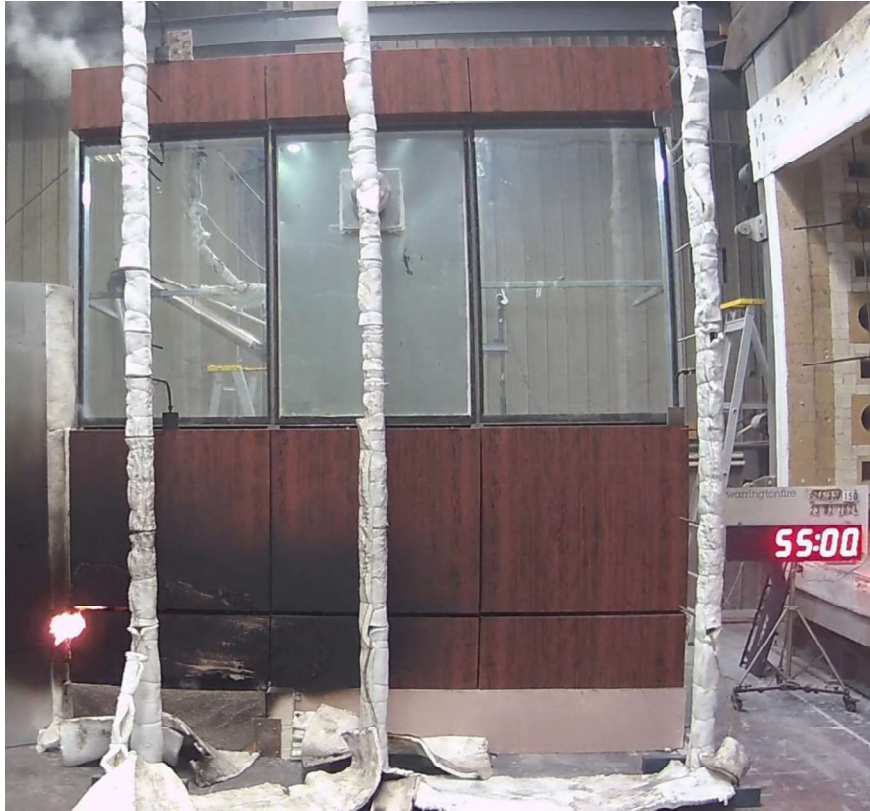
Figure 42 The specimen 55 minutes into the test (25 minutes after burner off and wind on).

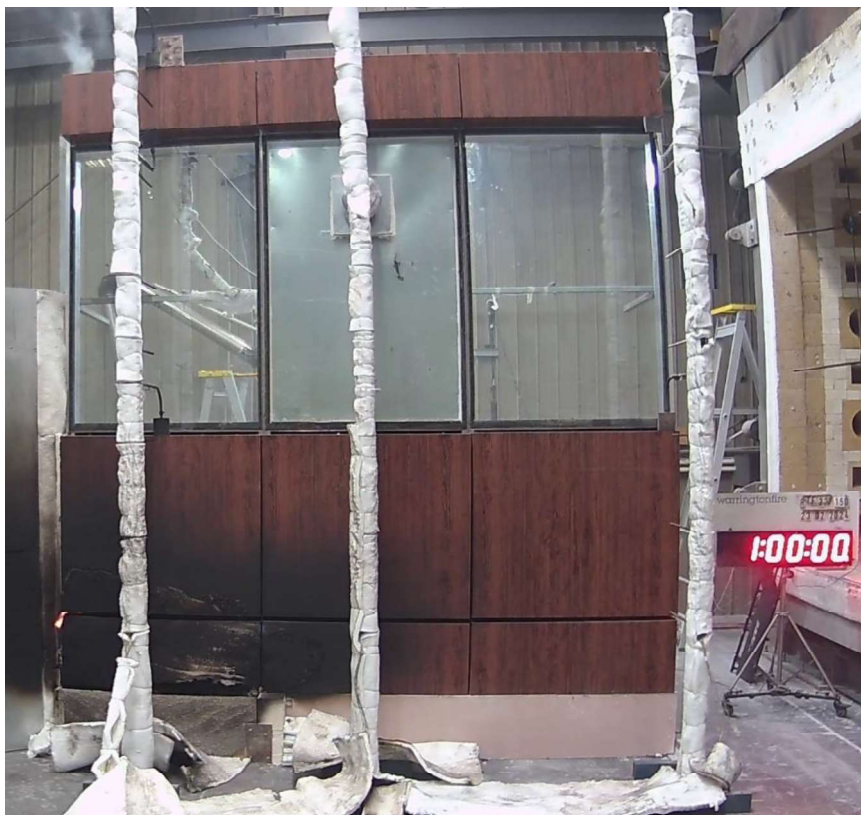
Figure 43 The specimen at the end of test.

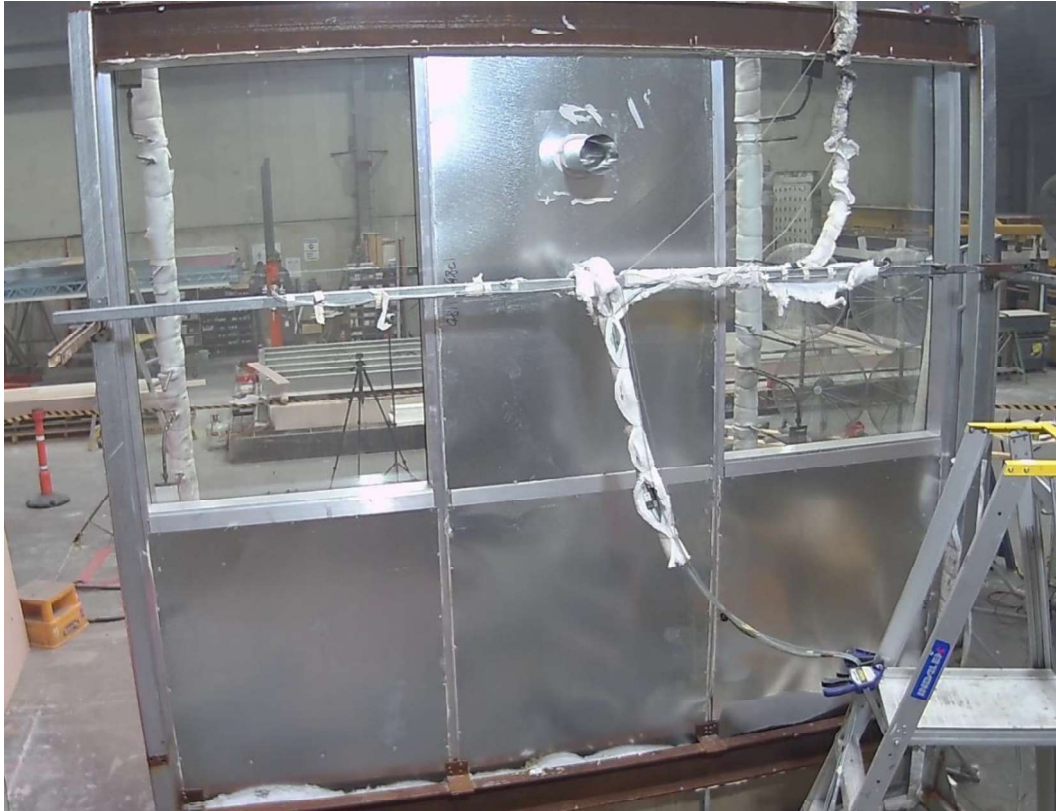
Figure 44 The unexposed side of the specimen at the end of test.
