Reaction to fire test report

Test standard: Ad-hoc test based off ISO 13785-1:2002

System: Aluminium composite panel (ACP) blanking wall system

Job number: RTF230141

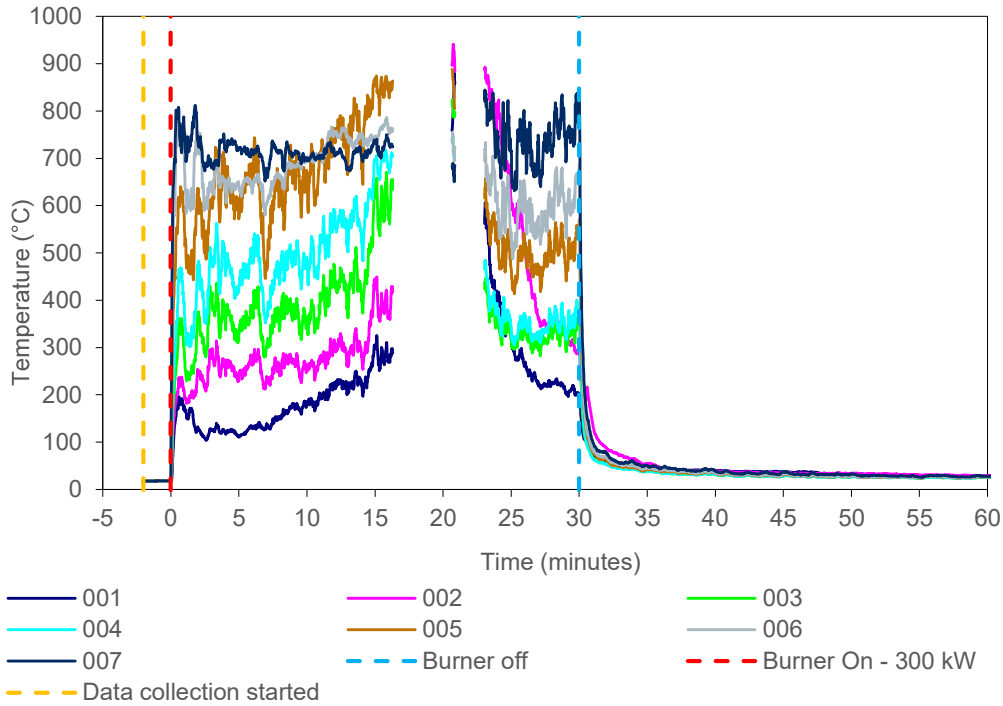
Note: Data lost from 16 minutes 18 seconds to 20 minutes 39 seconds, and from 20 minutes 51 seconds to 23 minutes and 3 seconds of the testing time.

Figure 3 External temperature data collected by thermocouples placed 60 mm from the front face of the specimen - in-line with the burner.

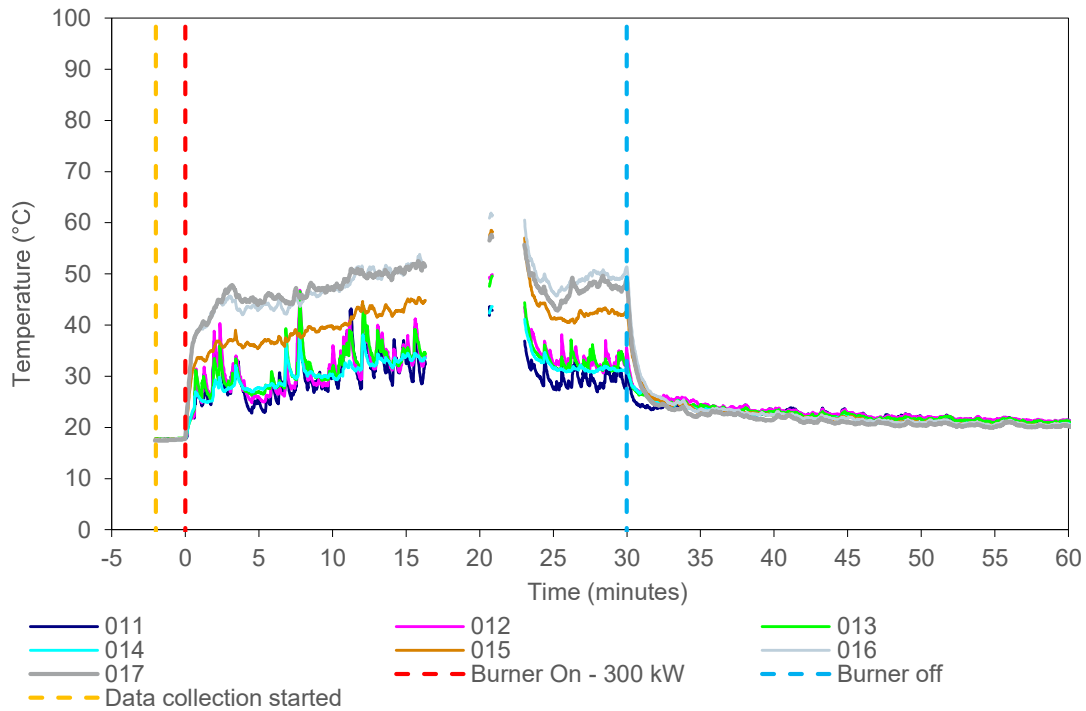
Note: Data lost from 16 minutes 18 seconds to 20 minutes 39 seconds, and from 20 minutes 51 seconds to 23 minutes and 3 seconds of the testing time.

Figure 5 External temperature data collected by thermocouples placed 60 mm from the front face of the specimen – central module.

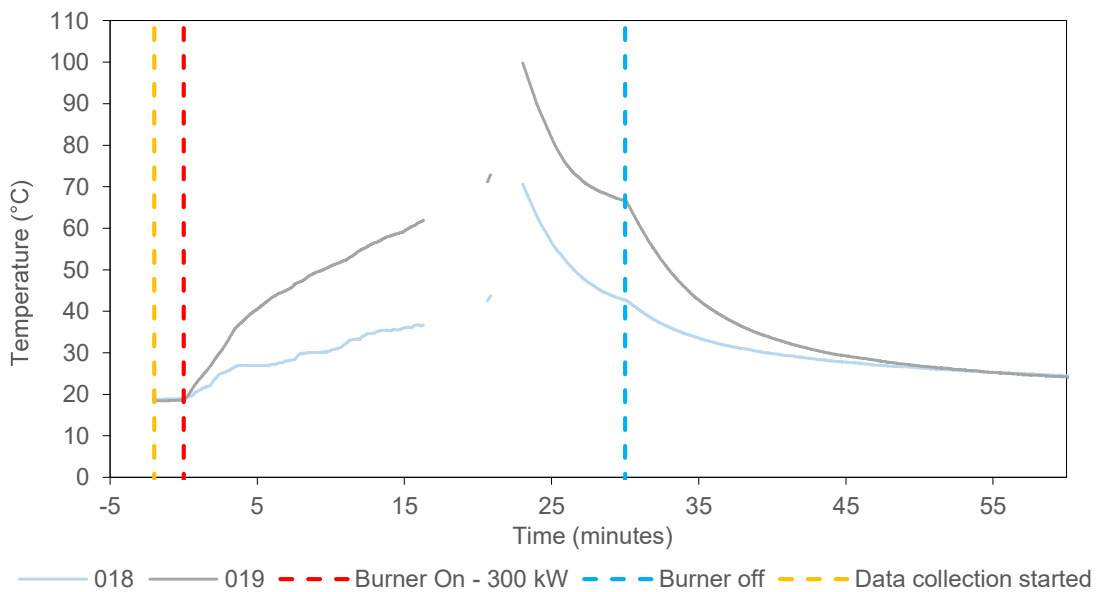
Note: Data lost from 16 minutes 18 seconds to 20 minutes 39 seconds, and from 20 minutes 51 seconds to 23 minutes and 3 seconds of the testing time.

Figure 6 External temperature data collected by plate thermocouples in-line with ACP – central module.

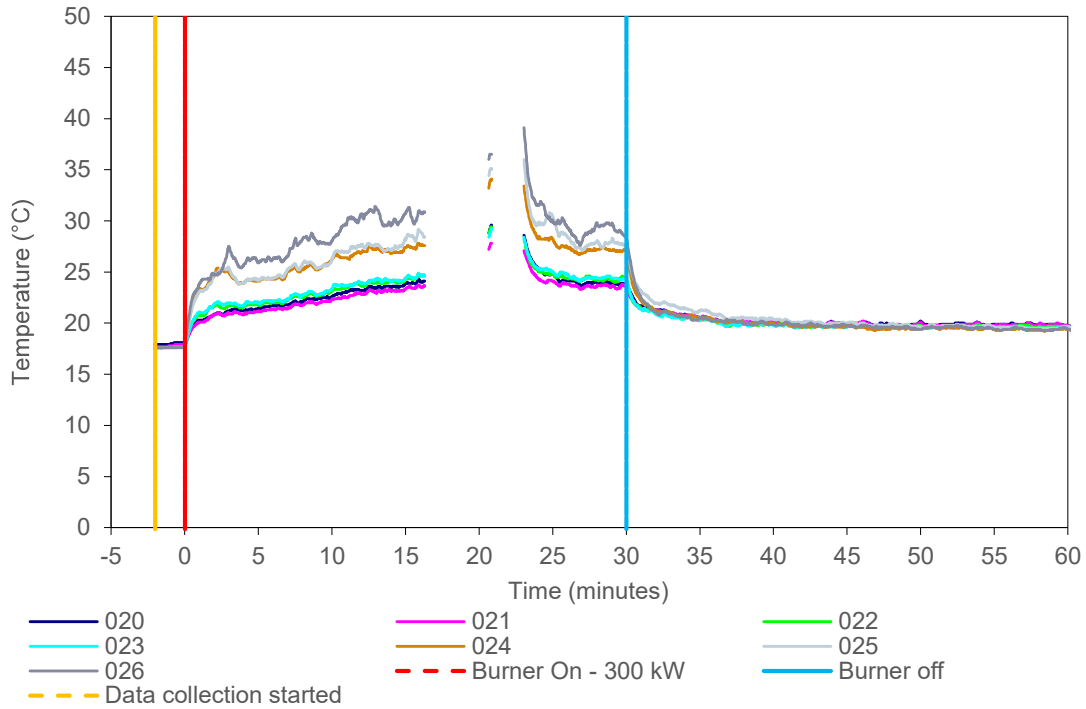
Note: Data lost from 16 minutes 18 seconds to 20 minutes 39 seconds, and from 20 minutes 51 seconds to 23 minutes and 3 seconds of the testing time.

Figure 7 External temperature data collected by thermocouples placed 60 mm from the front face of the specimen – away from burner.

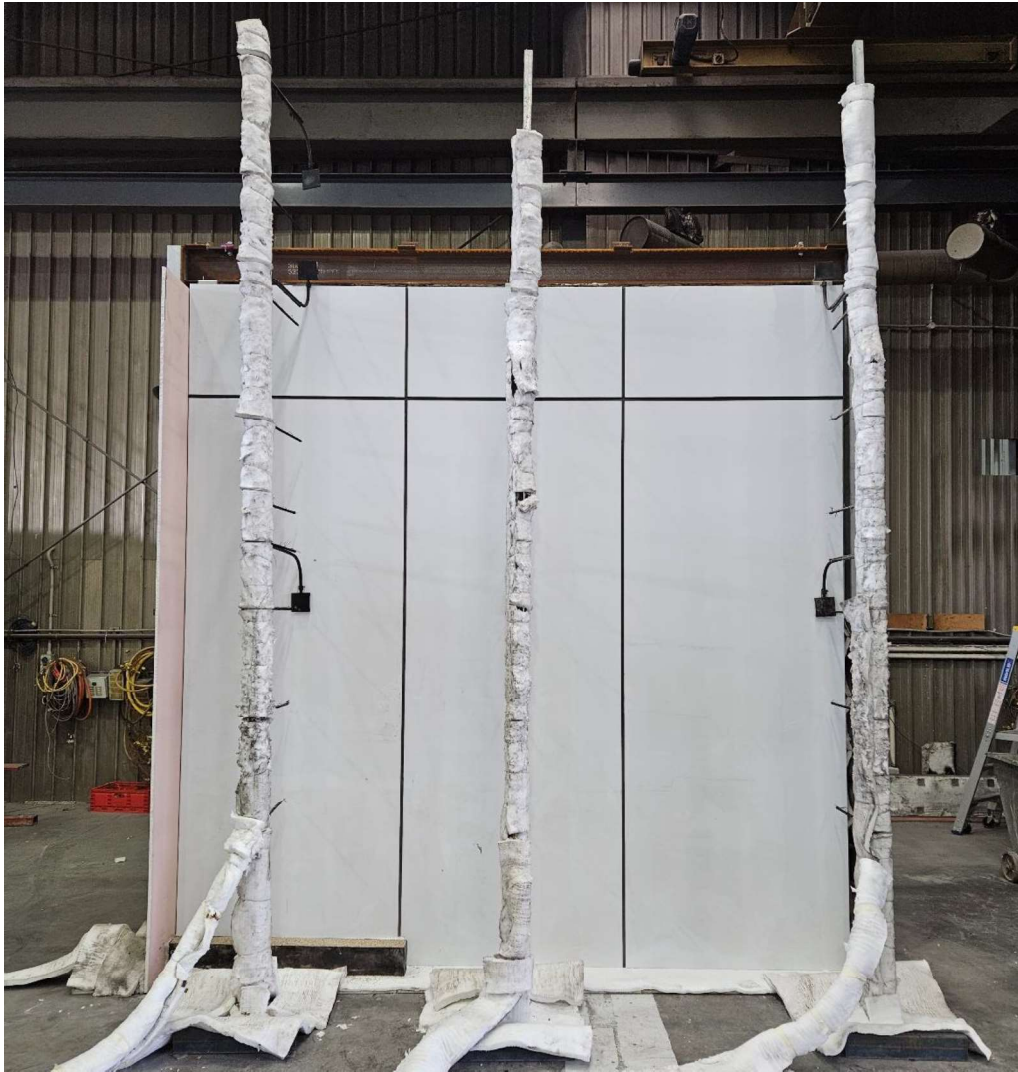
Figure 14 The specimen before the reaction to fire test - exposed side.

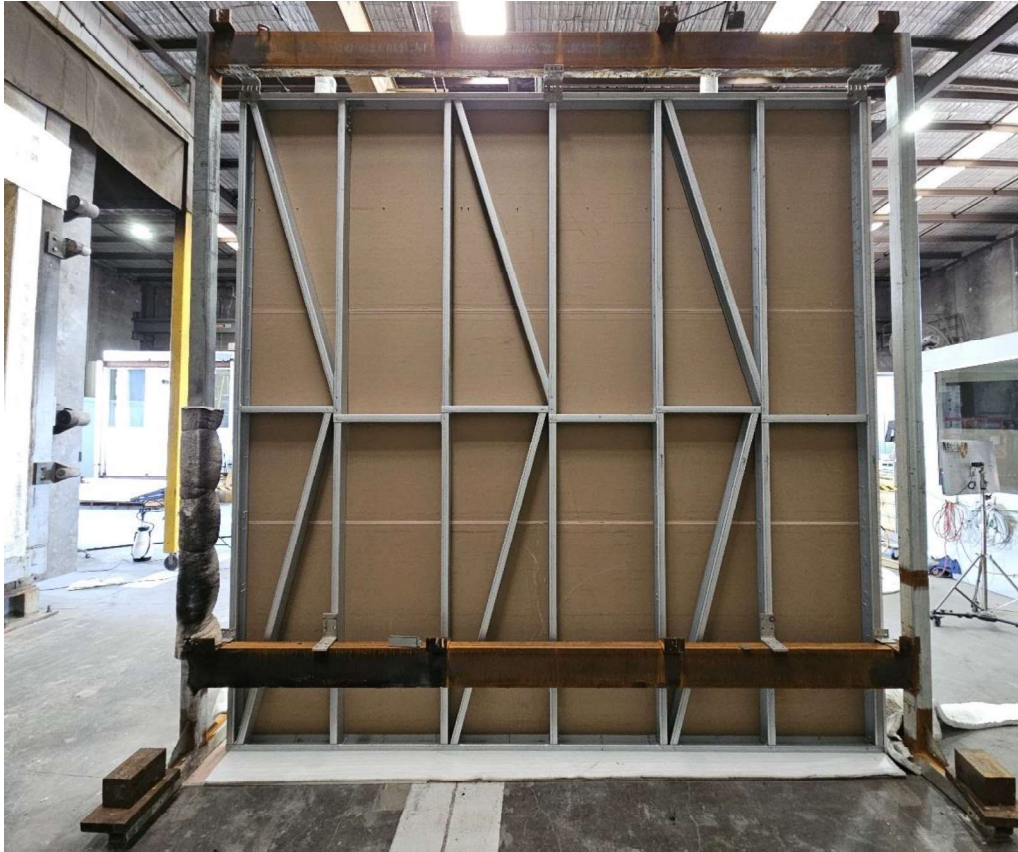
Figure 15 The specimen before the reaction to fire test - unexposed side.

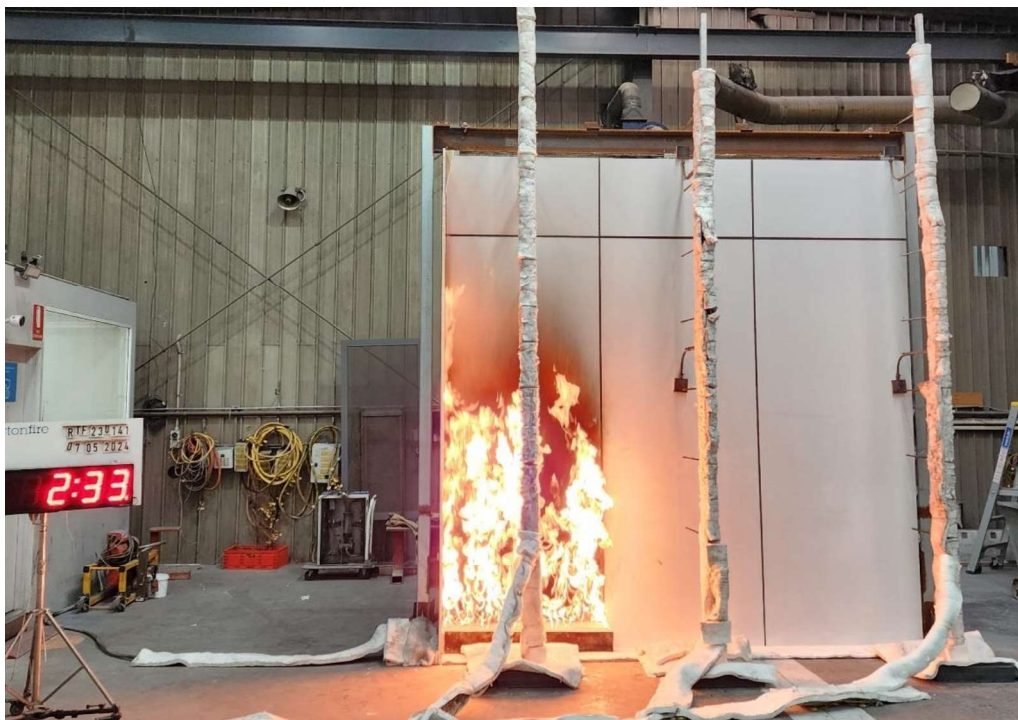
Figure 16 The specimen 2 minutes 33 seconds into the test (burner output at 300 kW)

Time		Des.	Observation
Min	Sec		
-2	00	All	Data collection started.
0	00	All	The reaction to fire test was started with the burner ignited with a heat output set at 300 kW.
1	30	A1	The lower face of the panel was discolouring.
2	31	A4	Smoke emitted from top left corner of the panel.
3	16	A1	The lower face of the panel started to deform.
4	24	A1	Smoke started to emit from the plasterboard on the back of the A1 panel.
5	18	A4	Intermittent flaming was observed along the gap between the left side of the panel and the plasterboard.

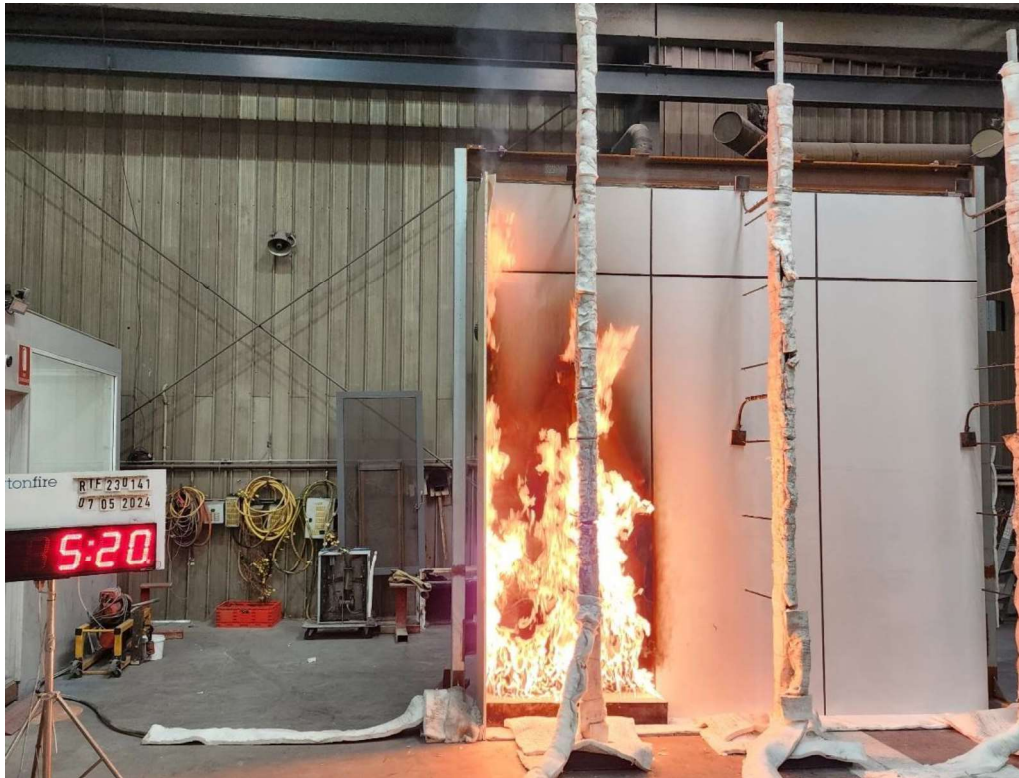
Figure 17 The specimen 5 minutes 20 seconds into the test (burner output at 300 kW)

Time		Des.	Observation
Min	Sec		
5	25	A4	There was smoke emitted from the top of the panel.
6	36	A4	There was flaming on the top left corner of the panel.
8	04	A1	The lower part of the panel appeared to open up.
9	36	A2	The left edge of the panel was discolouring.
13	30	A4	The flaming died off.
15	08	A1	There was flaming on the top left corner of the panel.
16	36	A1	Opened area reached 1/2 up panel.
18	30	A4	The left part of the panel surface started to deform
19	33	A4	There was flaming at the mid bottom of the panel.
20	10	A4	Flaming debris dropped from the panel.
21	00	A1	Opened area reached the top of the panel.
21	09	A4	The panel opened up and smoking debris started to emit from the panel.
22	29	A1	The bottom part on the back of the A1 was flaming.
23	10	A1/A2	The lower part of the joint was flaming.
23	17	A4	Opened area reached to the top of the panel.
26	57	A1/A2	Flaming reached 1/2 height of the panel along at the joint.

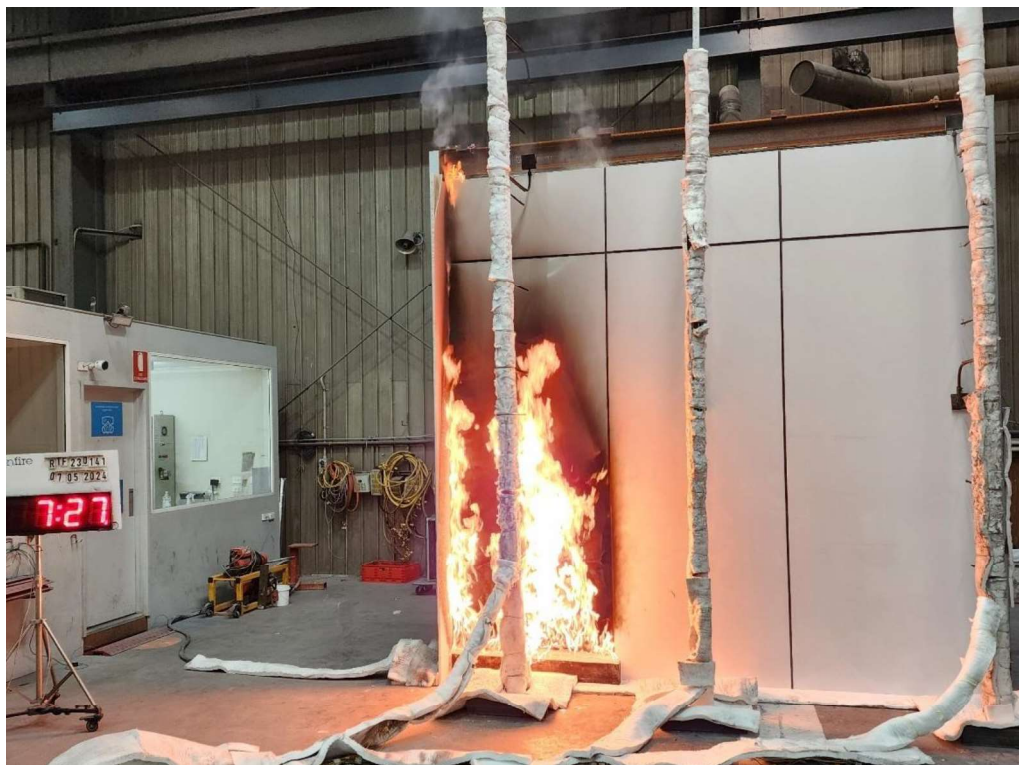
Figure 18 The specimen 7 minutes 27 seconds into the test (burner output at 300 kW)

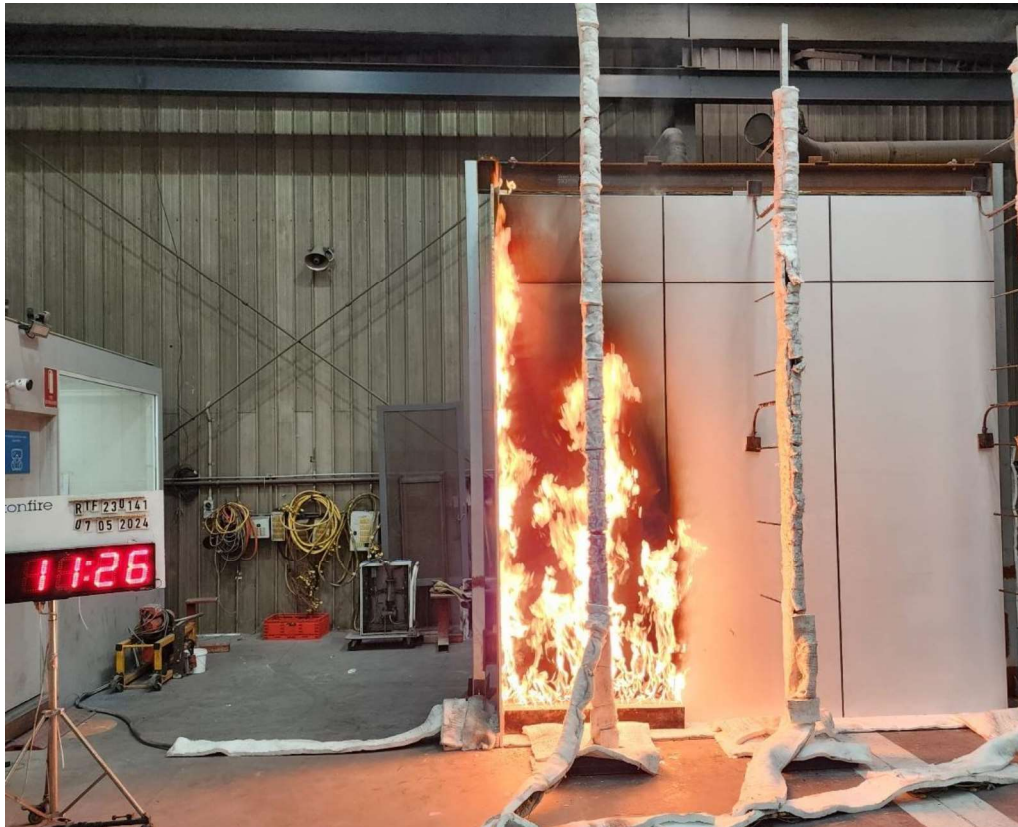
Figure 19 The specimen 11 minutes 26 seconds into the test (burner output at 300 kW)

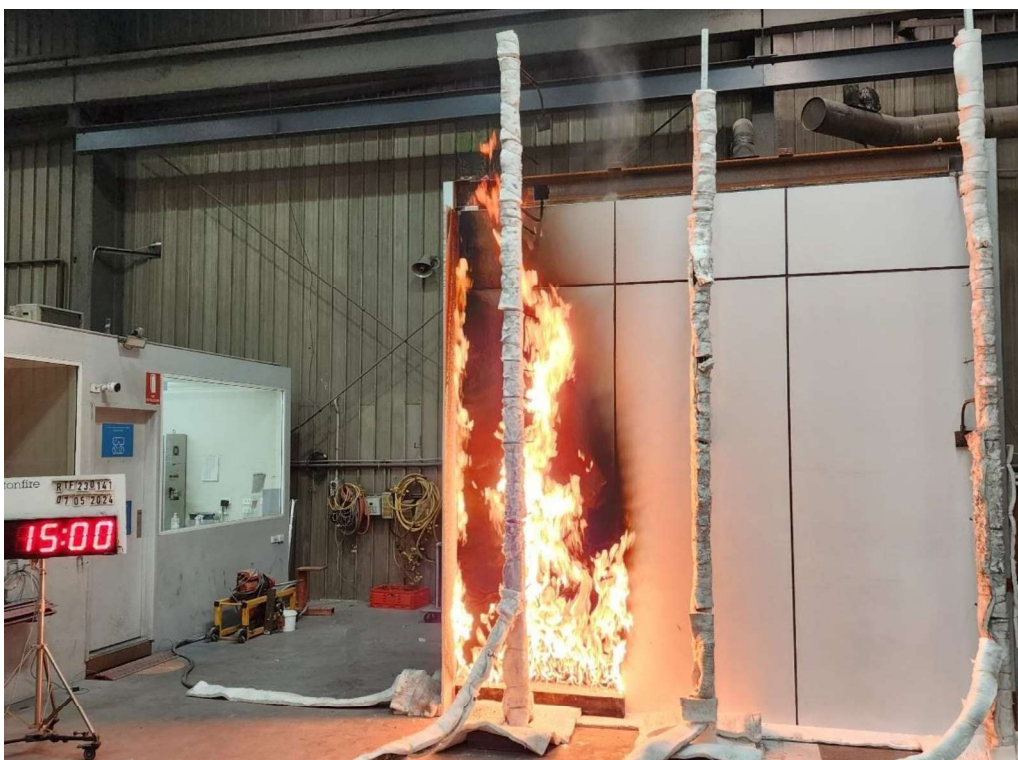
Figure 20 The specimen 15 minutes into the test (burner output at 300 kW).

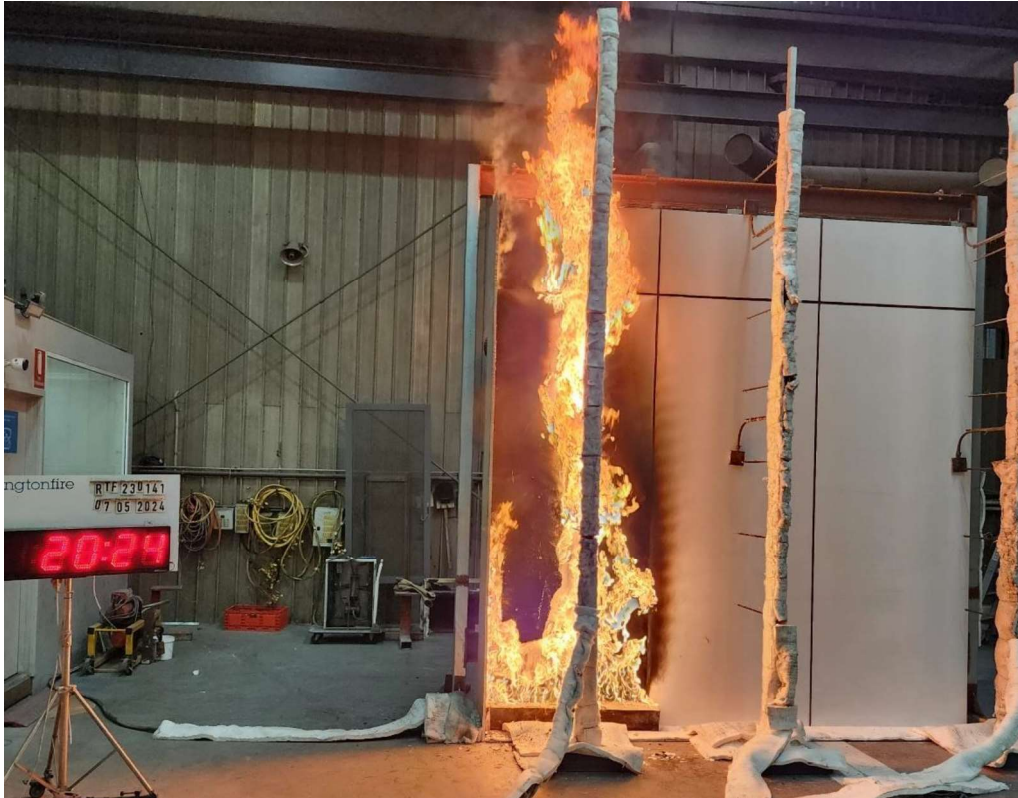
Figure 21 The specimen 20 minutes 24 seconds into the test (burner output at 300 kW).

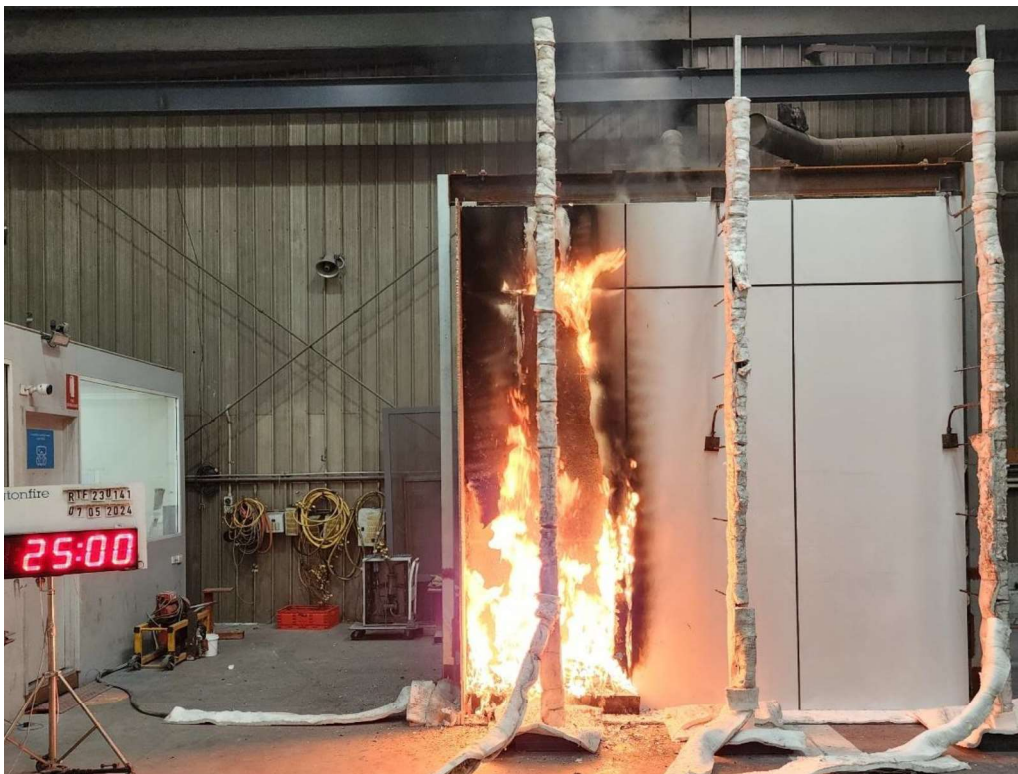
Figure 22 The specimen 25 minutes into the test (burner output at 300 kW).

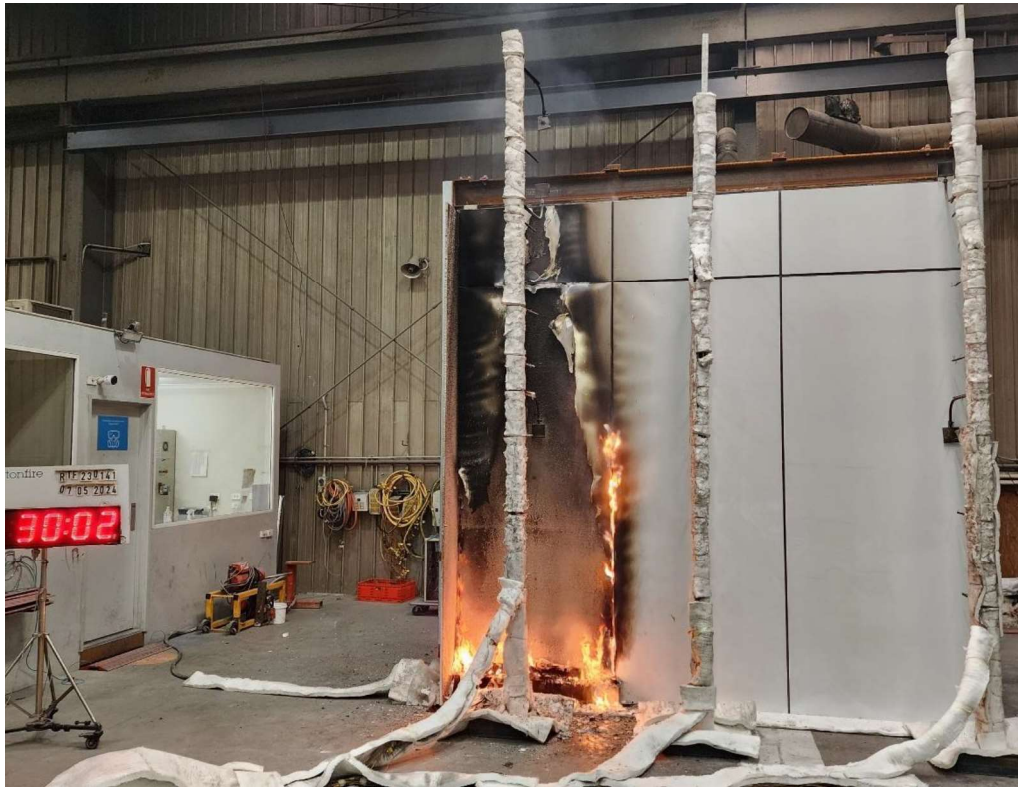
Figure 23 The specimen 30 minutes 2 seconds into the test (2 seconds after burner off).

30	00	All	The burner was turned off.
30	44	A1/A2	The bottom part of the A1 panel and the joint between A1 and A2 were still burning.
31	57	A1/A2	The flaming at the joint had self-extinguished.
55	49	A1	The bottom part of the panel was still burning.
60	00	All	The reaction to fire test was ended and the flaming was extinguished.

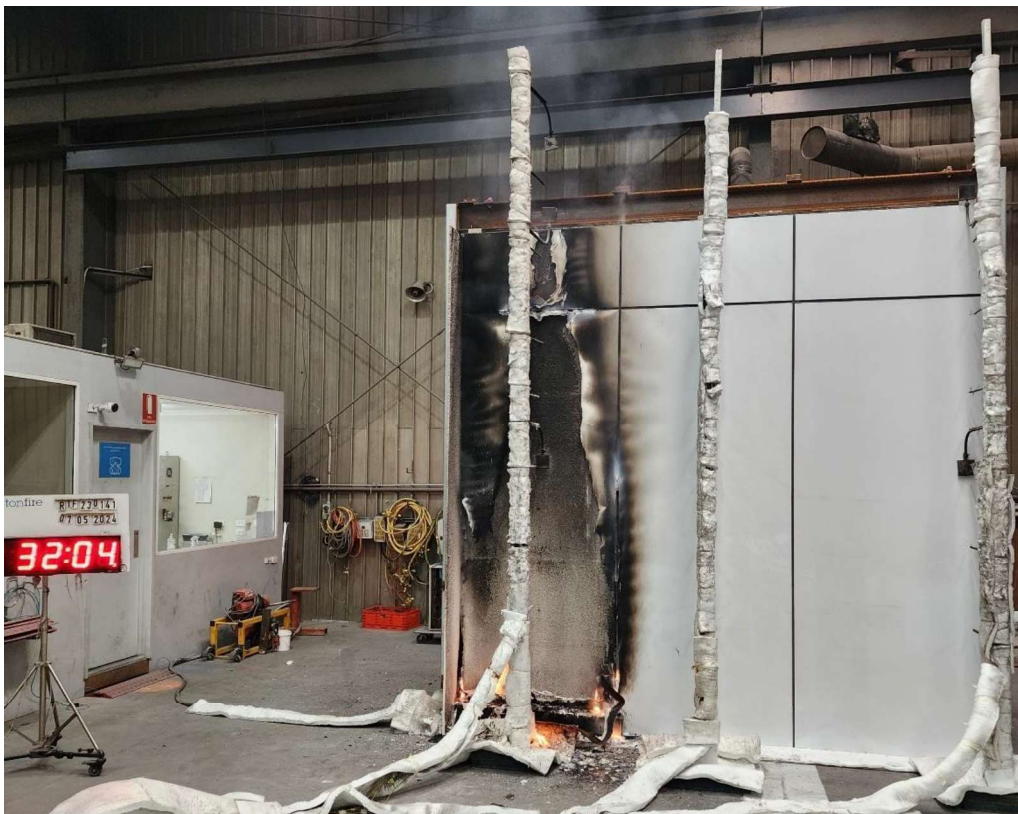
Figure 24 The specimen 32 minutes 4 seconds into the test (2 minutes 4 seconds after burner off).

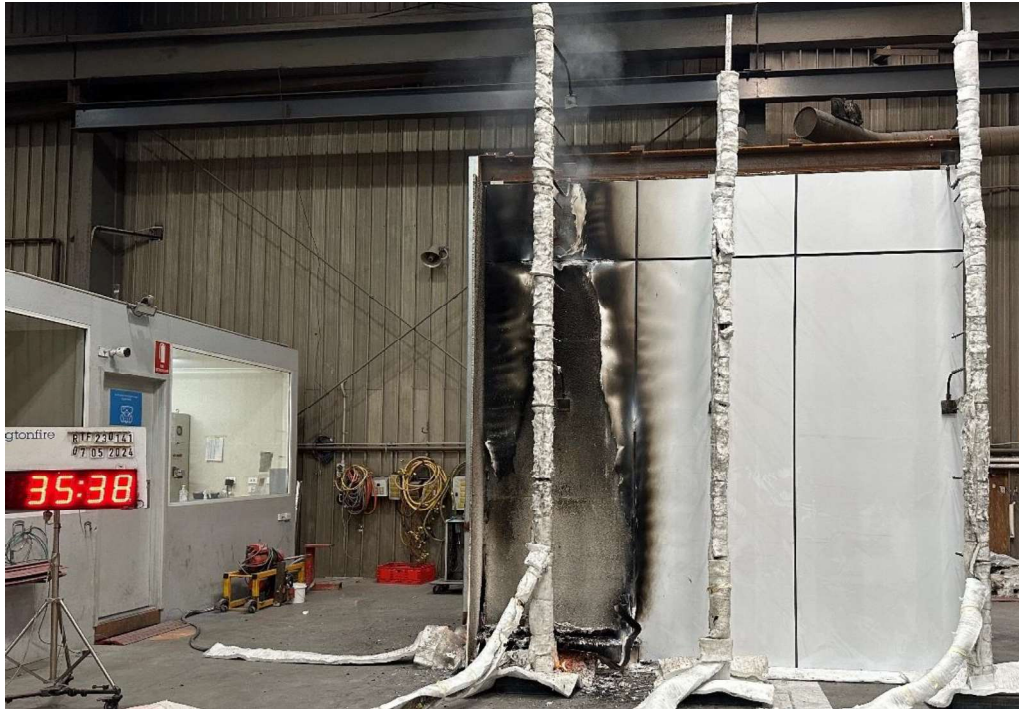
Figure 25 The specimen 35 minutes 38 seconds into the test (5 minutes 38 seconds after burner off).

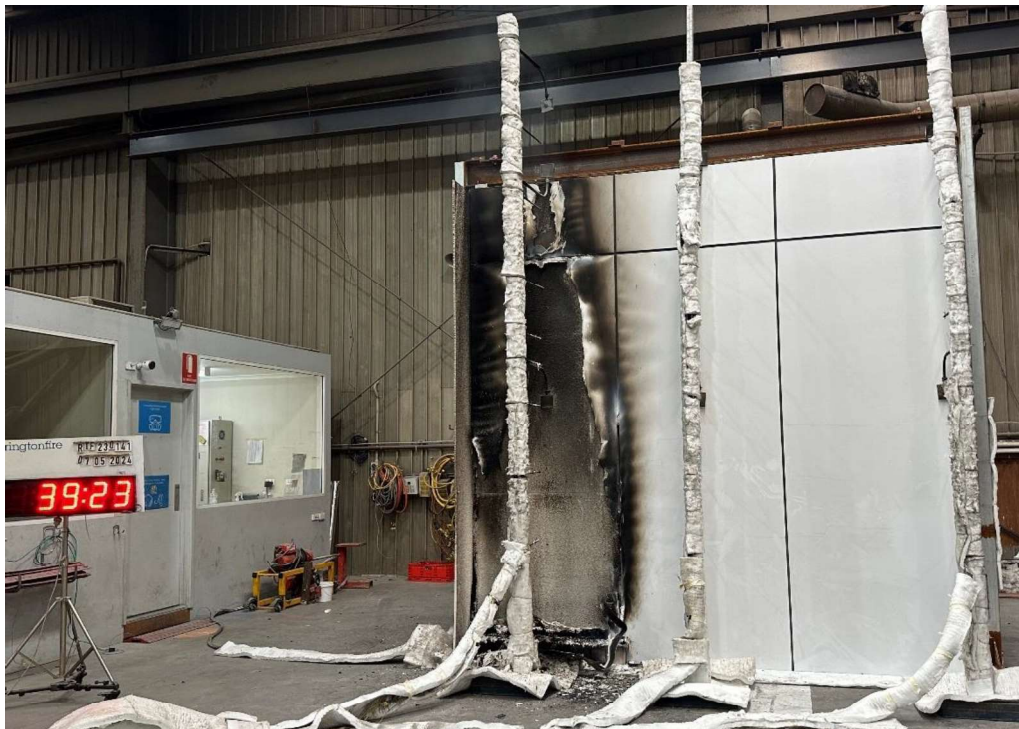
Figure 26 The specimen 39 minutes 23 seconds into the test (9 minutes 23 seconds after burner off).

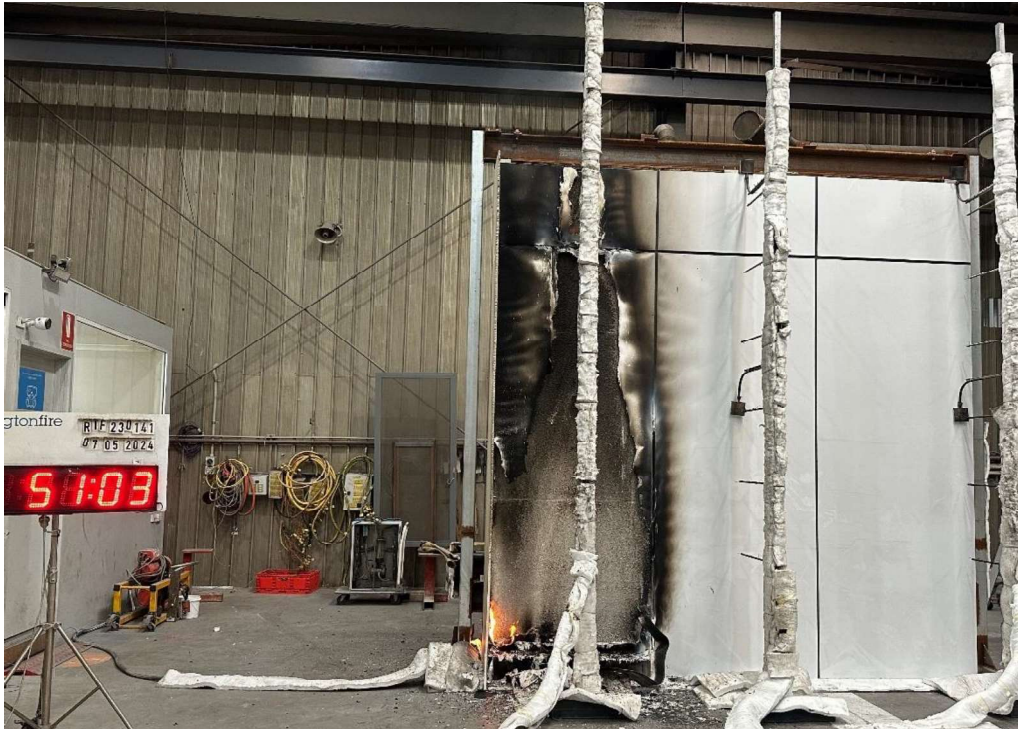
Figure 27 The specimen 51 minutes 3 seconds into the test (21 minutes 3 seconds after burner off).

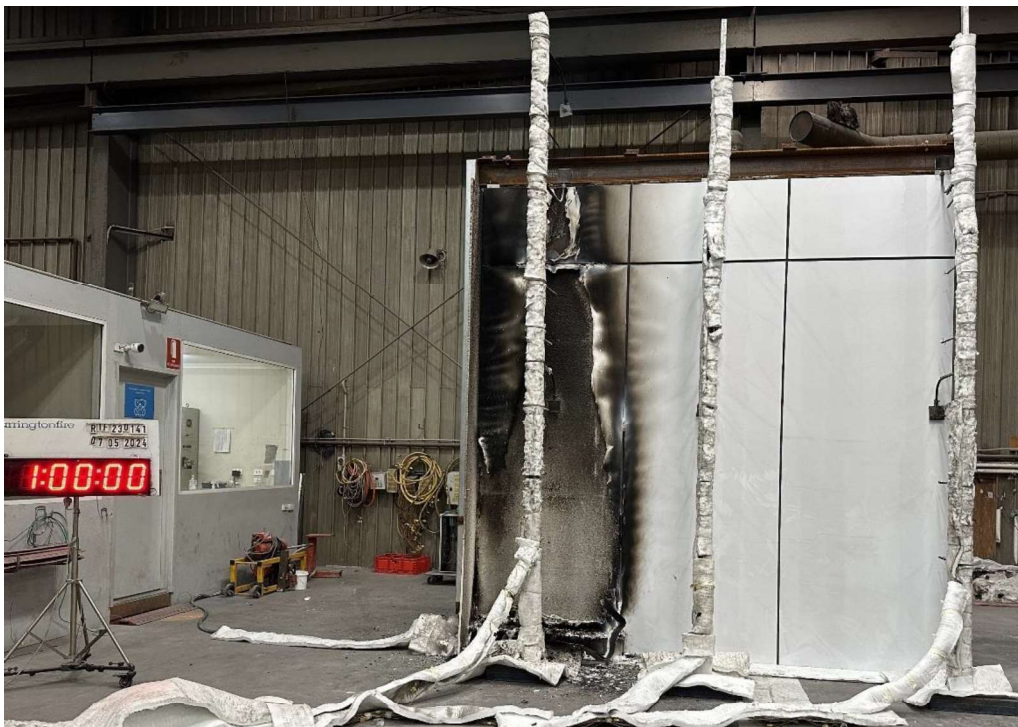
Figure 28 The specimen at the end of test.

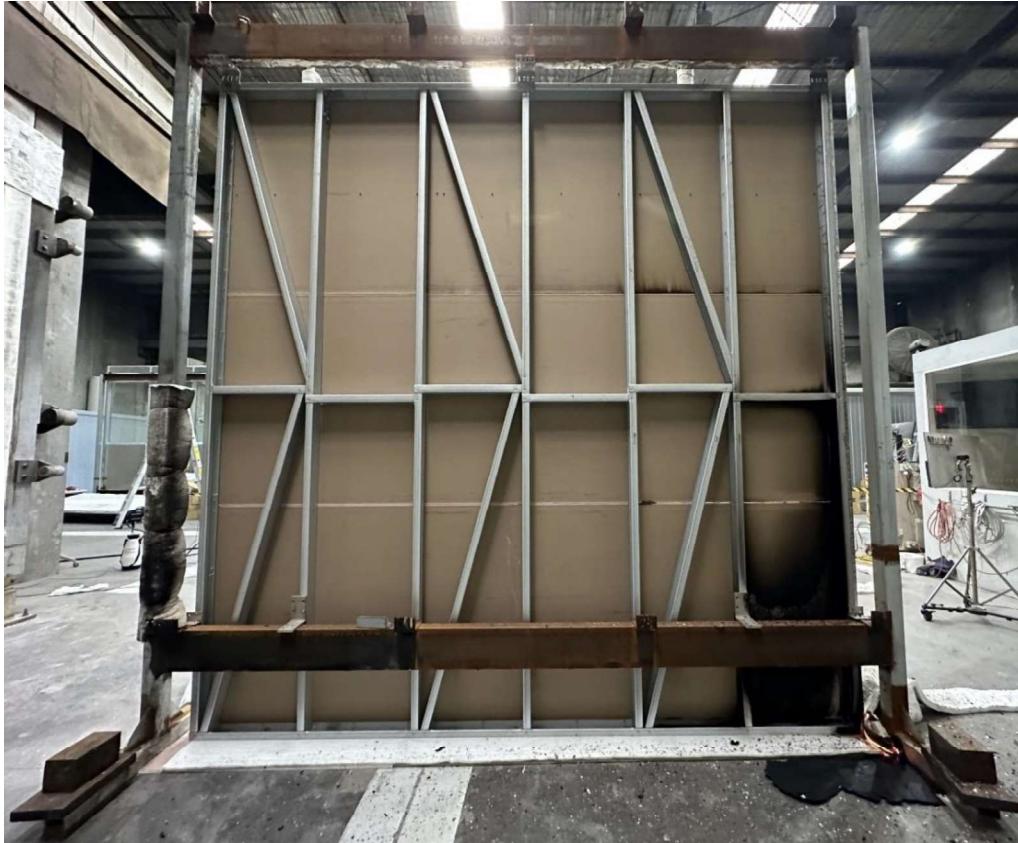
Figure 29 The unexposed side of the specimen at the end of test.
