# Reaction to fire test report

Test standard: Ad-hoc test based off ISO 13785-1:2002

System: Aluminium composite panel (ACP) and glazing external wall cladding system

Job number: RTF230140

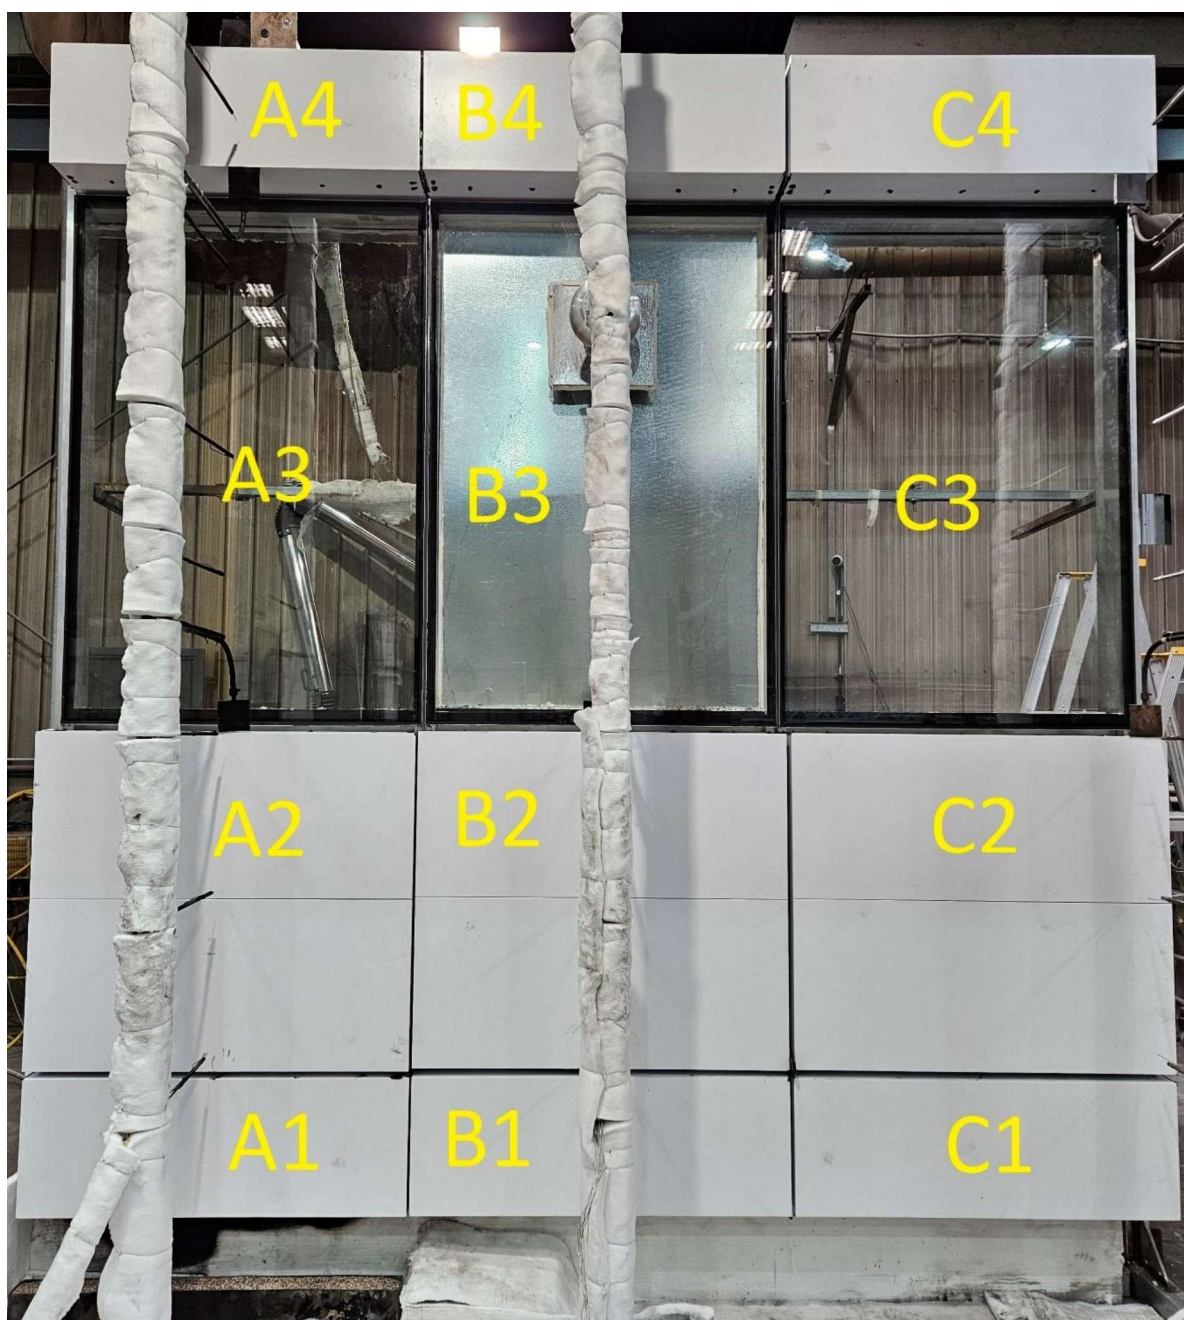
**Figure 11 Designation of section for the test observations**

Table 4 shows the observations of any significant behaviour of the specimen during the test. Figure 11 shows the panel and glazing designations sighted in the observations.

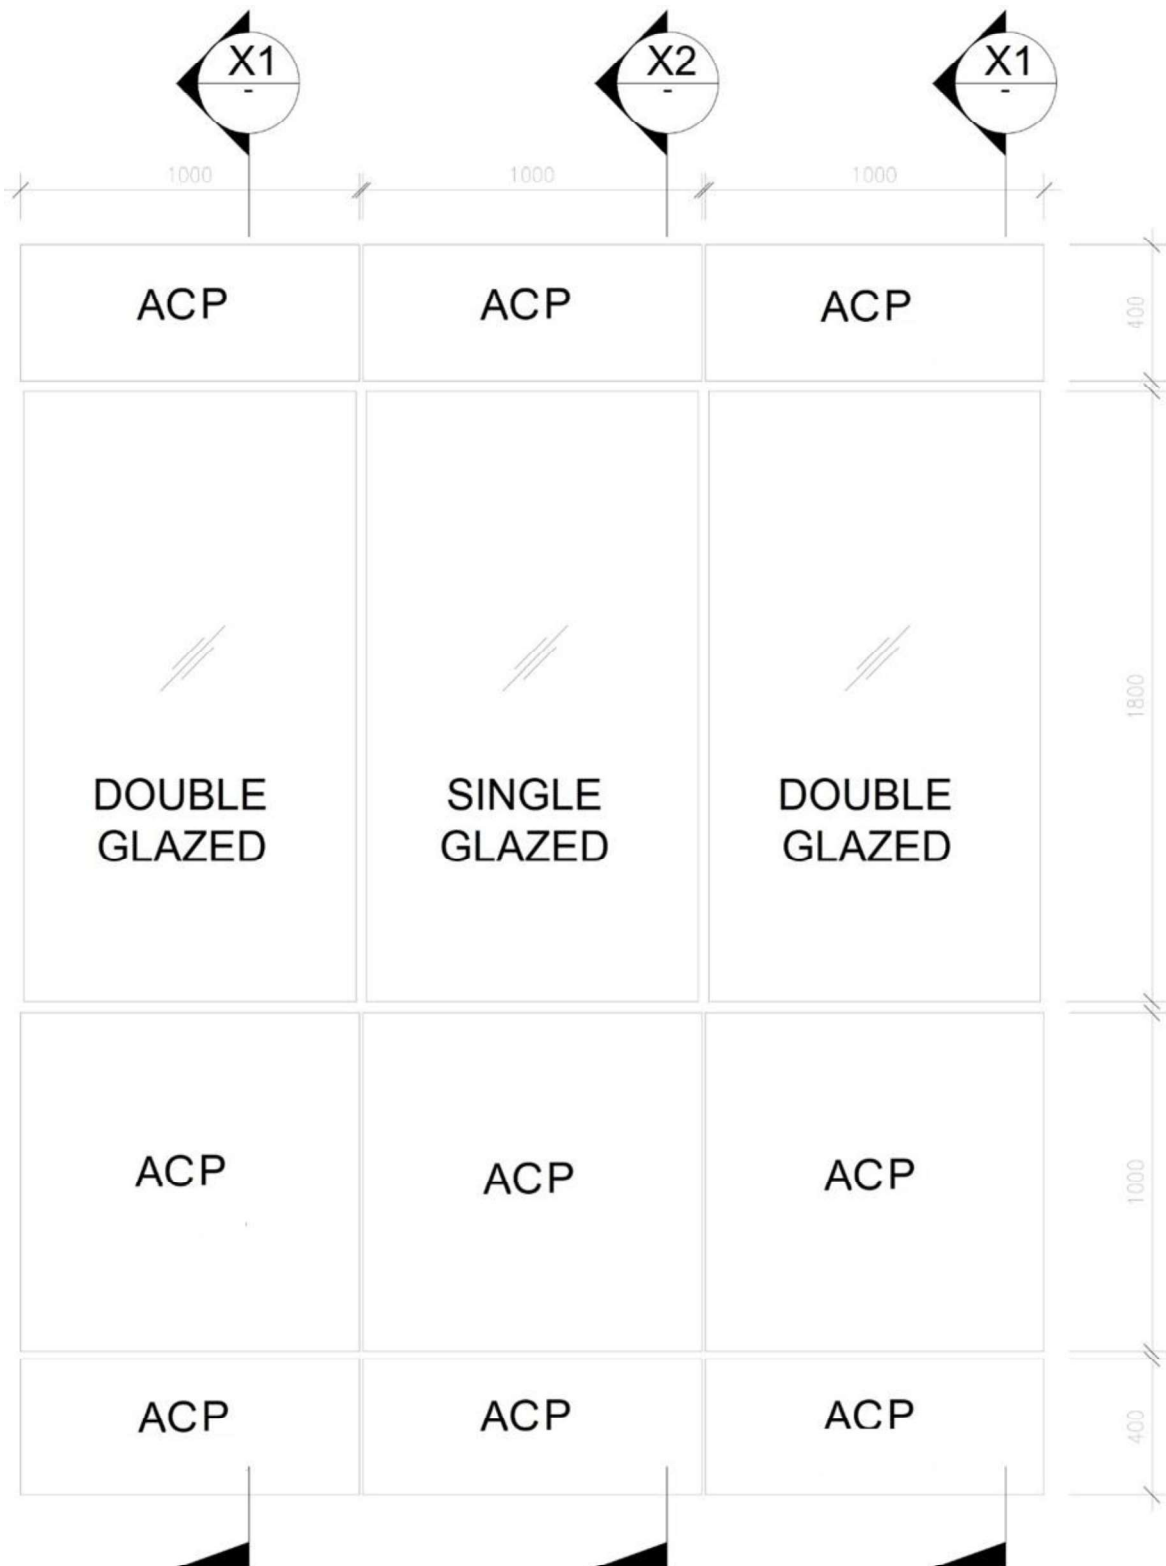
**Figure 13 System assembly – Front view**

Glazing	The glazing, both double (item 3) and single (item 4), were attached to the aluminium framing (item 6) as shown in Figure 13 to Figure 23 and Figure 26. The glazing was sealed around the perimeter with weather sealant (item 15).
Smoke seal	Smoke seal barrier (item 11) was attached to C-purlins of the test rig (item 5) with screw fixings (item 24) at approximate 600 mm centres. PET insulation (item 13) was installed into the 60 mm wide cavity above the barrier (item 12).
Penetration	The penetration went through holes in the single glazing (item 4) and back-pans (item 1) of the second module. These were fixed to the back-pan and the window with a steel sheet (backing plate), using screws and sealant and just sealant, respectively.

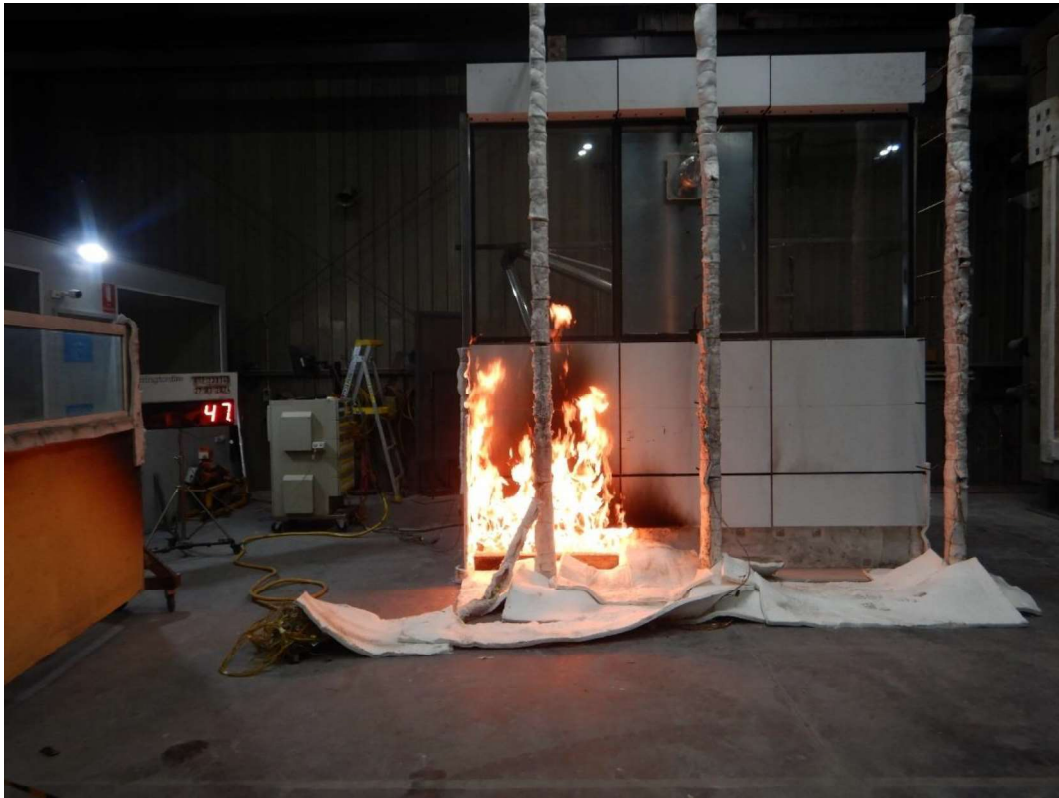
**Figure 29** The specimen 47 seconds into the test (burner output at 300 kW)

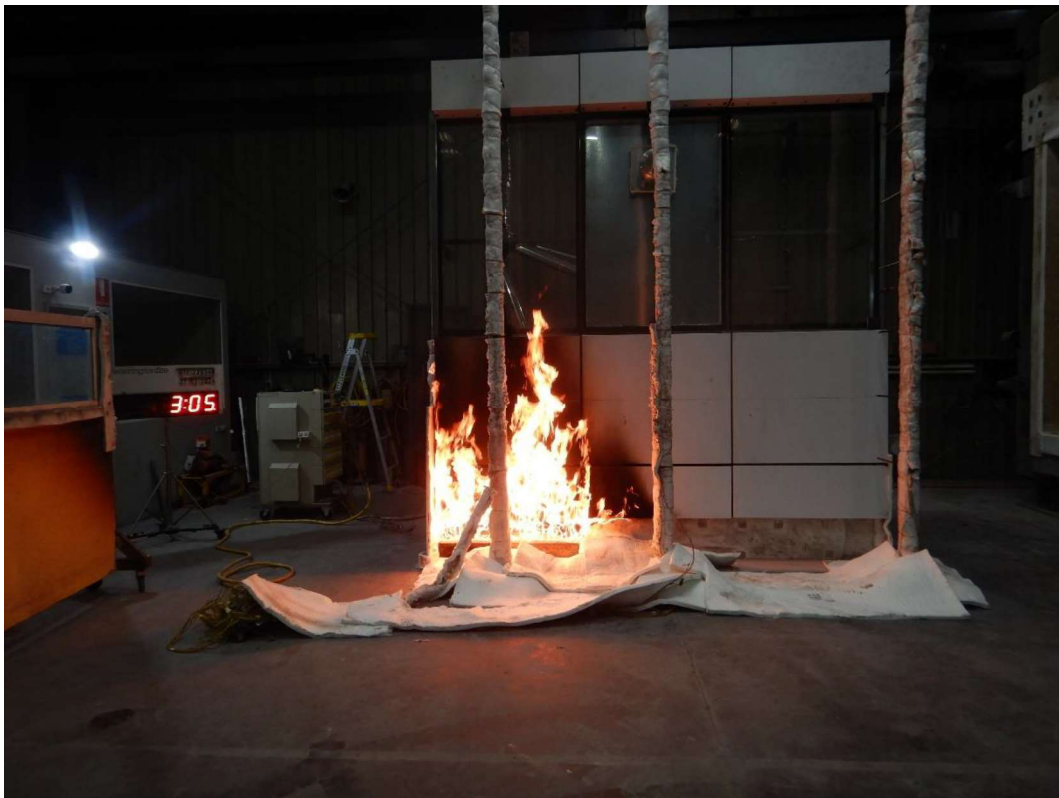
**Figure 30** The specimen 3 minutes 5 seconds into the test (burner output at 300 kW)

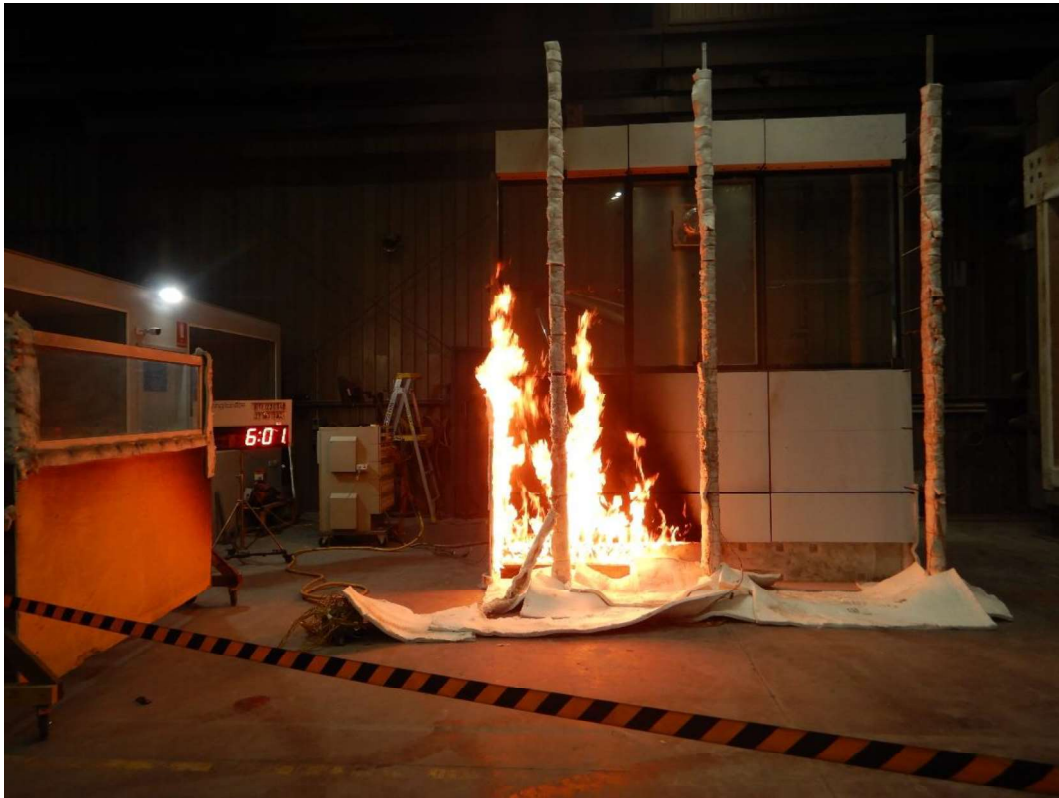
**Figure 31** The specimen 6 minutes 1 second into the test (burner output at 300 kW)

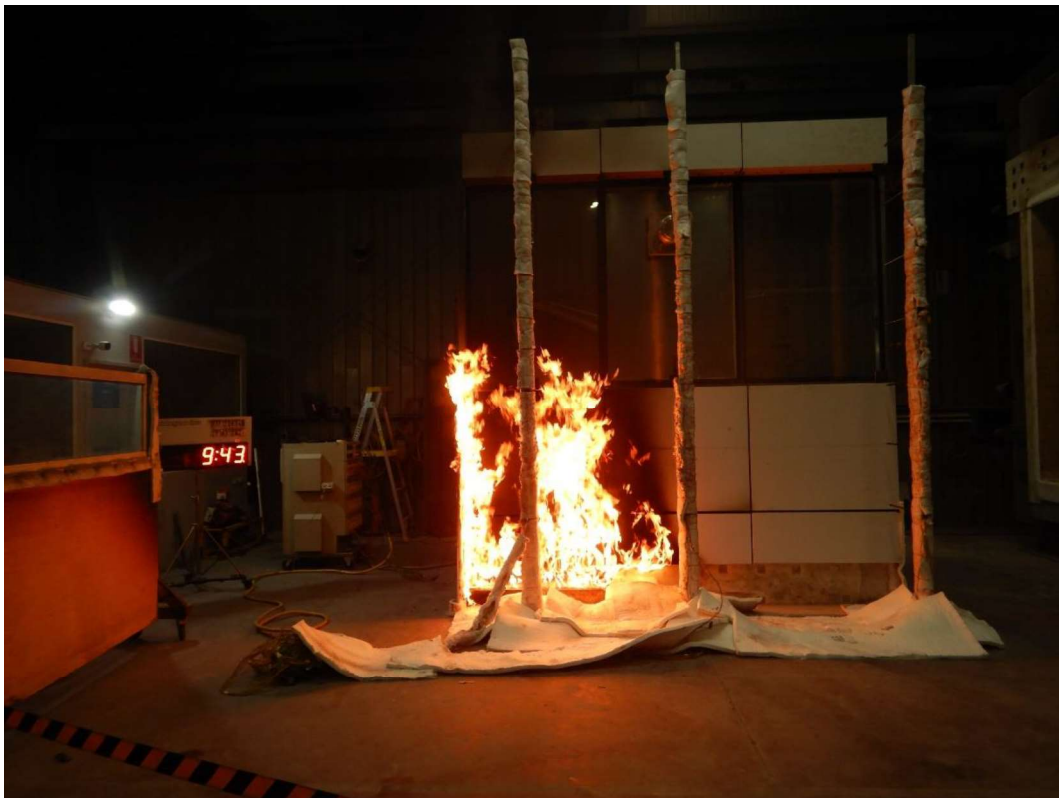
**Figure 32** The specimen 9 minutes 43 seconds into the test (burner output at 300 kW)

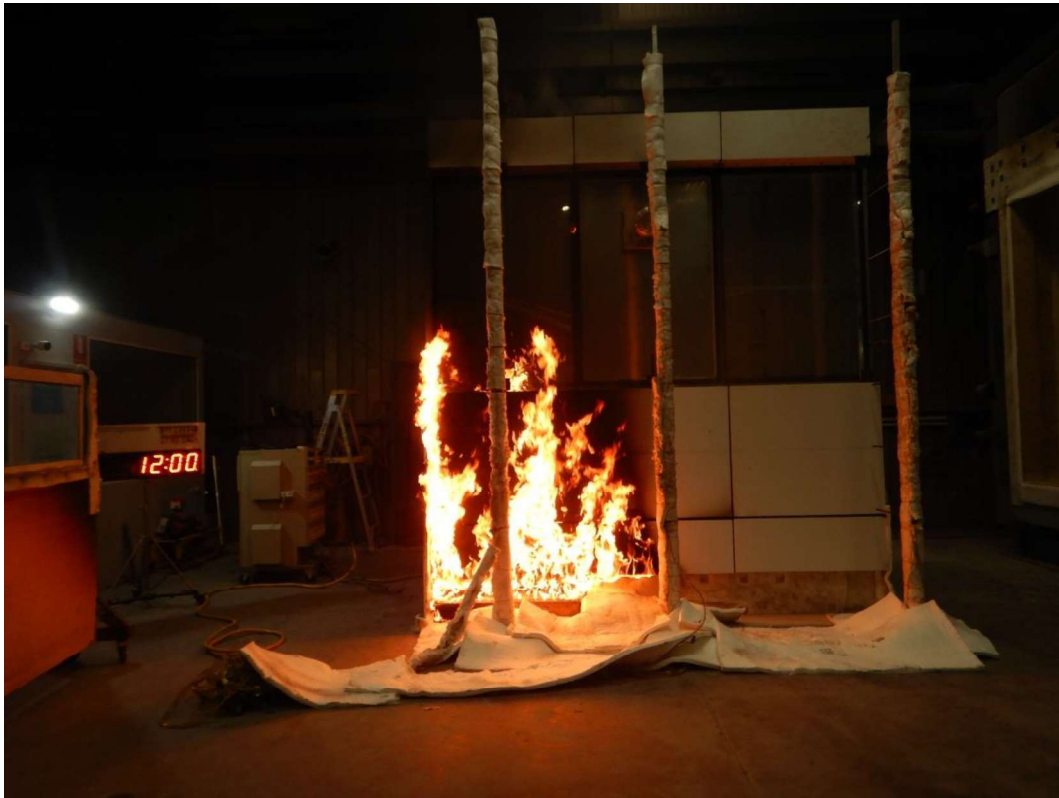
**Figure 33** The specimen 12 minutes into the test (burner output at 300 kW)

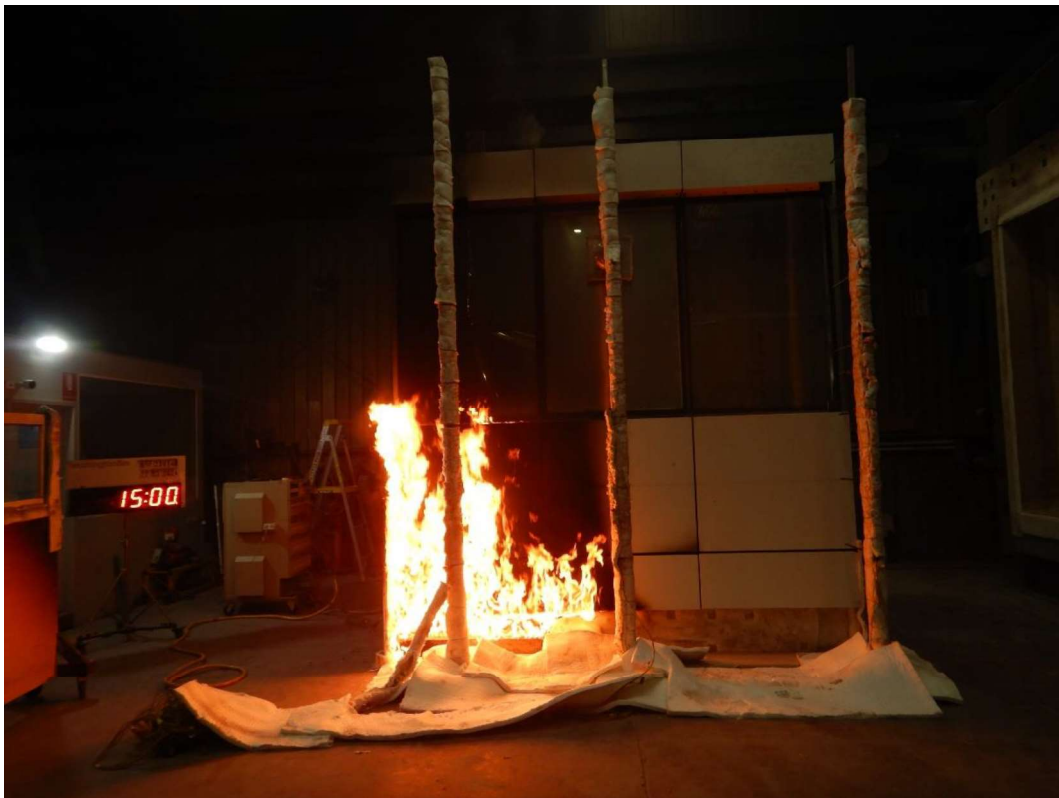
**Figure 34** The specimen 15 minutes into the test (burner output at 300 kW)

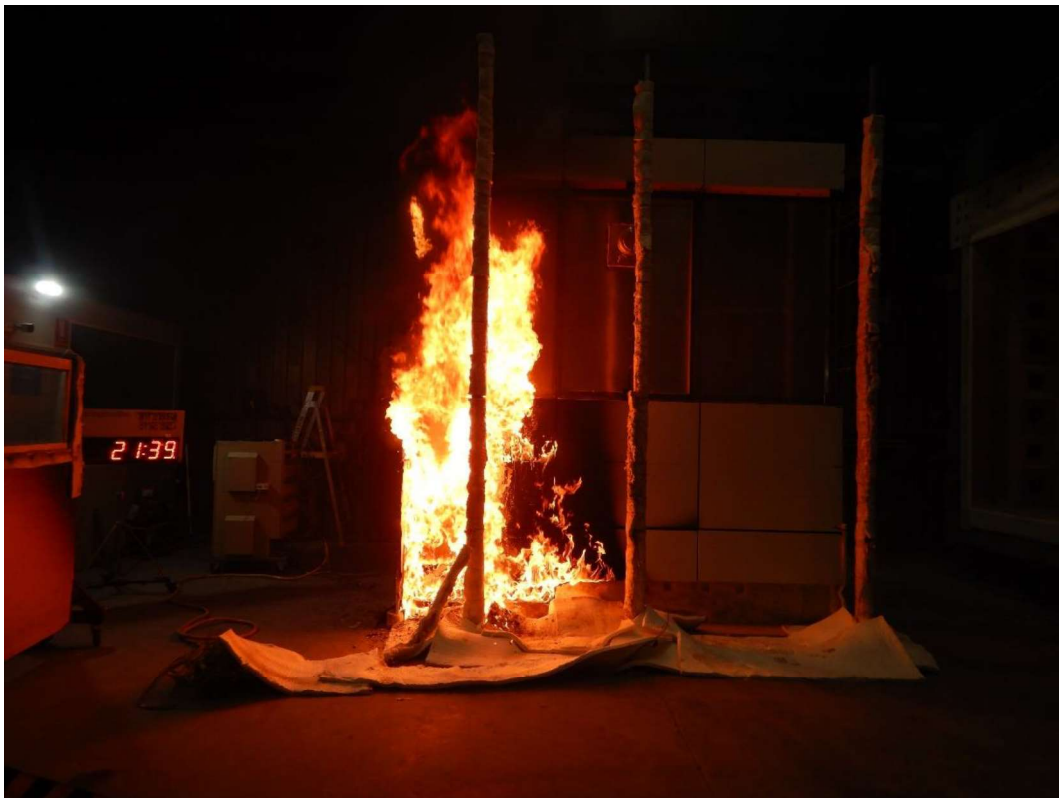
**Figure 36** The specimen 21 minutes 39 seconds into the test (burner output at 300 kW)

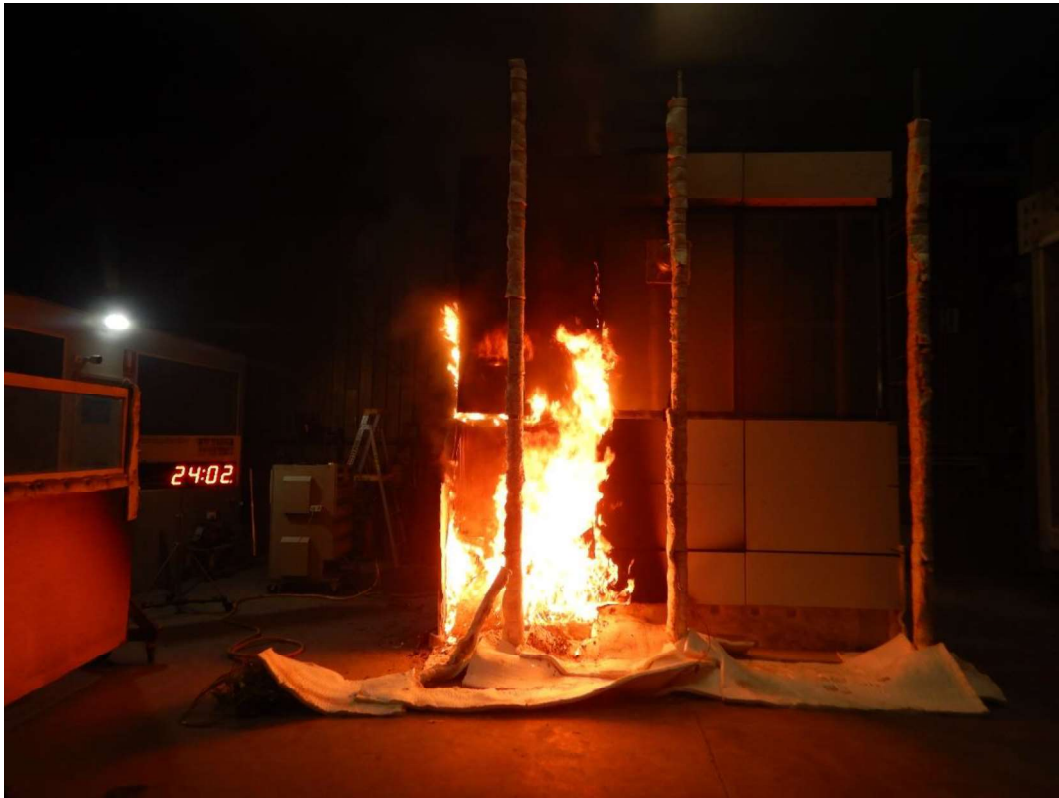
**Figure 37** The specimen 24 minutes 2 seconds into the test (burner output at 300 kW)

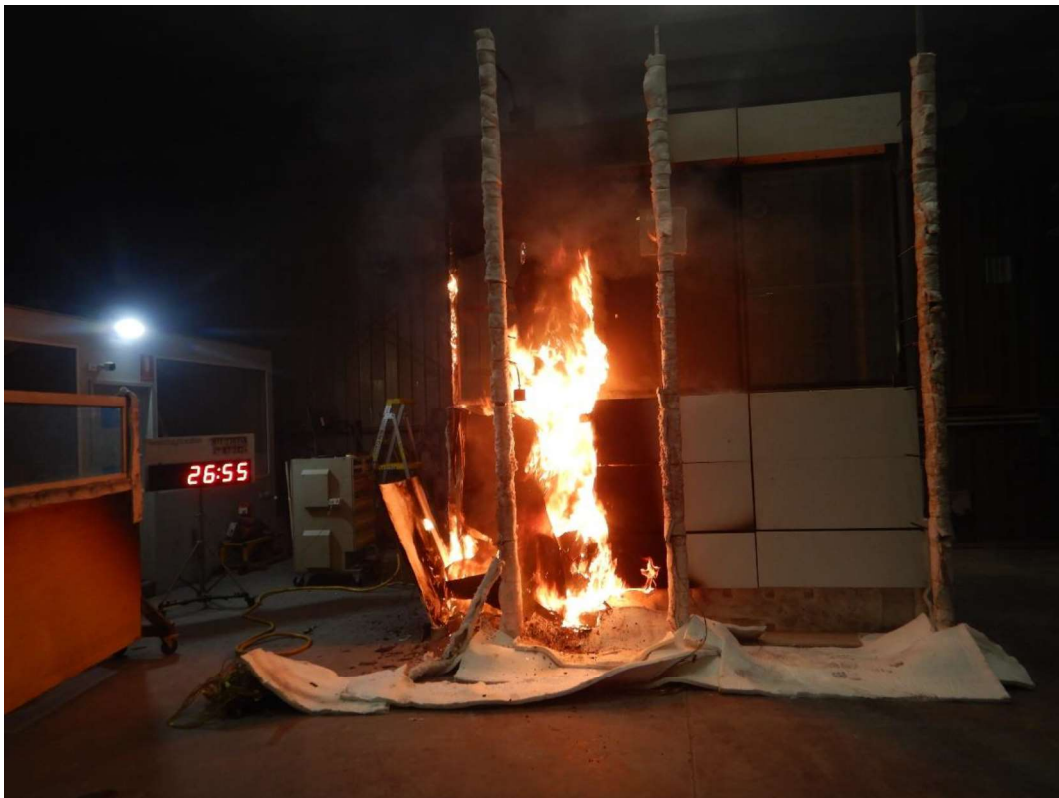
**Figure 38** The specimen 26 minutes 55 seconds into the test (burner output at 300 kW)

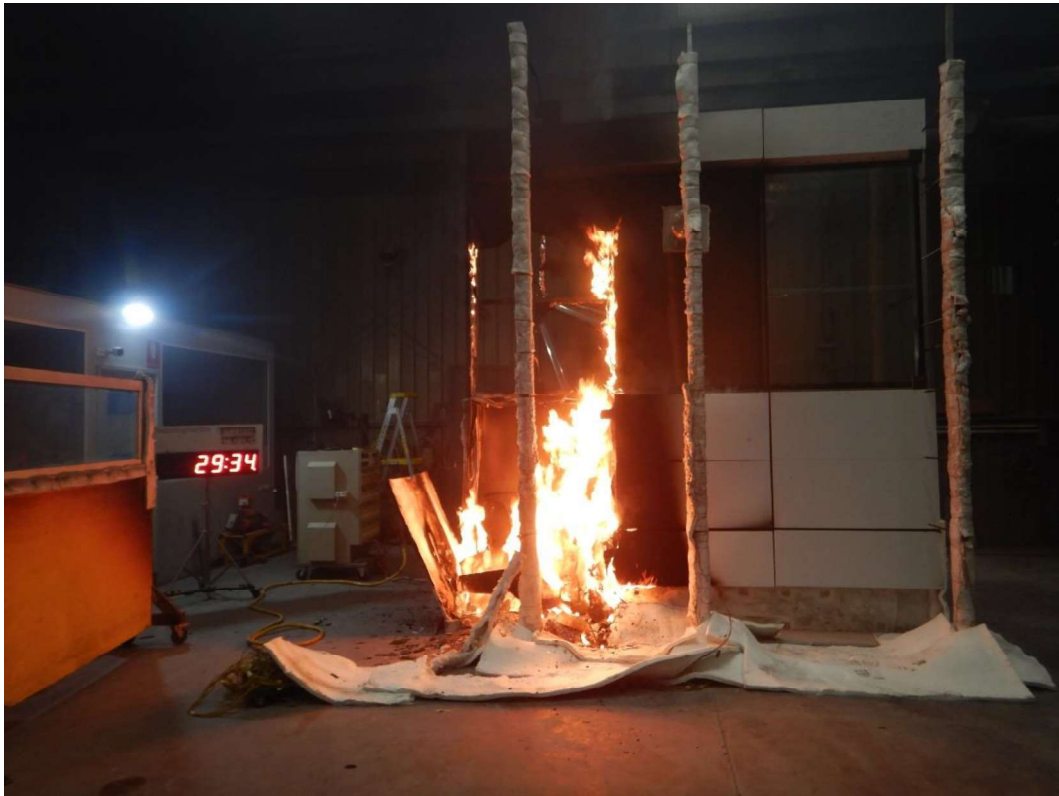
**Figure 39** The specimen 29 minutes 34 seconds into the test (burner output at 300 kW)

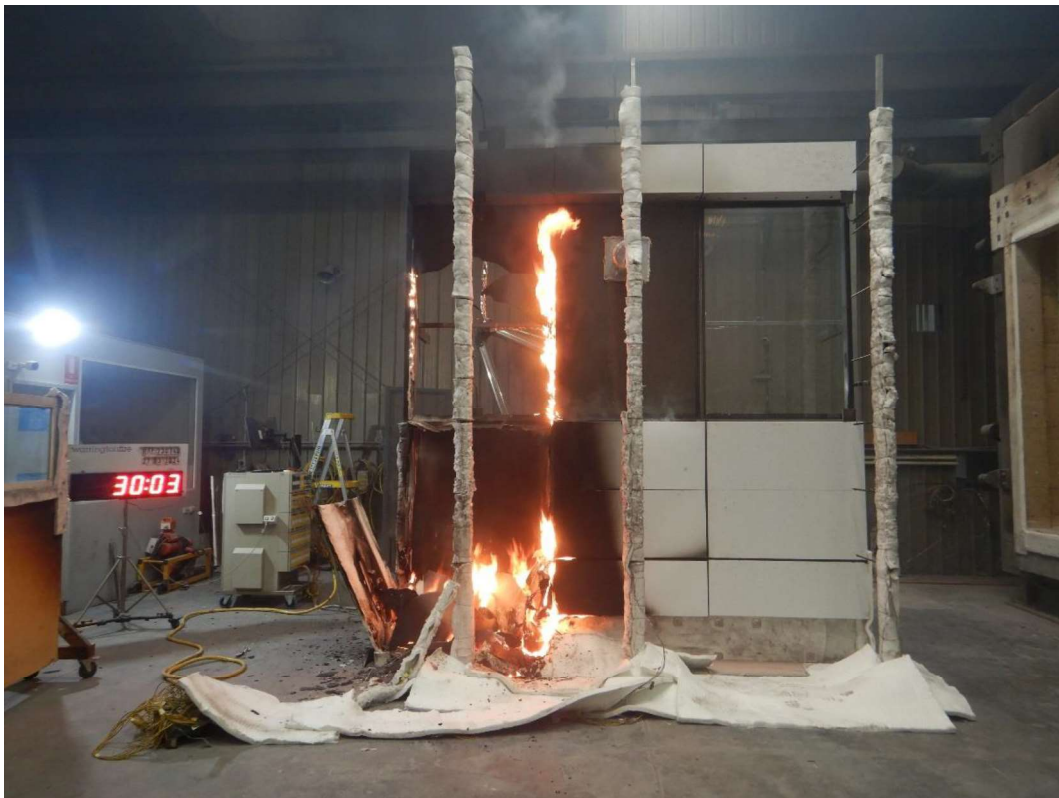
**Figure 40** The specimen 30 minutes 3 seconds into the test (burner off)

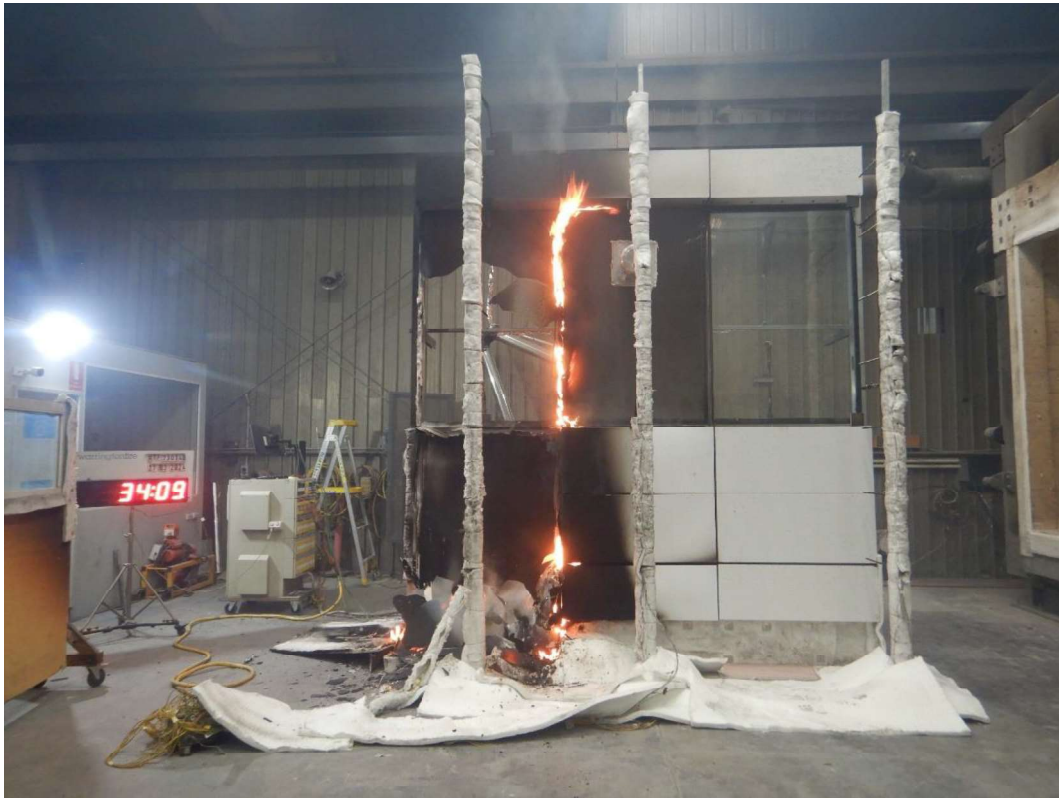
**Figure 41** The specimen 34 minutes 9 seconds into the test (burner off)

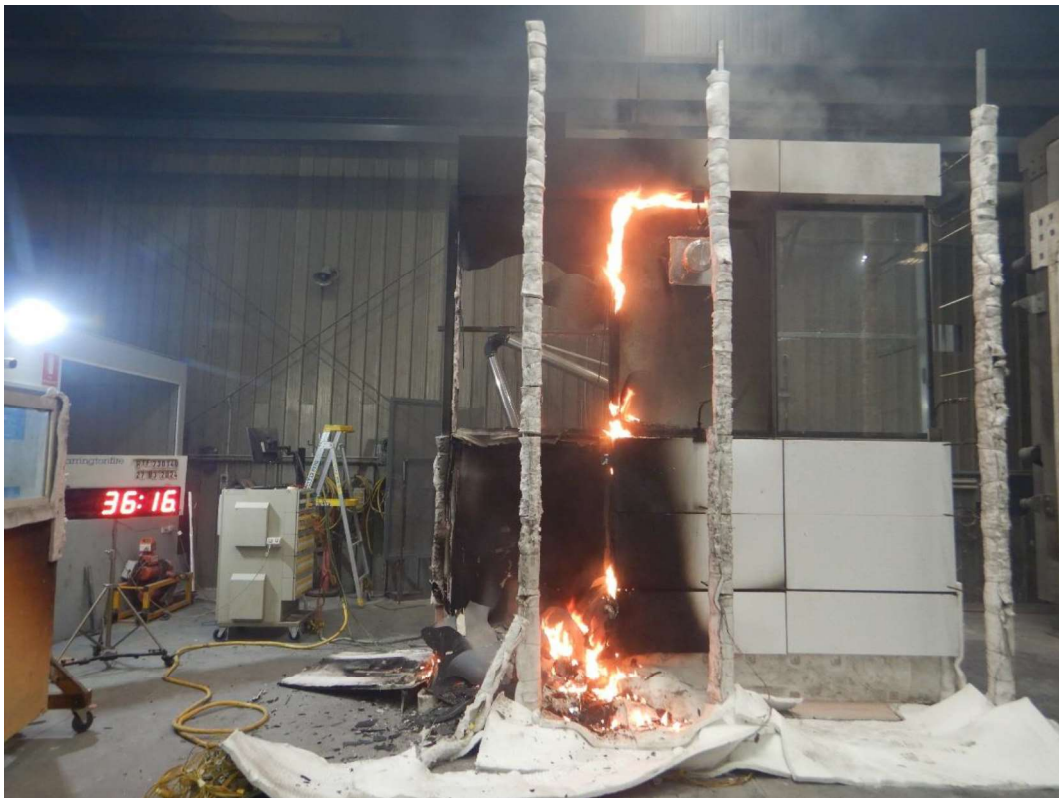
**Figure 42** The specimen 36 minutes 16 seconds into the test (burner off)

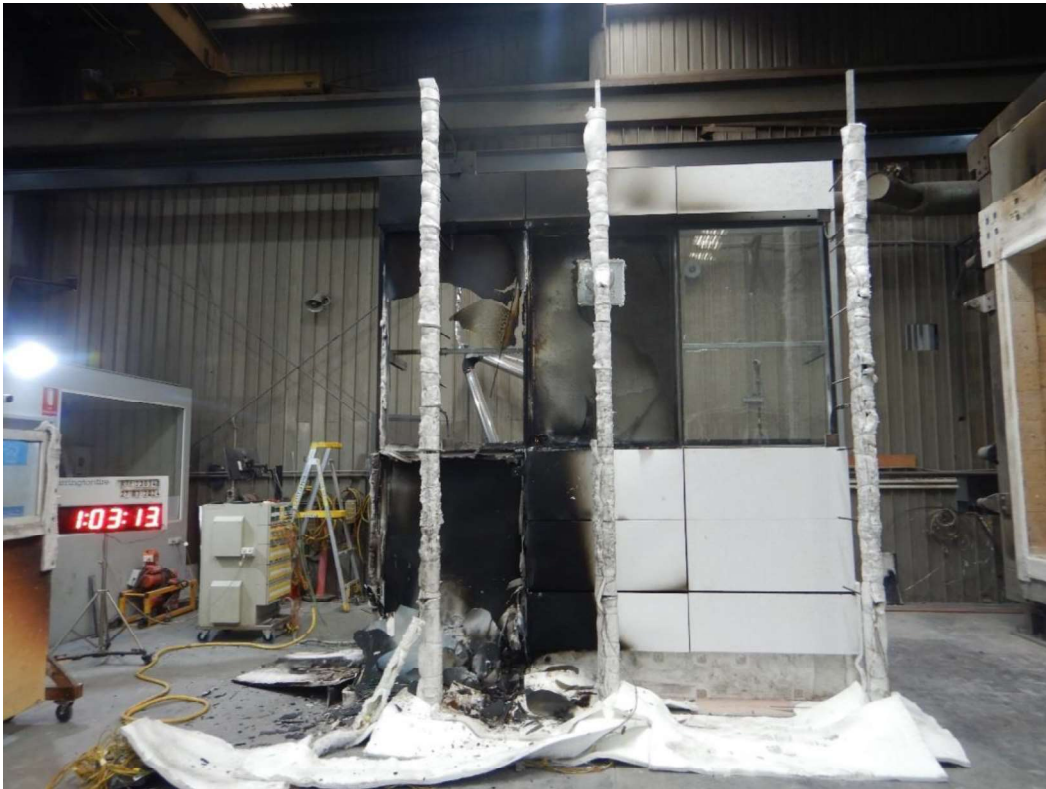
**Figure 43** The specimen at end of test – exposed side

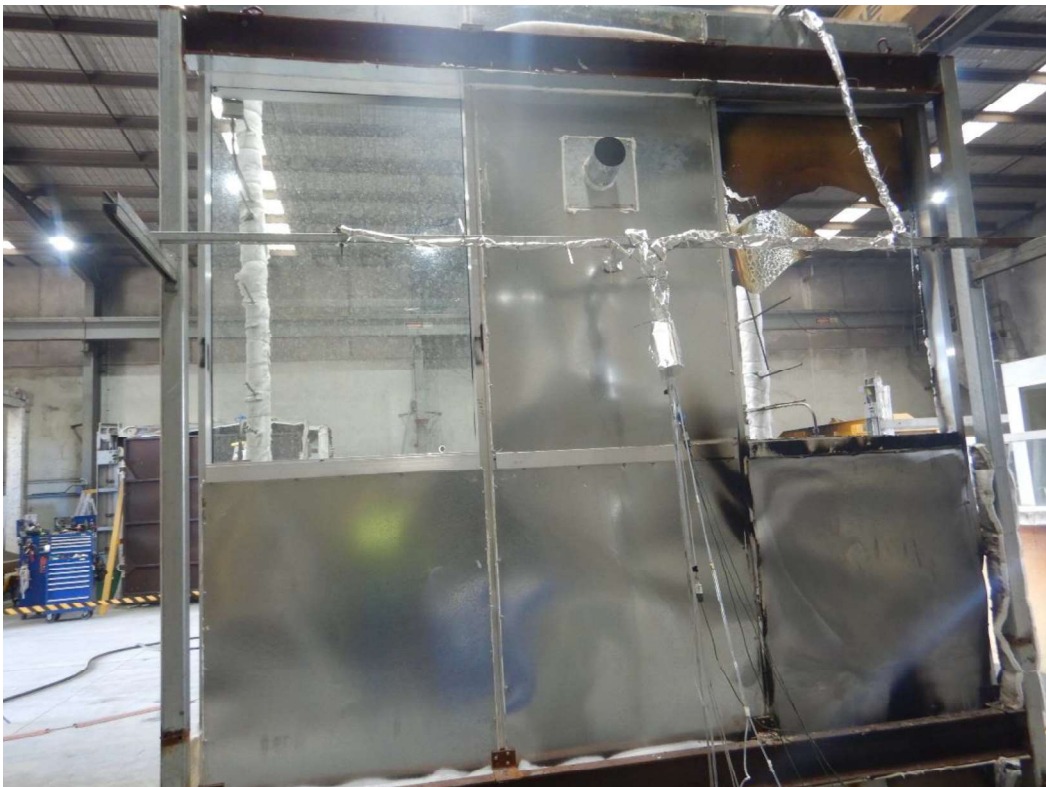
**Figure 44** The specimen at end of test – unexposed side
