# Palmers Rd Corridor (Western Freeway to Calder Freeway) – Historic Archaeology & Cultural Heritage

Heritage Victoria Project Number: 4334

**Report Sponsor:** VicRoads

**Date of Completion:** 28 August 2014

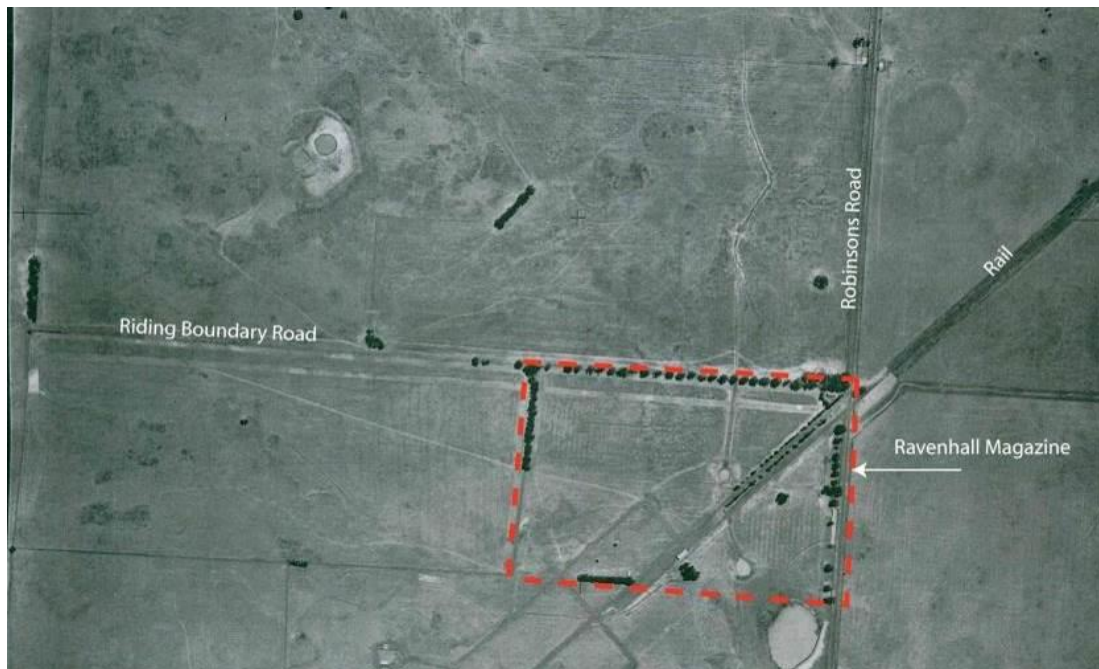
**Figure 5: Detail of aerial photograph of 1960, showing the Ravenhall Magazine and storage Facility and railway line (outlined in red). Note the lack of houses in area (DSE aerial photography unit)**

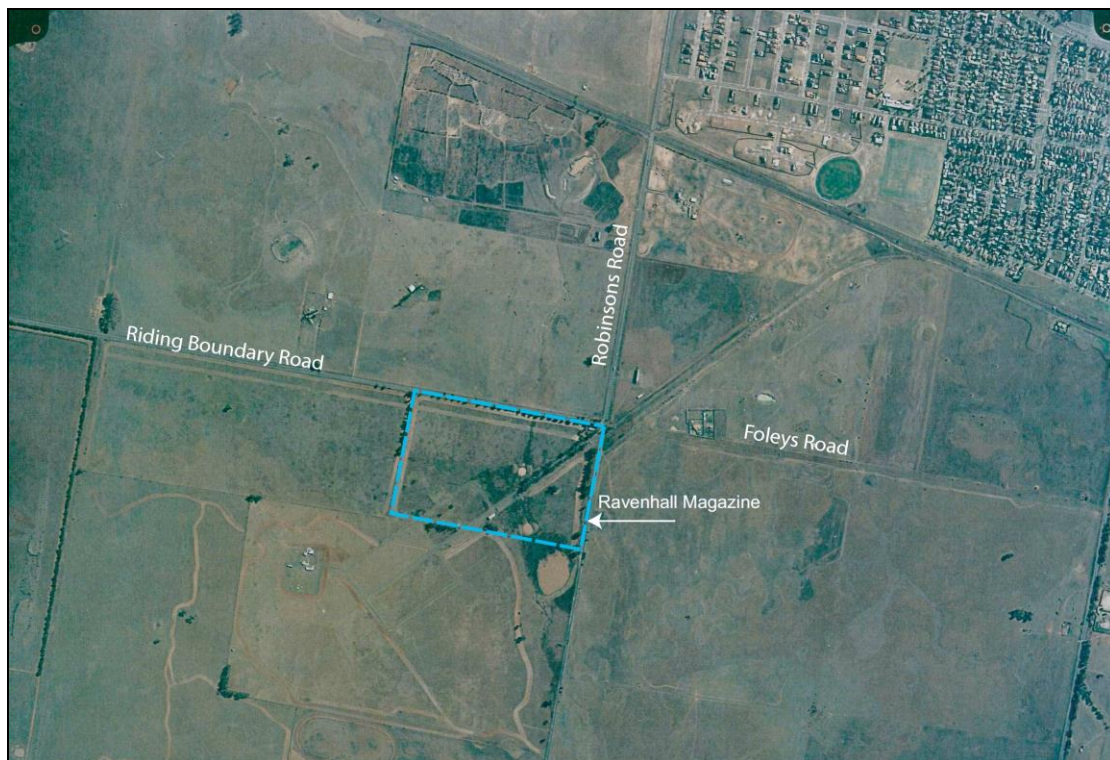
**Figure 6: 1989 aerial photograph of the south of the study area, showing housing development and pastoral land use in and around the Ravenhall Magazine and Storage Facility (outlined in blue) (DSE Aerial Photography Unit).**

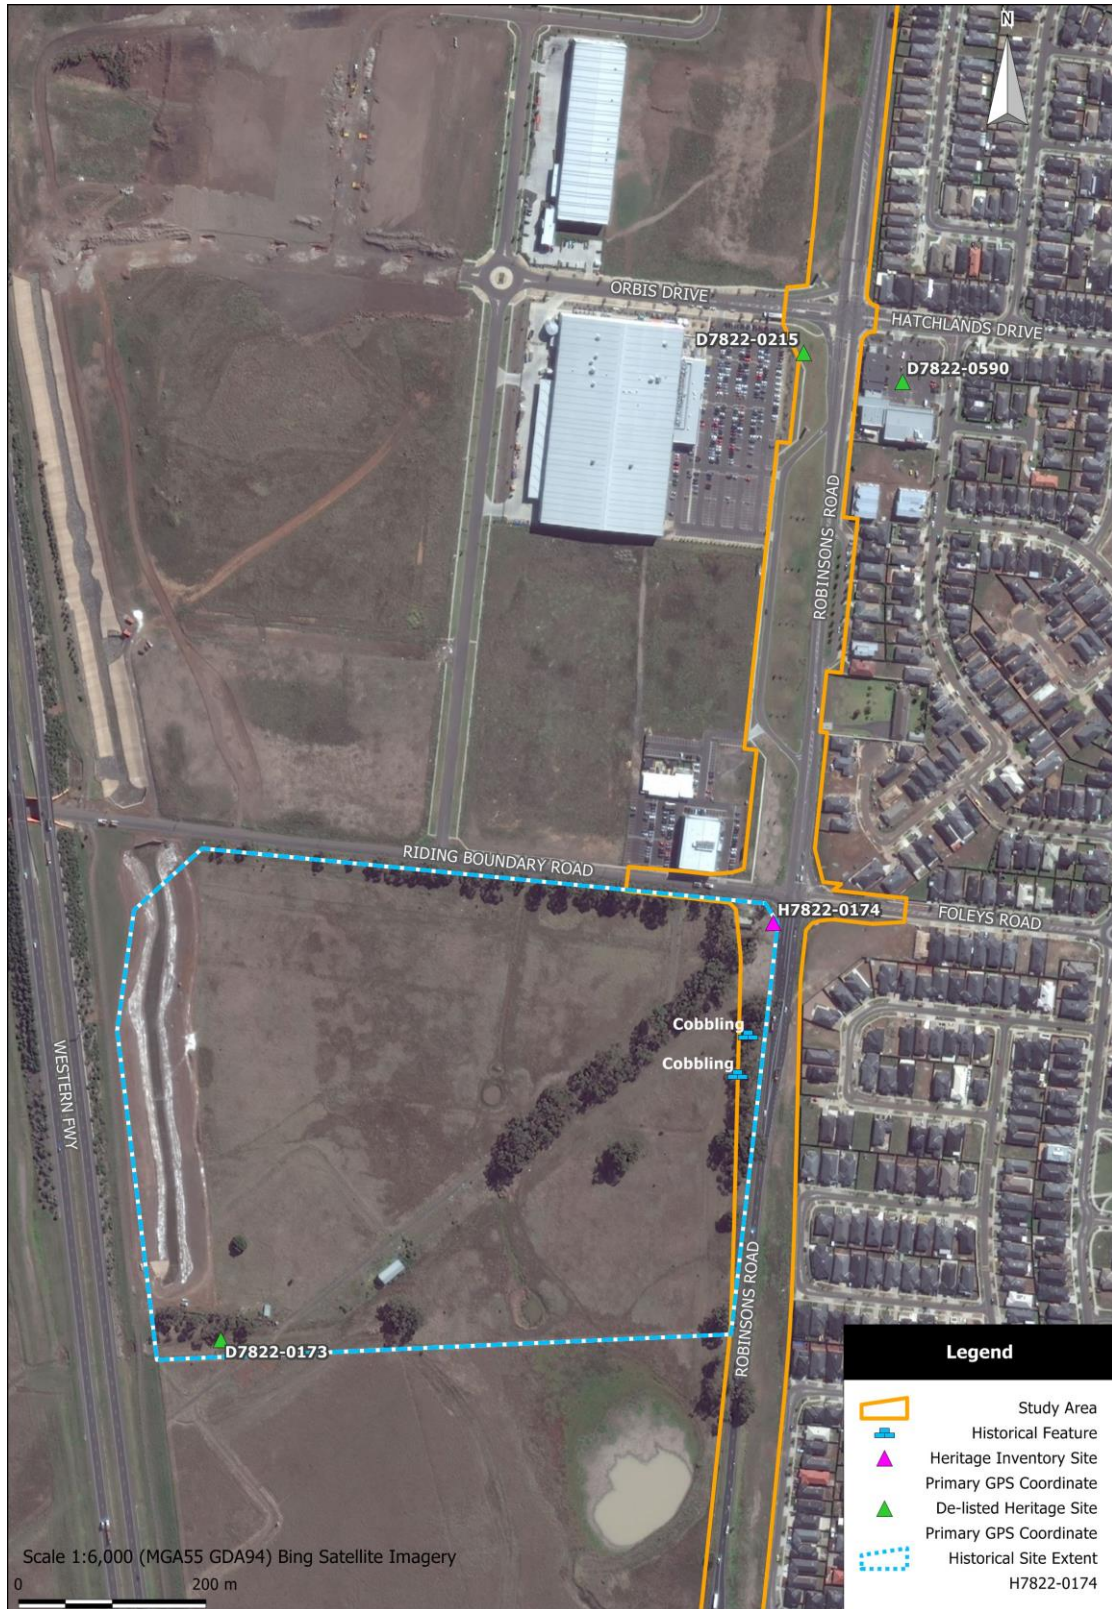
**Figure 8: The locations of H7822-0174 (Ravenhall 2 Magazine and Storage Facility) and dry stone wall D7822-0173 (Ravenhall 1)**

This facility forms part of the wider complex of buildings in the Deer Park area that were constructed during World War II for the purposes of explosive and ammunition manufacture and storage. It was decommissioned in 1946 and the buildings were cleared. Little is known of the sites usage in the post-war period until 1961 when it was used as a rocket engine test and ammunition storage site, although it is likely that it was put to pastoral purposes in the intervening period. When inspected by du Cros and Murphy the buildings were being used for shearing and stabling sheep (du Cros and Murphy 1994: 14). Six features were recorded by du Cros and Murphy, including extant buildings constructed of timber, corrugated iron and asbestos sheeting; an access road; an embankment of a former railway siding; a gate; plantings of sugar gums; and an historic artefact scatter in the NE corner of the property. When inspected again by Gardiner (2010), all of these features were still present. The site location is shown in Figure 8.

This site comprises a dry stone wall, which runs parallel to Robinsons Road within the study area, forming the boundary between the road reserve and the Ravenhall 2 Magazine and Storage Facility (H7822-0174). When recorded the stone wall surrounded the entirety of site H7822-0174 (Figure 8). The eastern part of this wall remains *in situ* today but is in a very poor state of preservation (Photographs 1 and 2).

This was a section of dry stone wall running along the western side of Robinsons Road between Riding Boundary Road and the Ballarat to Melbourne railway line. It has been destroyed and no trace of it remains. The previously recorded location of the site is shown in Figure 8.

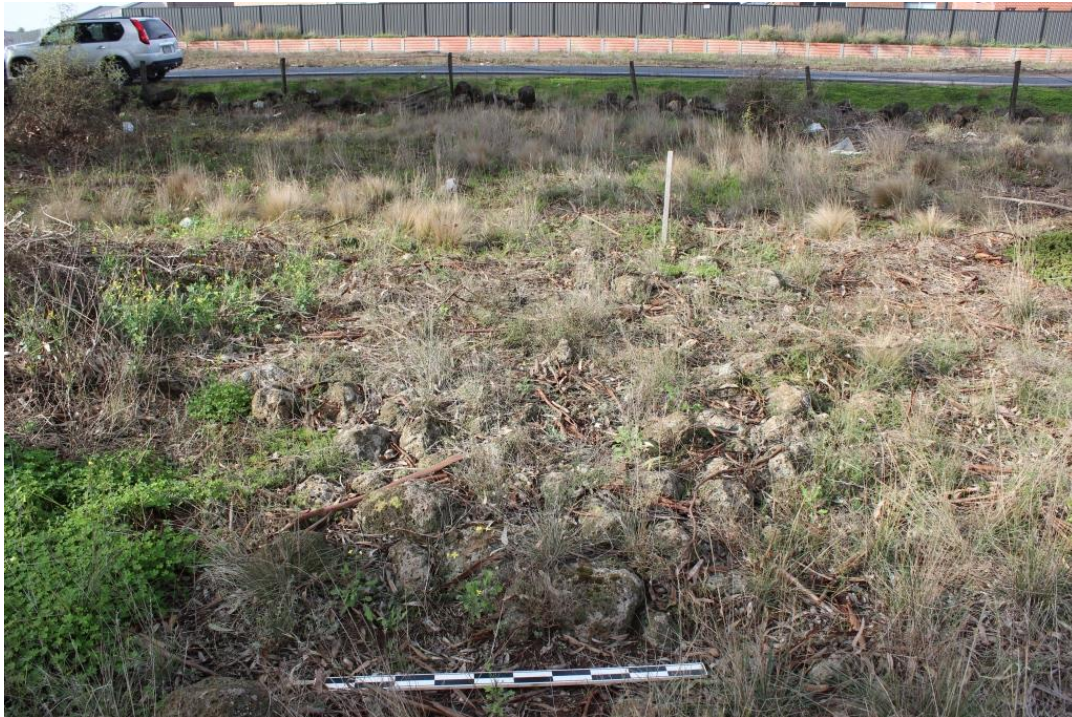
**Photograph 1:** Ravenhall 2 (7822-0174), showing one of two areas of cobbled surface, looking north-east towards Robinsons Rd. Note the stone wall along the fence line (D7822-0173), (K. Flemming 24.06.13).

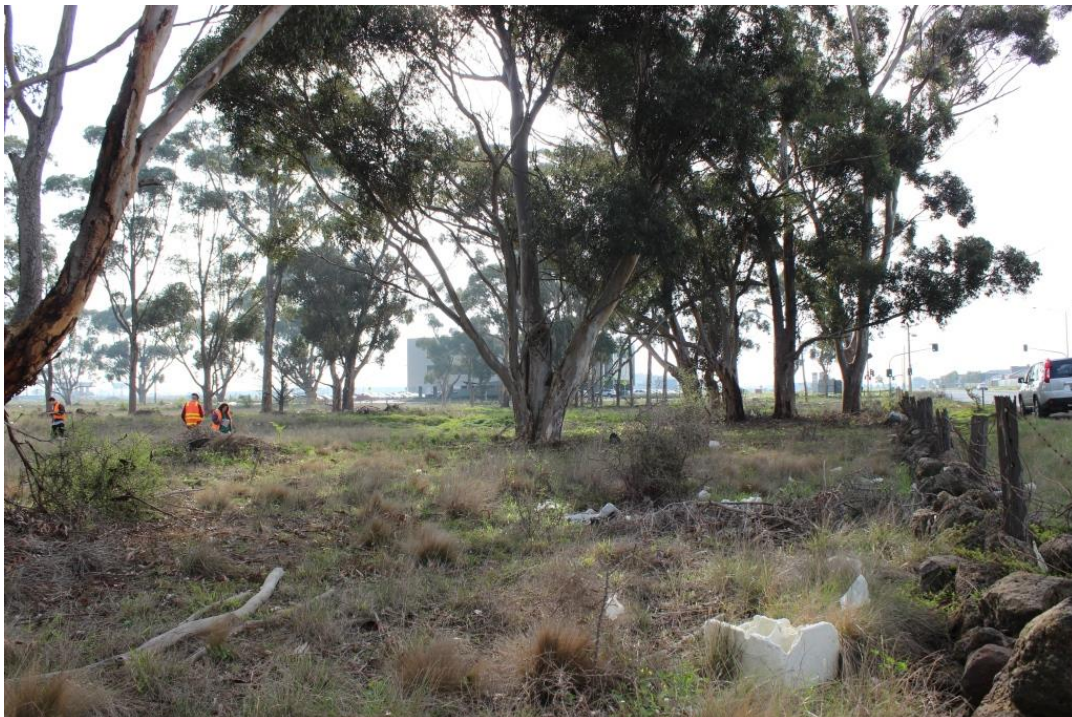
**Photograph 2:** Looking north at the north-east corner of the Ravenhall 2 Magazine and Storage Facility site (H7822-0174), with the delisted dry stone wall, D7822-0173, to the right, (K. Flemming 24.06.13).

recommended that temporary fencing, bunting, or equivalent be erected around this wall, in order to avoid harm to this site during the works.

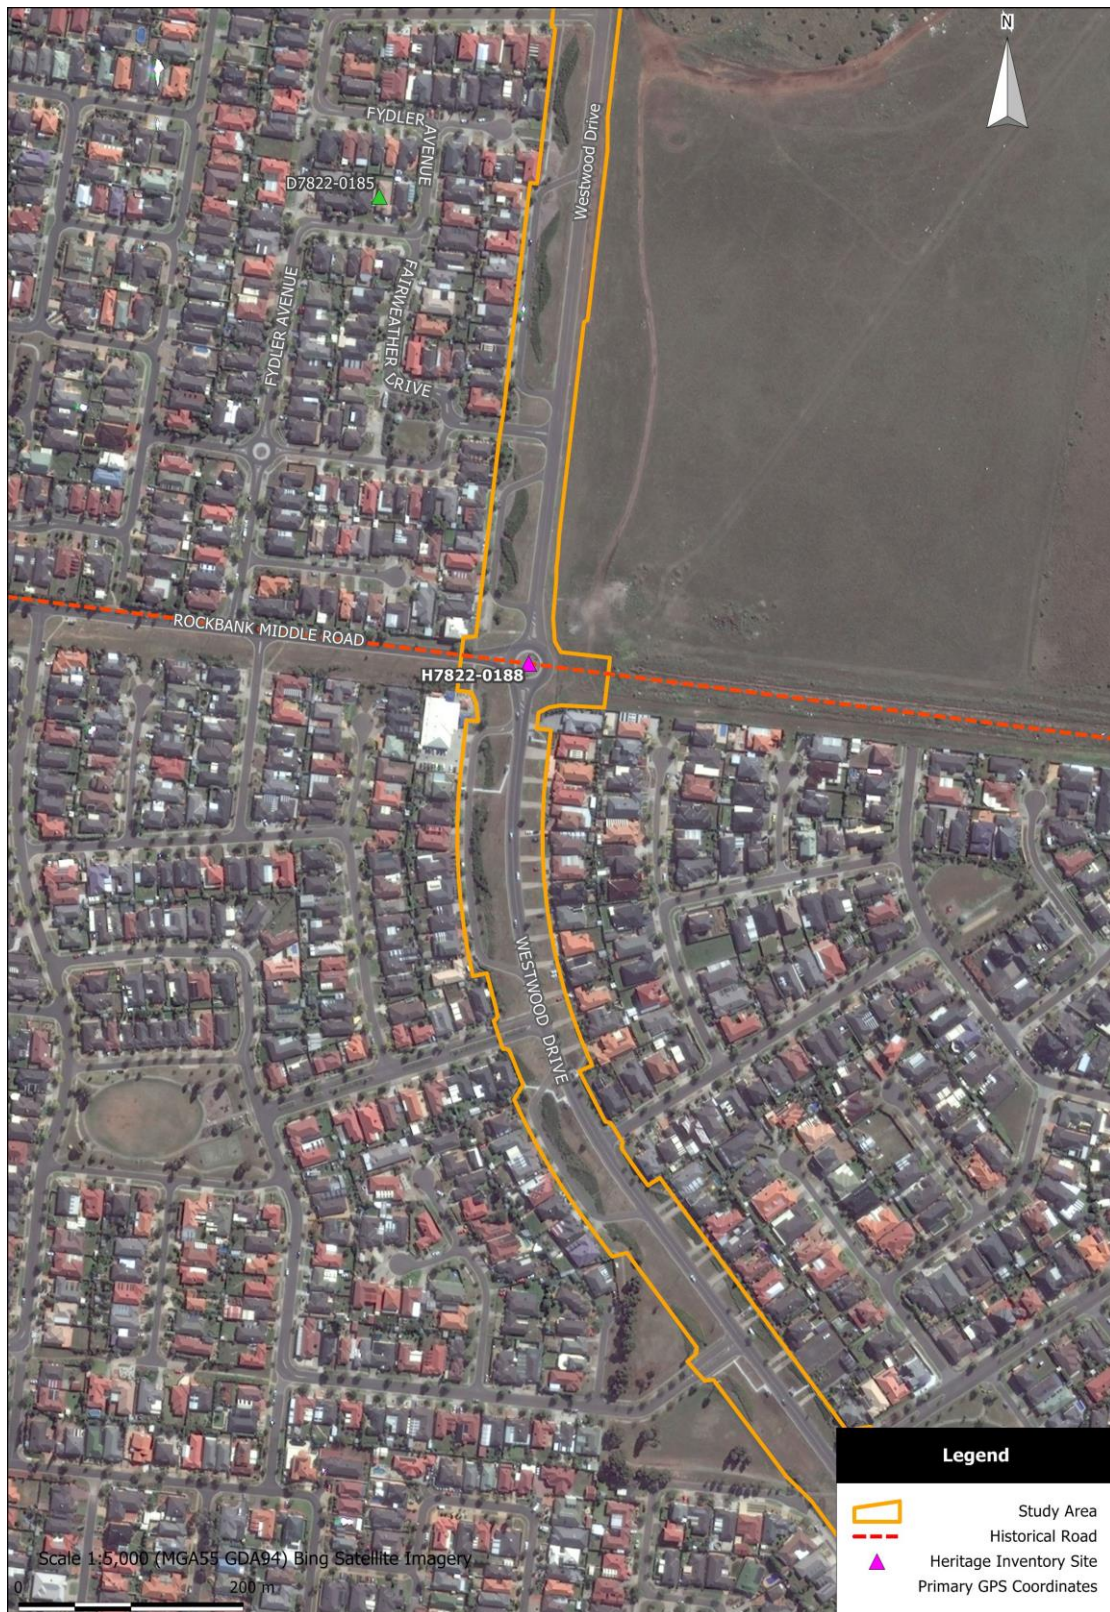
Figure 9: The location of cobble road H7822-0188 (the historical road)

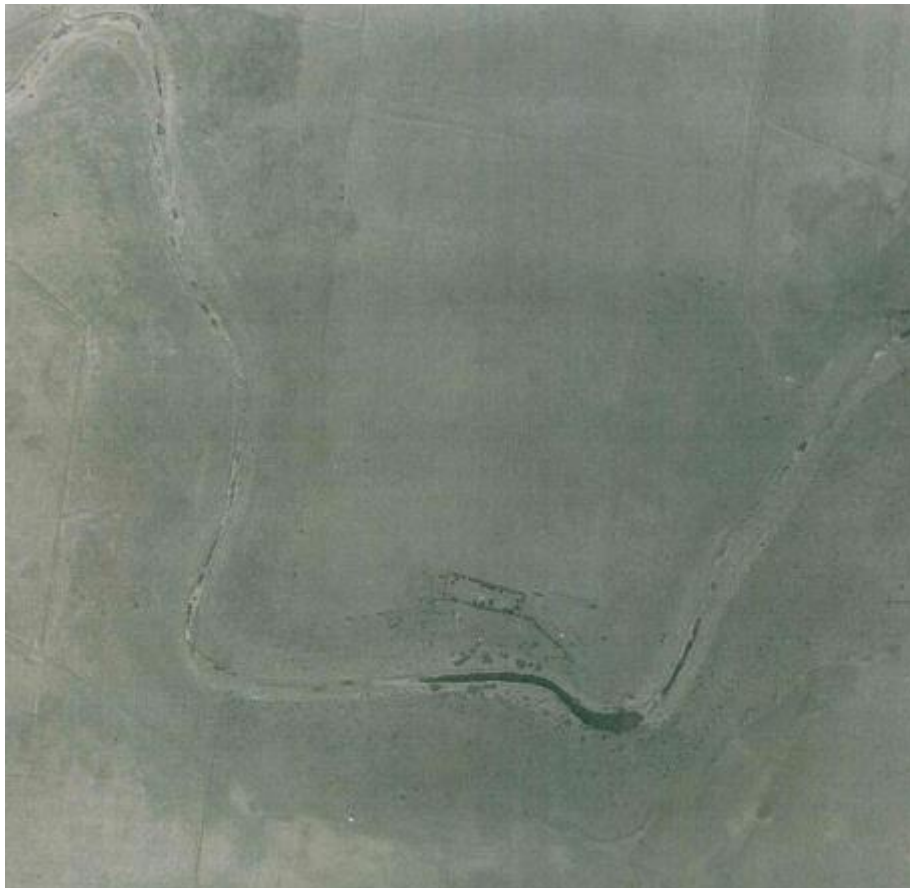
Three rectangular structures, the northernmost labelled "Woolshed" and the two structures to the south labelled "Huts" are marked in the same location on a plan sent by Robert Russell in a letter to the Surveyor-General dated December 13, 1852. These structures are also identified in Parish plans from 1856 (Figure 10) and 1859 (Figure 11), the easternmost of which is the hut identified by Vines. By 1893 it would appear that none of these structures were extant, as they do not appear on the parish plan from this time (Department of Crown Lands and Survey 1893). Aerial photography from 1945 shows what appear to be sections of stone walling, possibly forming an animal pen, at the site (Figure 12).

**Figure 12: Detail from 1945 aerial photograph of the site of the Drovers Hut, showing what appear to be sections of walling (DSE aerial photography unit).**

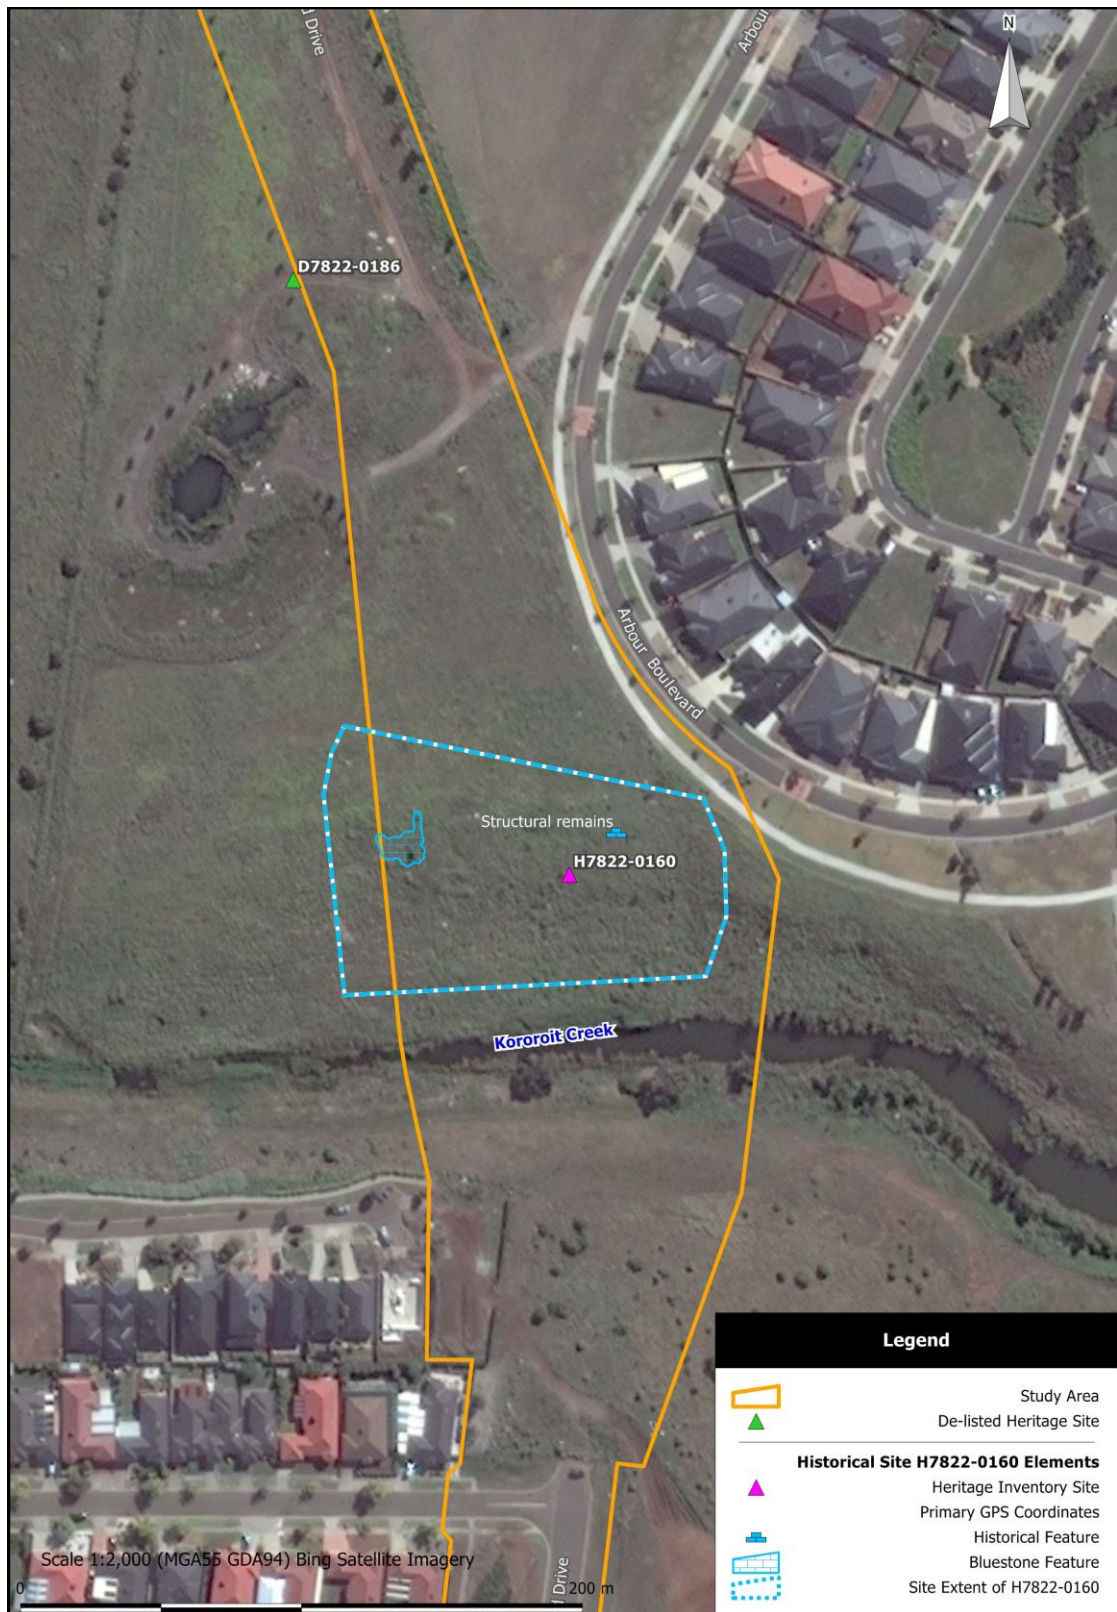
As a result of the current investigation, this site was relisted on the VHI as H7822-0160 (see Appendices 2 and 3). The location of the site and its identified features are shown in Figure 13.

Figure 13: Map showing the location of identified features of site H7822-0160 (Drover's Hut)

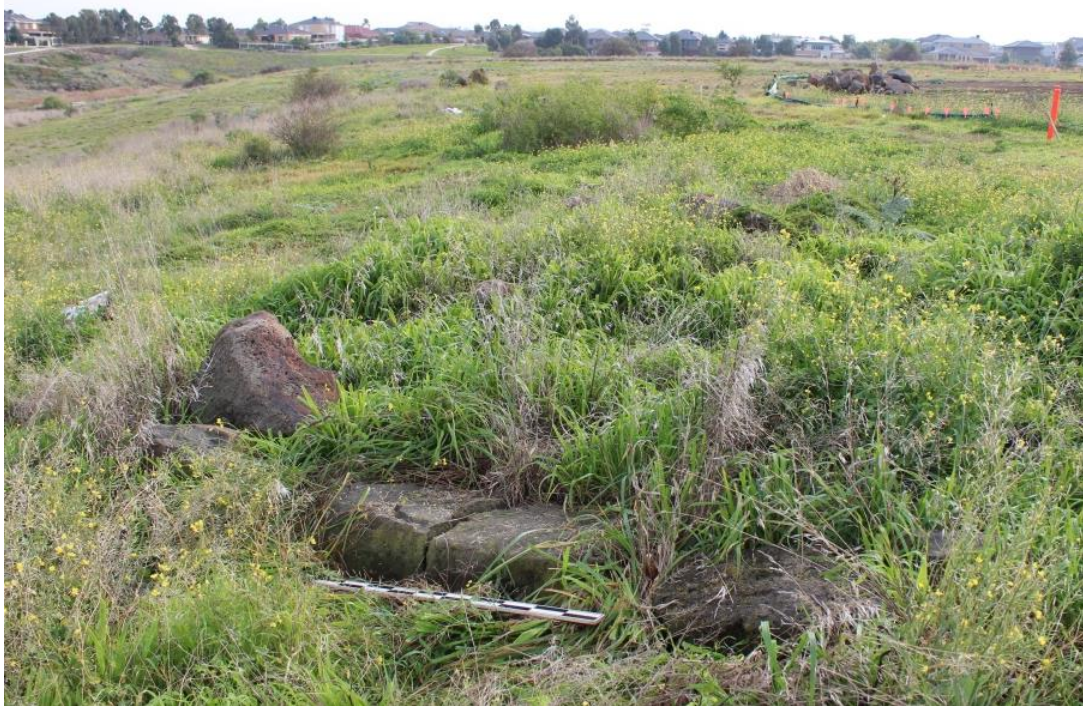
When visited in the course of this survey, the bluestone foundations of the hut and a concrete floor were relocated (Photographs 4 - 6). Whilst the site appears to have deteriorated since originally recorded by Vines, the foundations and floor appear to be completely intact, albeit partially obscured by dumped soil and rubbish. There is a second structure approximately 50m to the west, consisting of roughly constructed walls of squared bluestone and fieldstones, clearly in a secondary context (Photograph 7). These form a roughly rectangular enclosure, the feature recorded by Gardiner in 2010. Scattered historical artefacts were noted on bare patches of ground around the site.

**Photograph 4:** Bluestone foundations of site H7822-0160 (Drover's Hut) in foreground; a second feature, comprising a secondary alignment of bluestone blocks, probably the remnants of the former woolshed, is located in the boxthorn bushes in the centre background (K. Flemming 24.6.2013)

Archaeological excavation of that portion of the site that will be affected by the construction of the southbound carriageway and the eastern span of the bridge over Kororoit Creek was conducted in 2013, pursuant to a Consent issued by Heritage Victoria (Appendix 4). This resulted in the exposure and recording of the bluestone foundations and remnant surfaces of what was probably an early homestead, one of the first to be established in this region (B.Green, in preparation).

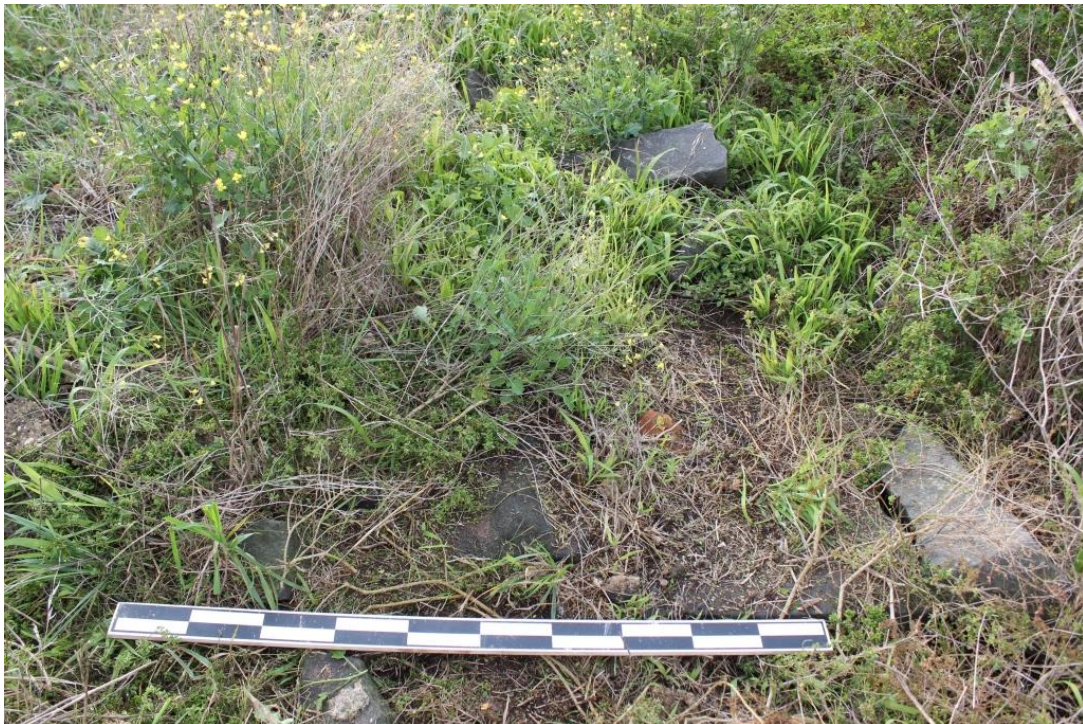
**Photograph 5:** *In situ* bluestone foundations at H7822-0160 (Drover's Hut) (K. Flemming 24.6.2013)

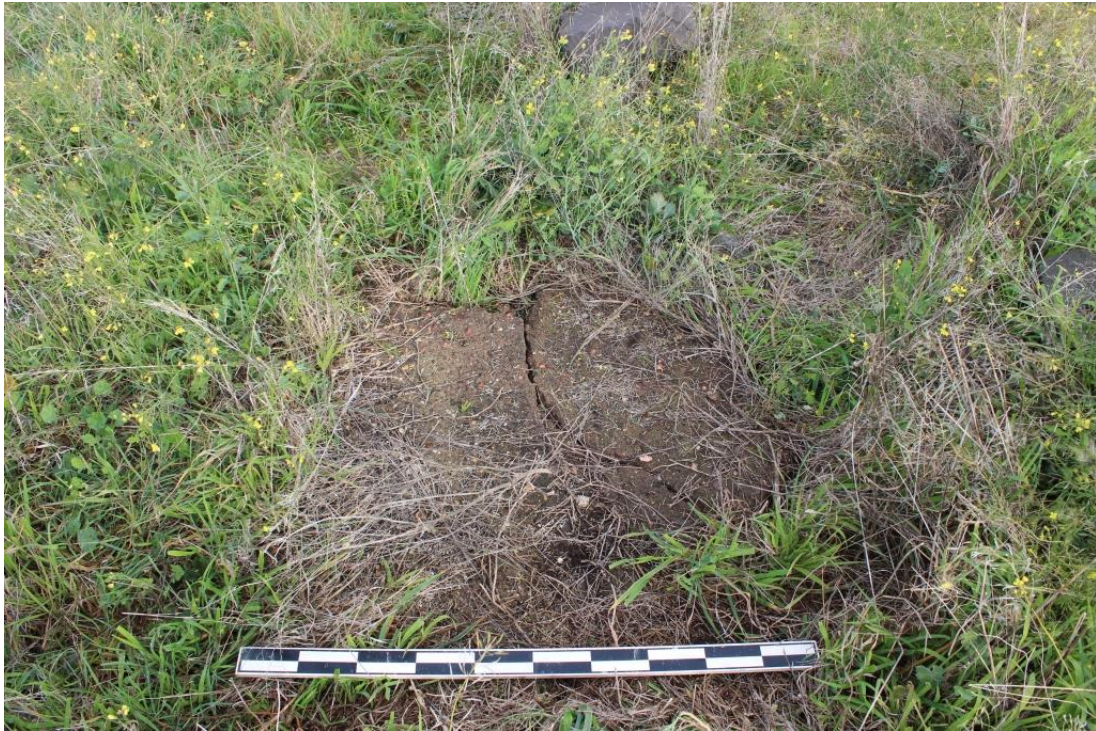
**Photograph 6:** *In situ* section of concrete floor at H7822-0160 (Drover's Hut) (K. Flemming 24.6.2013)

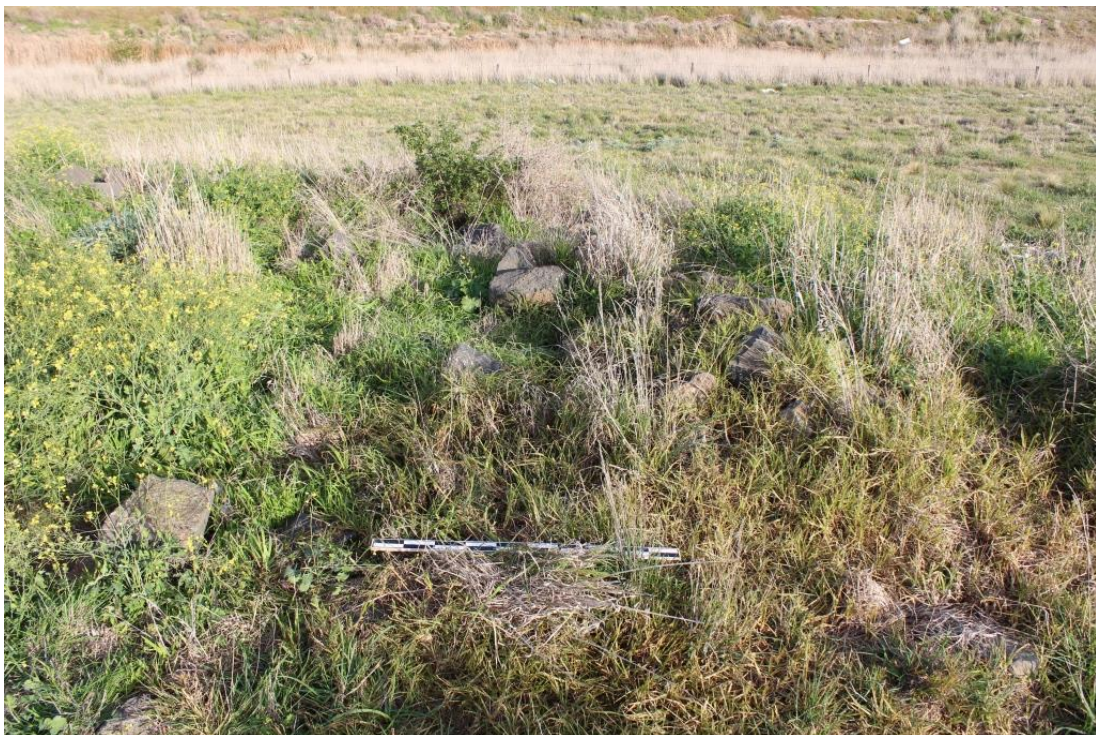
**Photograph 7:** Secondary alignment of bluestone blocks in a linear arrangement, probably remains of the former woolshed, at site H7822-0160 (Drover's Hut), looking south (K. Flemming 24.6.2013)

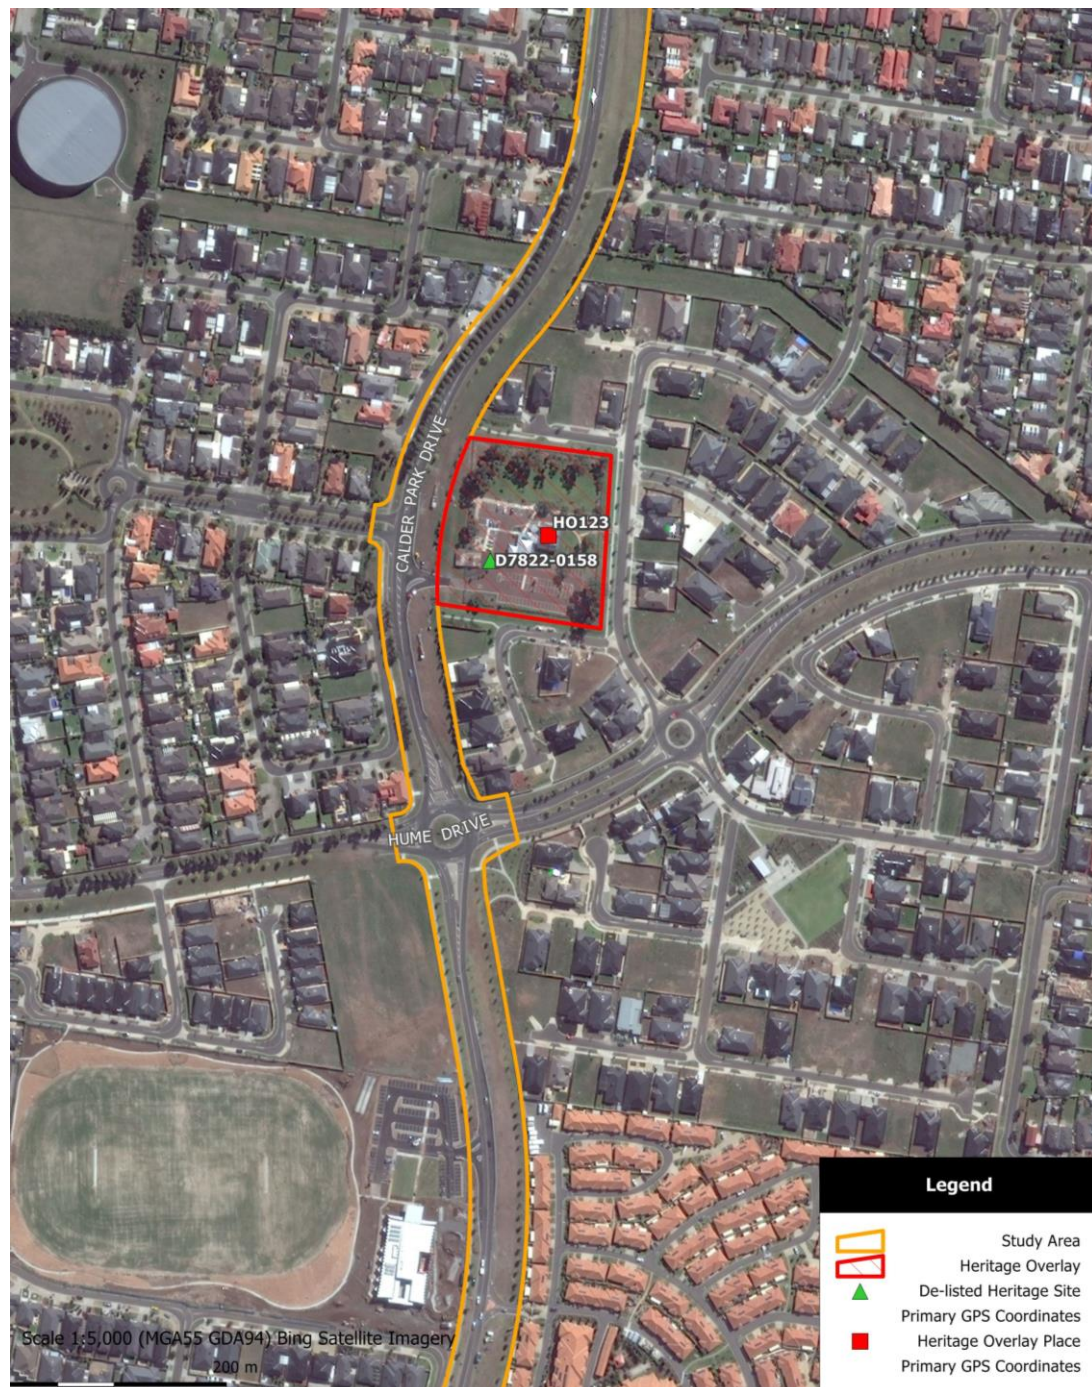
Figure 14: The location of HO123, the former “Dalgook” homestead.

This historic homestead, constructed in 1906, has been delisted from the Victorian Heritage Inventory but is included in the City of Melton Heritage Overlay (HO123). It is located on the east side of Calder Park Drive to the north of Hume Drive, adjacent to the study area (Figure 11).

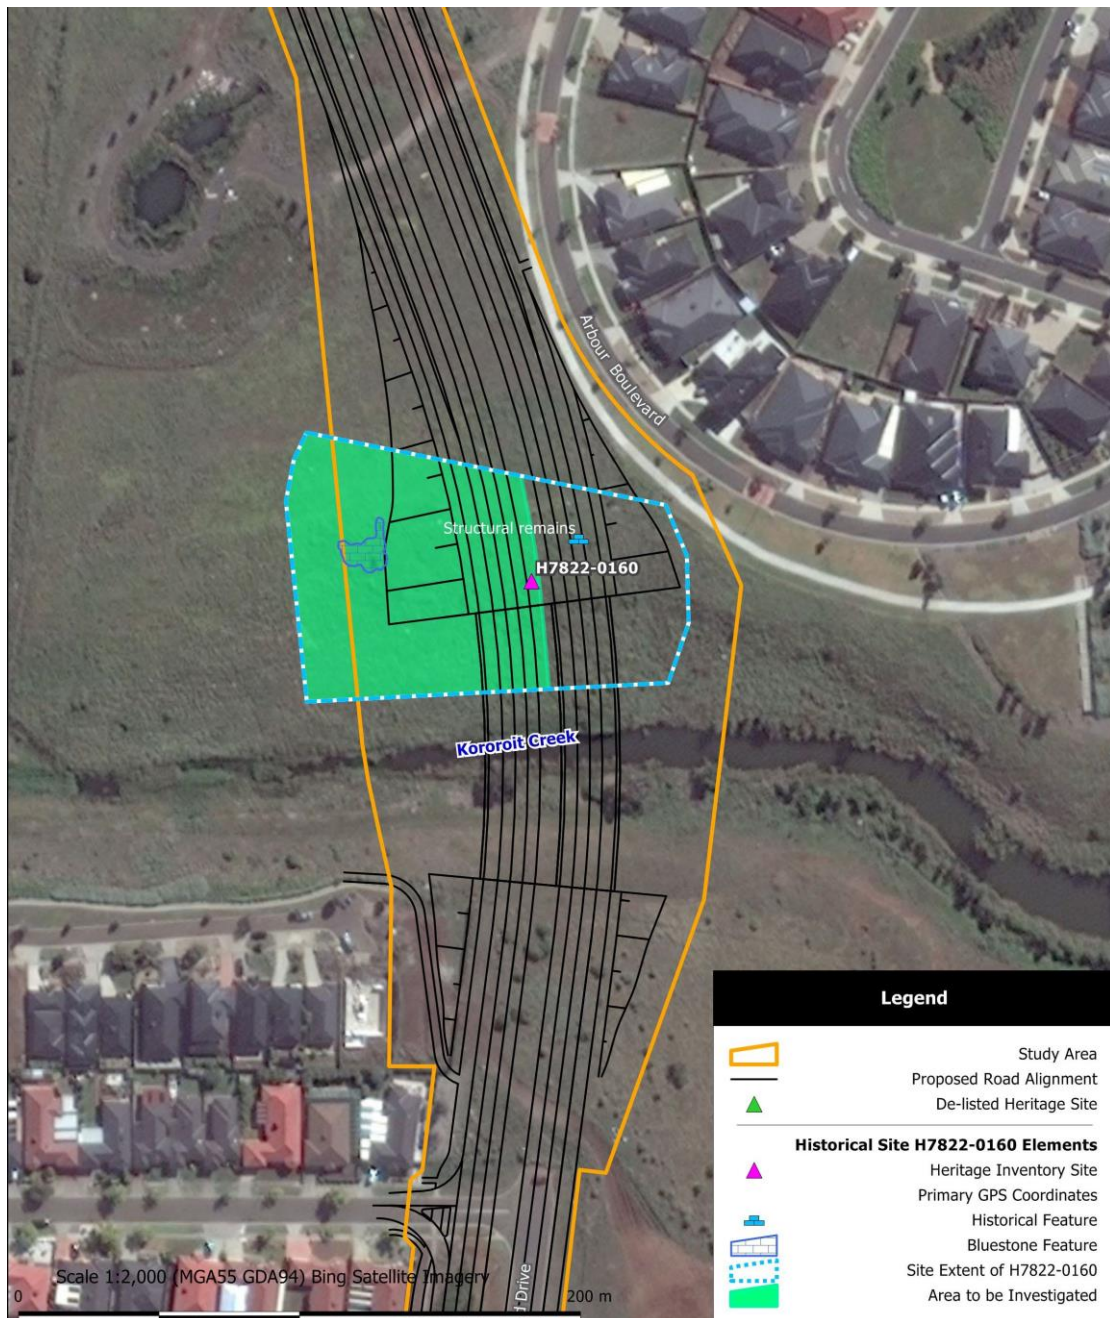
The "Drover's Hut" site (H7822-0160) is situated directly in the path of the development of Westwood Drive and of both spans of a new bridge to be constructed over Kororoit Creek. Consent for that part of the site (the "hut" itself, marked as 'structural remains' in Figure 15) that will be damaged by construction of the southbound carriageway and the eastern bridge over Kororoit Creek has been issued by Heritage Victoria (C873 cf. Appendix 4). However, a further Consent will be required for works on the northbound carriageway and western span of the bridge, works that will cause an impact upon extant remains in the western portion of the site. Figure 15 shows the area of H7822-0160 yet to be investigated.

Figure 15: Plan showing the features of H7822-0160 “Drover’s Hut” and the area yet to be investigated.

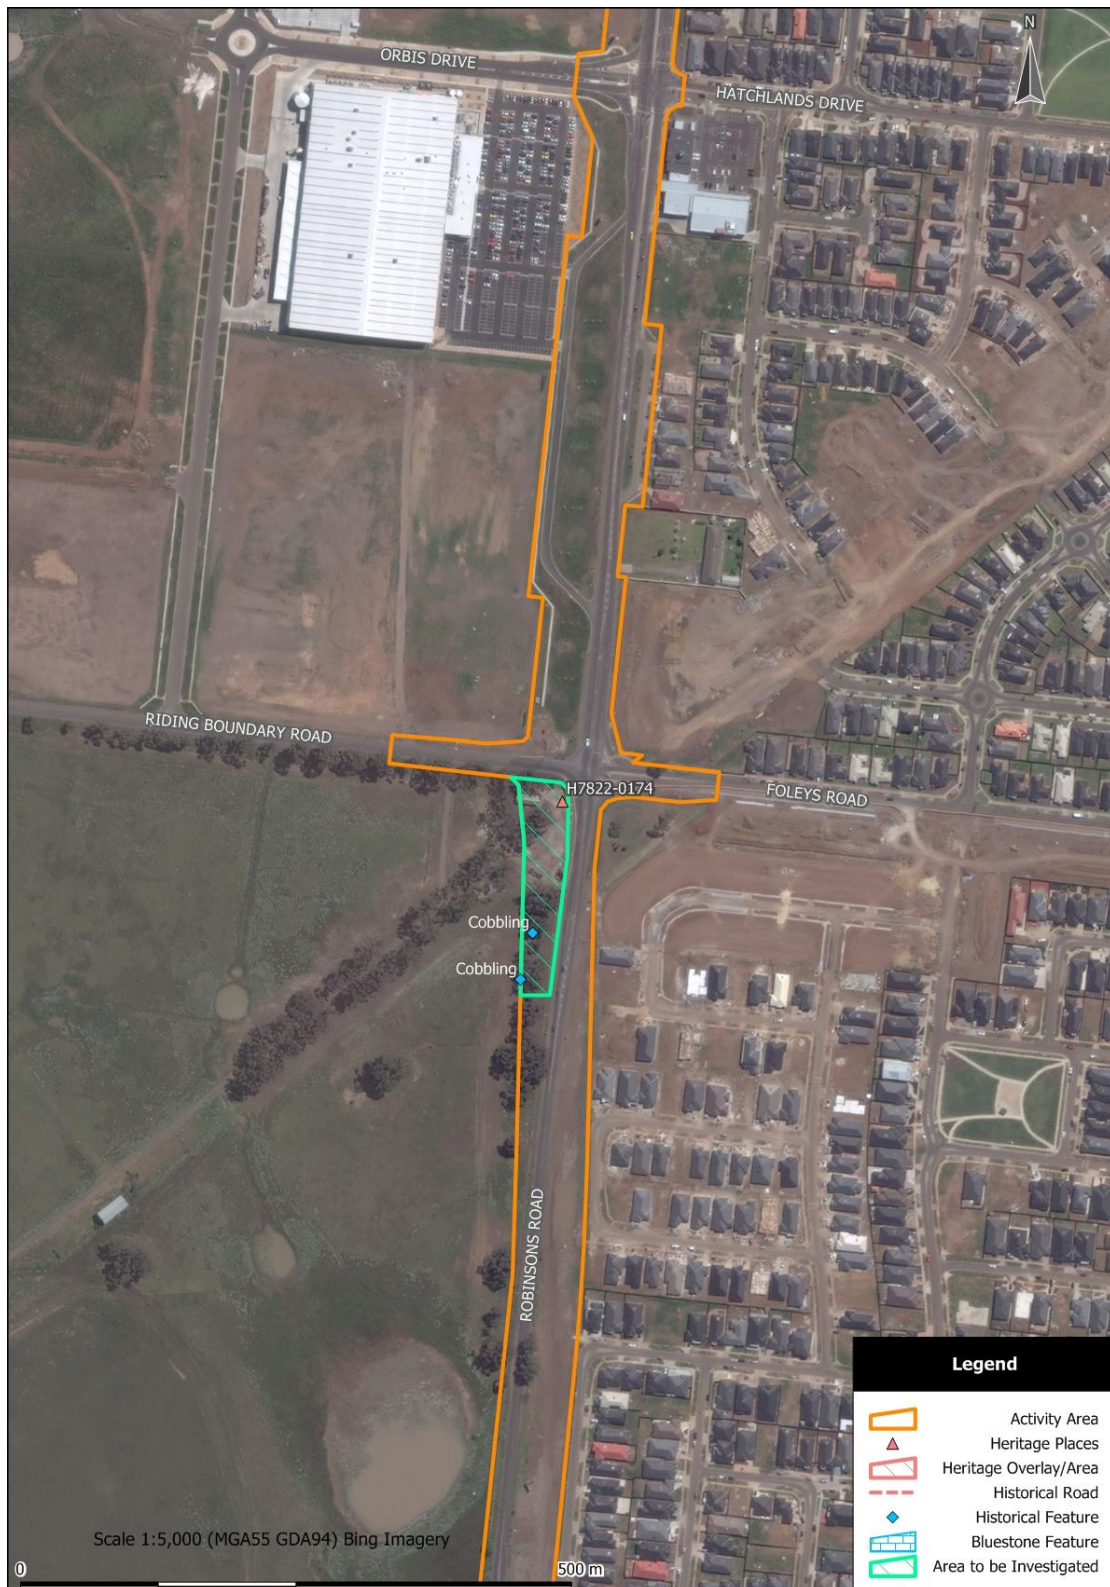
Figure 16: Plan showing the area of site H7822-0174 that will require further investigation.

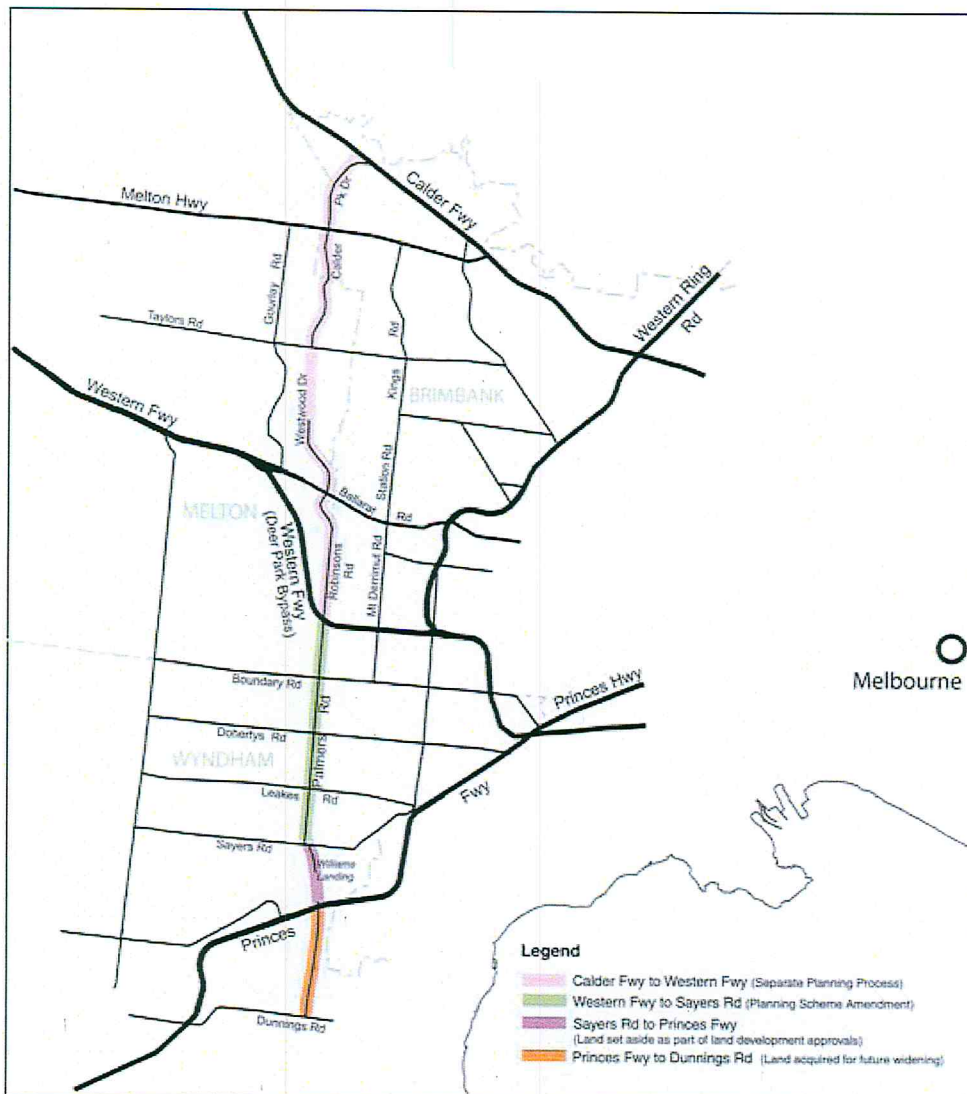
**Figure 1: Palmers Road Corridor**

North of the Western Freeway, the land adjoining the corridor is largely ‘built out’ for a good part of its length, with a minimum 40 metre corridor set aside for a future road widening. As stated above, the only section of road that has not yet been constructed (single lane-each way) is the crossing of Kororoit Creek at Westwood Drive, for which planning approval has been granted.

For Stages 2 and 3 (identified in pink), the land adjoining the corridor is largely ‘built out’ for a good part of its length, with a minimum 40 metre corridor set aside for a future road widening. As stated above, the only section of road that has not yet been constructed (single lane-each way) is the crossing of Kororoit Creek at Westwood Drive, for which planning approval has been granted.

The Palmers Road Corridor (see Figure 1) was identified and set aside in the 1997 Melton East Strategy Plan (MESP) which set out the land use and transport network through the Caroline Springs-Hillside-Sydenham area. The plan included the designing of subdivisions and locating of activity centres away from the Palmers Road corridor to enable its development ultimately as a six-lane dual carriageway arterial. The MESP and growth area plans have dictated a land use pattern around a primary six-lane dual carriageway arterial. The 25km route traverses municipalities of the City of Wyndham, City of Brimbank and the Shire of Melton.

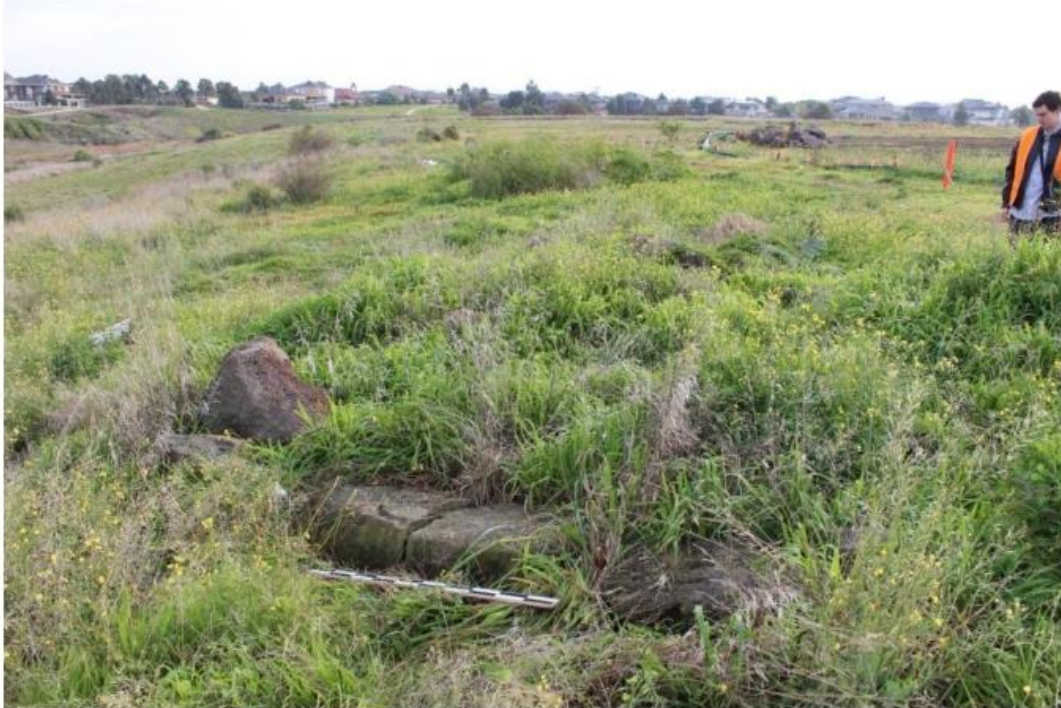
Foundations of hut, facing NW

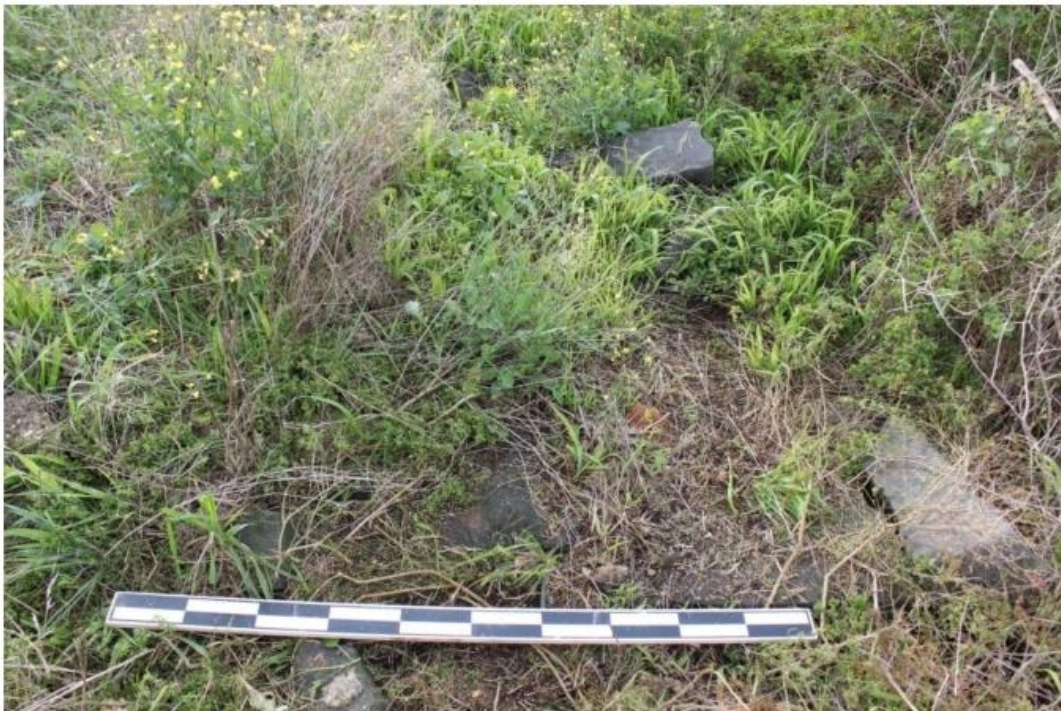
Foundations of hut - detail

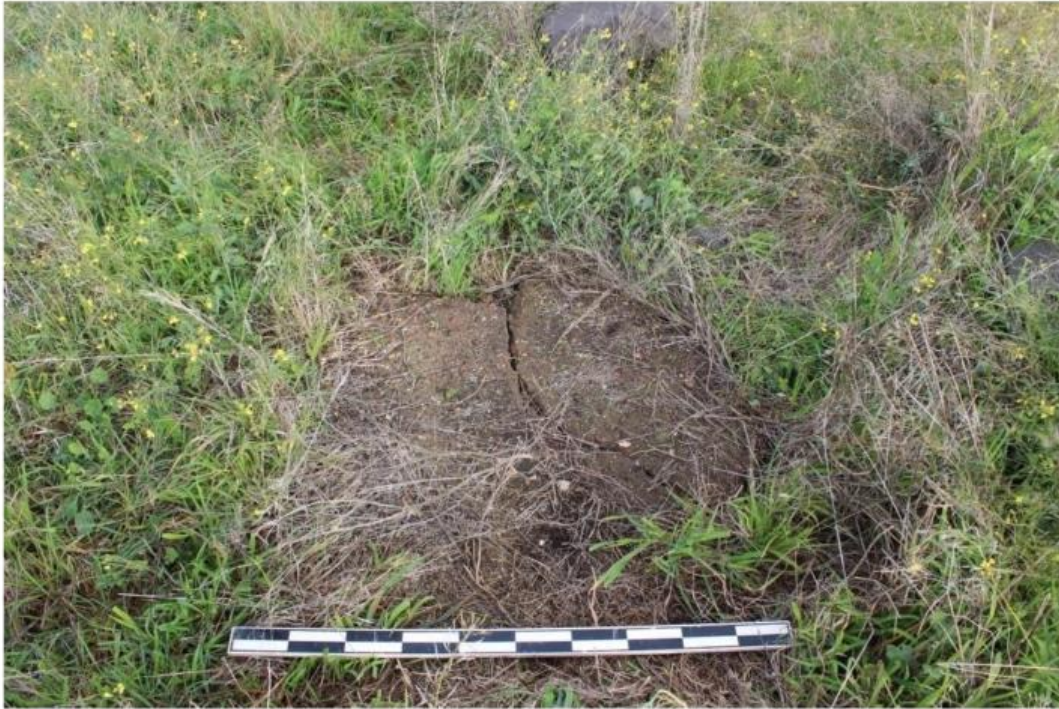
Concrete floor adjacent to hut foundations
