# Palmers Rd Corridor (Western Freeway to Calder Freeway) – Historic Archaeology & Cultural Heritage

Heritage Victoria Project Number: 4334

**Report Sponsor:** VicRoads

**Date of Completion:** 28 August 2014

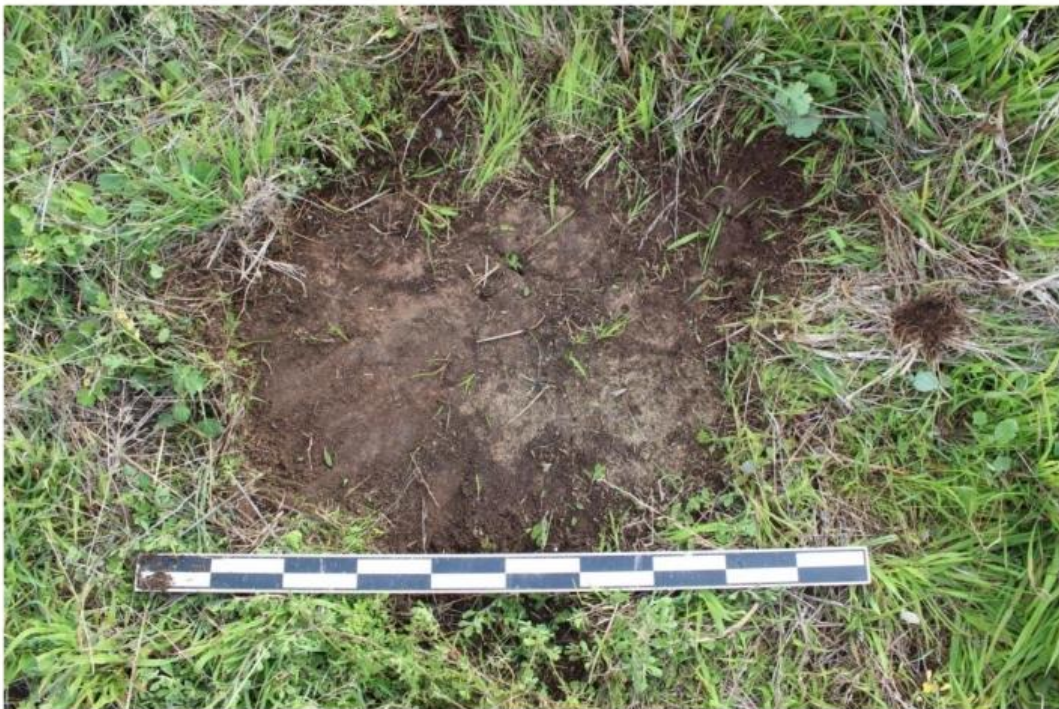
Concrete floor inside hut

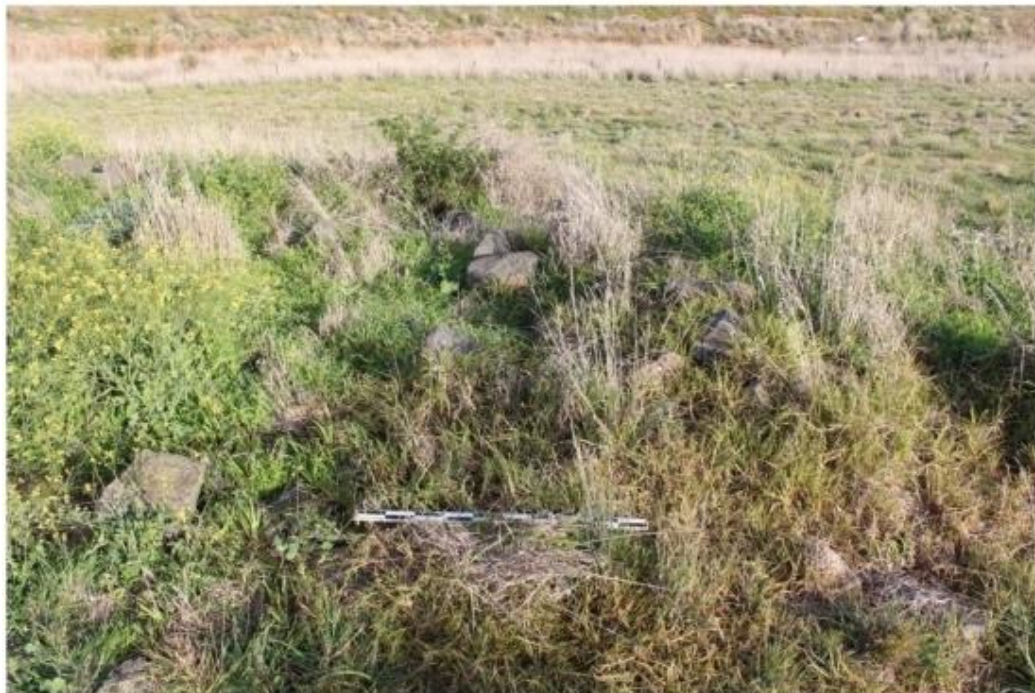
Secondary alignment of bluestone blocks to west of hut at location of former structure, view S

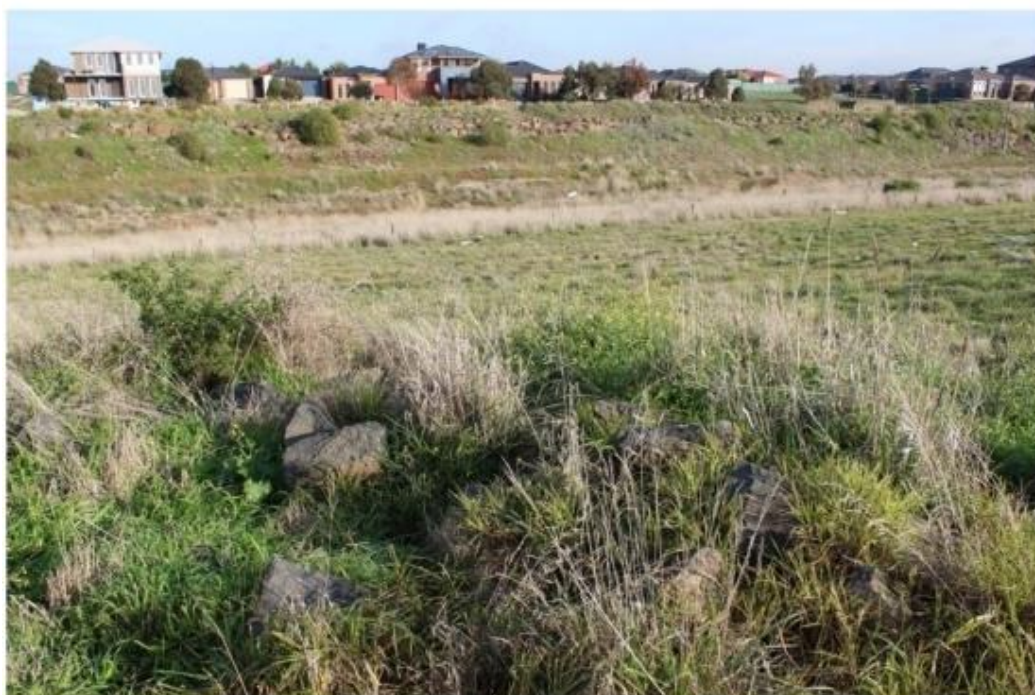
Secondary alignment of bluestone blocks to west of hut at location of former structure, view SW with Kororoit Creek in middle background
