Western Highway Project Section 2: Beaufort to Ararat, Victoria

Threatened Species Management Plan

May 2014

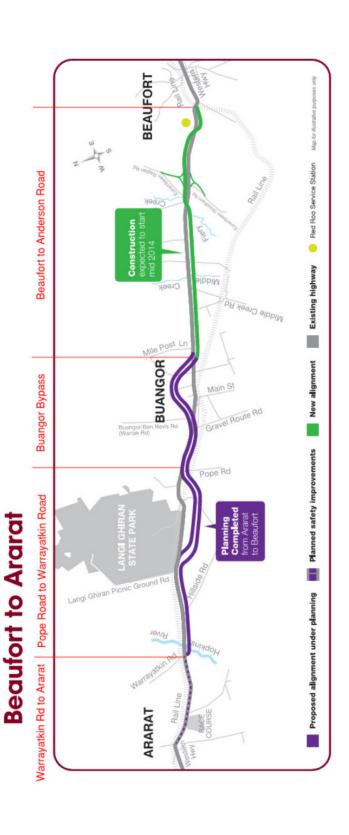
16. APPENDIX A- PROJECT LOCATION

As shown in Appendix A, Section 2 of the Western Highway Project consists of up to four sub sections:

- Beaufort to Buangor
- Buangor Bypass
- Buangor to Warrayatkin Road
- Warrayatkin Road to Ararat

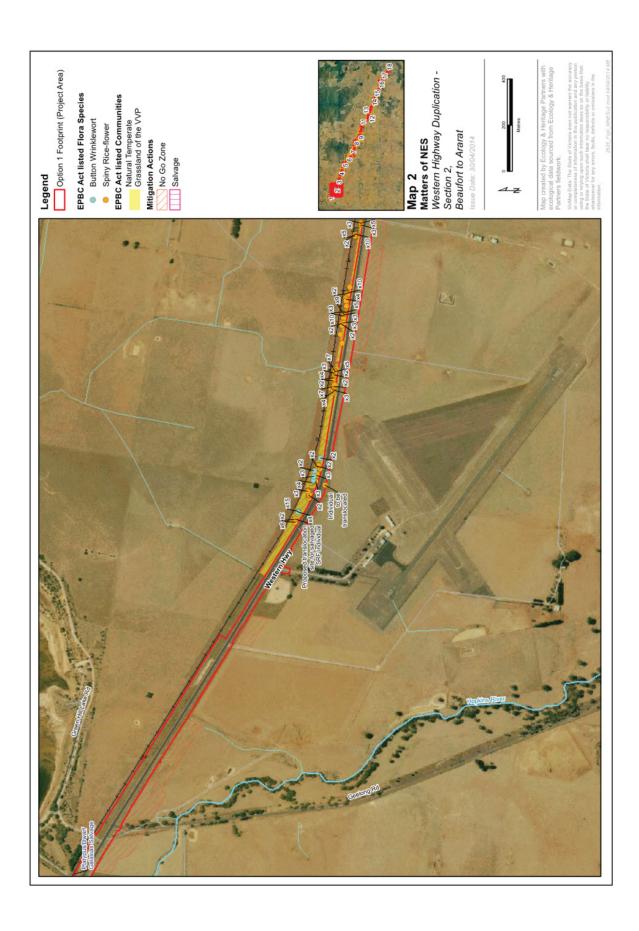
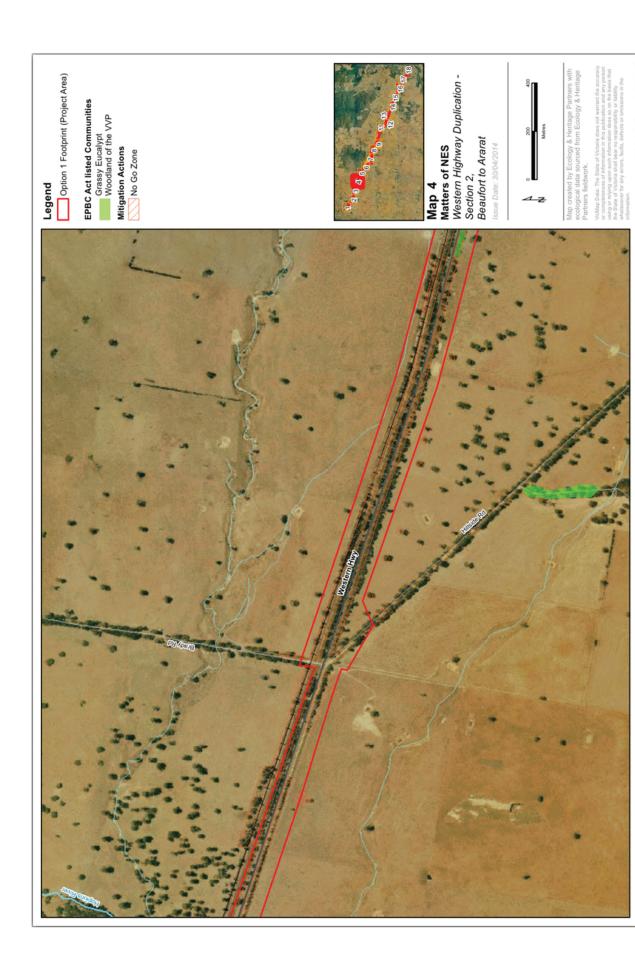
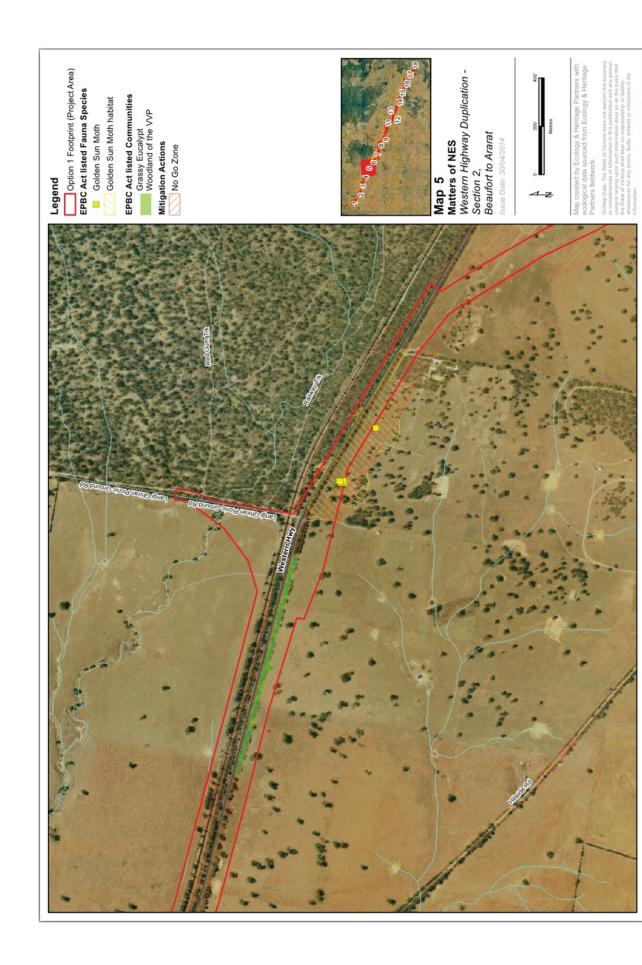
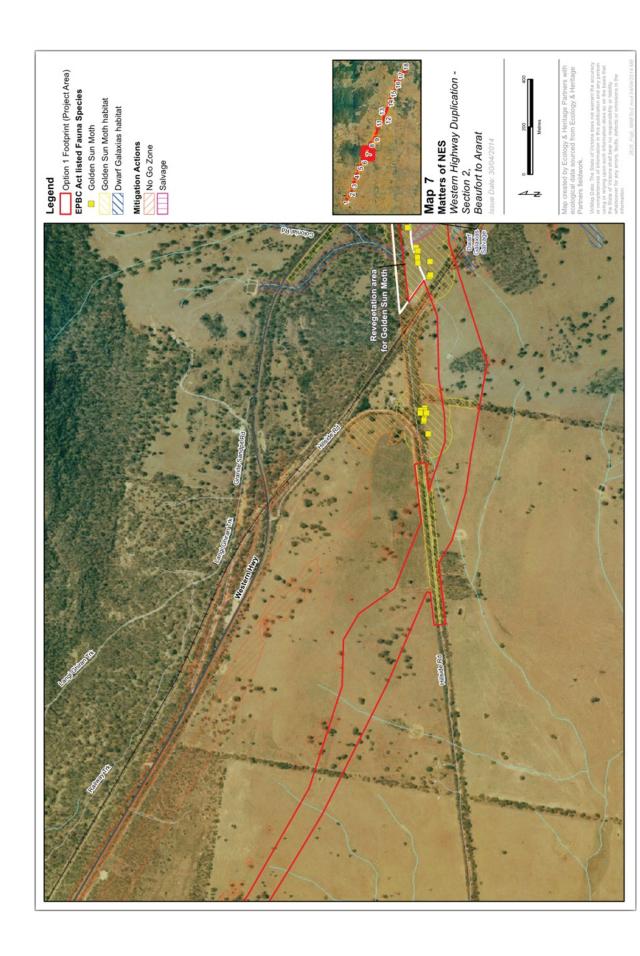
17	APPENDIX F	3- MATTERS	OF NES	MAPS
	AFF LINDIA L	J- IVIA I LLIVU '	OI NEO

Mitigation Actions
No Go Zone

Prior to construction works occurring within 500m, permanent fencing will constructed around the population immediately east of Warrayatkin Road (Appendix B, Map 3) and the population within Woodnaggerak Reserve at Middle Creek (Appendix B, Map 13). The permanent fencing must be monitored every 6 months after erection with any noted damaged repaired within 4 weeks. This must be undertaken for a period of 10 years post-construction.

The Golden Sun Moth revegetation area is 5.6 hectares and a preliminary location is marked on Appendix B; Map 8. Topsoil excavated during construction must be replaced over the disturbed zone after construction.
