Pyrenees Highway (Sec 2) Ch 10.9 – 15.0km Safer Roads Infrastructure Project Green Gully, Victoria

Annual Compliance Report No. 3
October 2024
EPBC Reference 2016/7809

Date: 11 October 2024
Version: 1.0

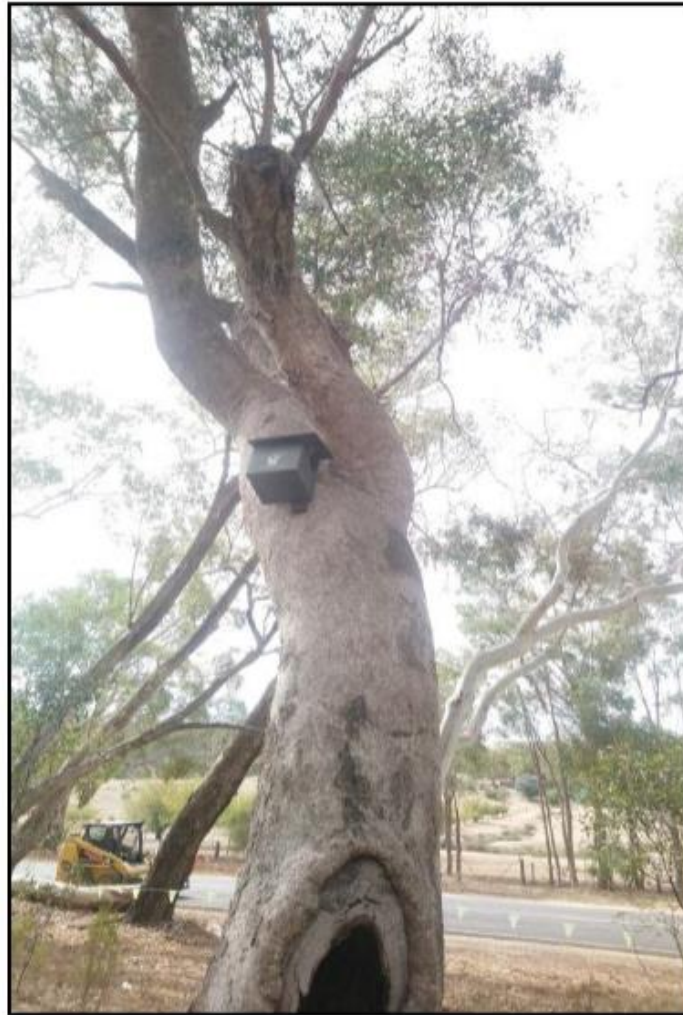
Photo 1: Brushtail Possum nest box, Pyrenees Highway,
Newstead

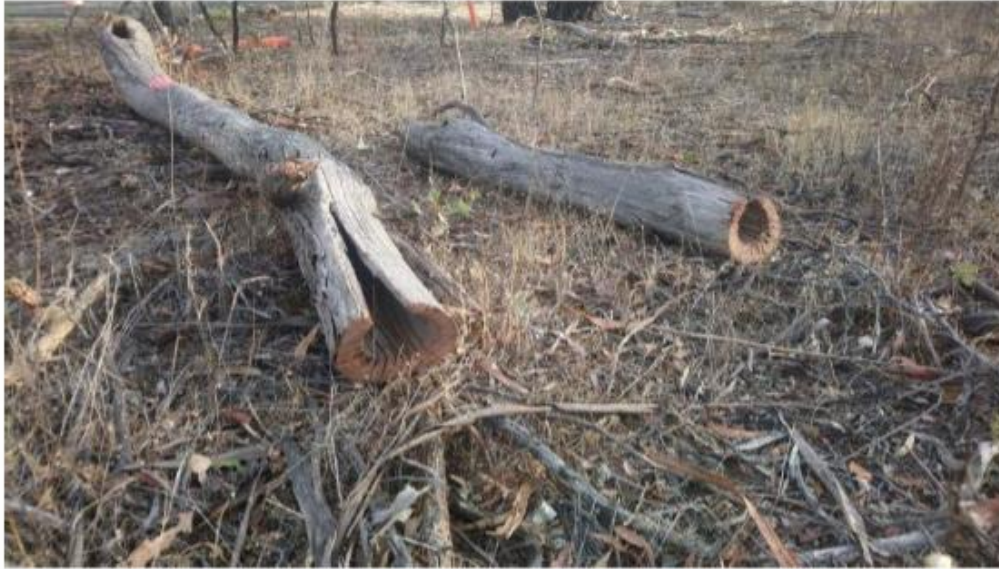
Photo 1: Hollow logs placed in road reserve as habitat

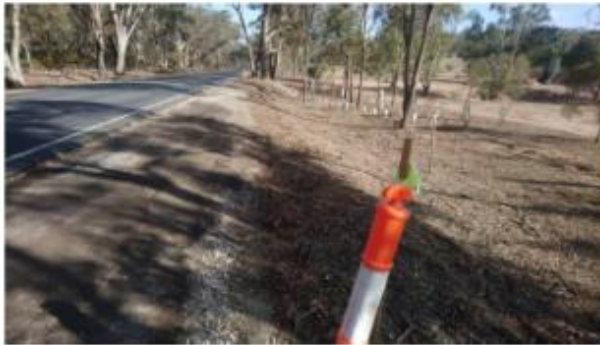
Much of the road verge within 3 meters of the road edge is degraded or has relatively low cover and provides no significant fauna habitat (Photo 1 is an example of low cover in the road verge).

Photo 1: Pyrenees Highway, showing limited ground cover for fauna habitat

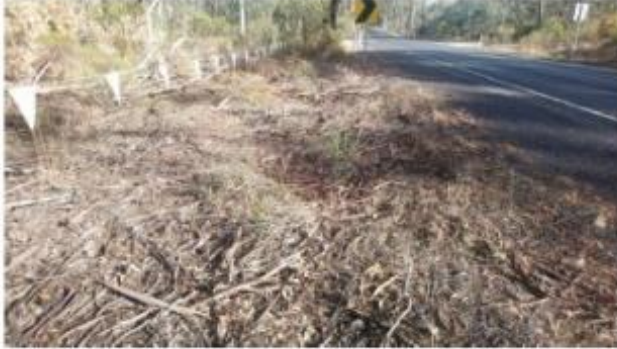
Of the sites inspected, there were three sites that in my view contained potential habitat for fauna. The fauna species would most likely be reptiles and amphibians (particularly at culverts). The three sites are shown in Photos 2, 3 and 4.

Photo 2: Pyrenees Highway, showing ground cover for fauna habitat (CH 11.115 - CH 11.150 LHS formation widening (fill construction))

It is recommended that these three sites be monitored for fauna during the clearing and grubbing of ground litter, rocks and top soil.

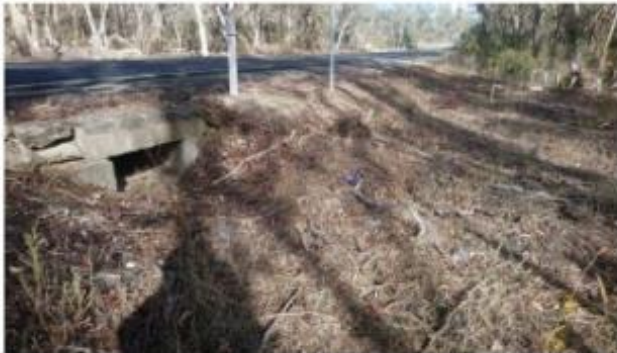
Photo 3: Pyrenees Highway, showing ground cover for fauna habitat (CH 13.610 - CH 13.690 LHS formation widening (fill construction))

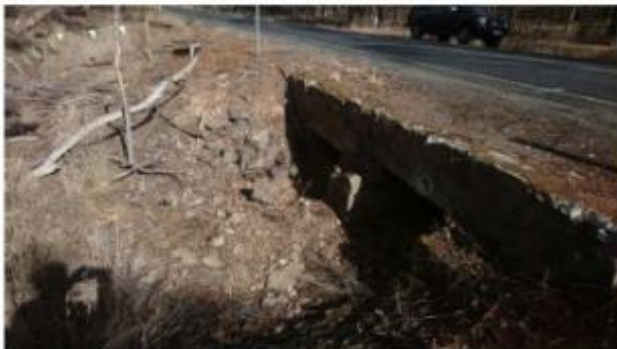
Photo 4: Pyrenees Highway, showing culvert and rocks; potential for fauna habitat (CH 11.14)
