Office of the Chief Investigator
Transport Safety

**Rail Safety Investigation
Report No 2009/14**

**Passenger Fatality
Connex Melbourne Ltd
Melbourne Central Station
(Melbourne Underground Rail Loop)
20 October 2009**

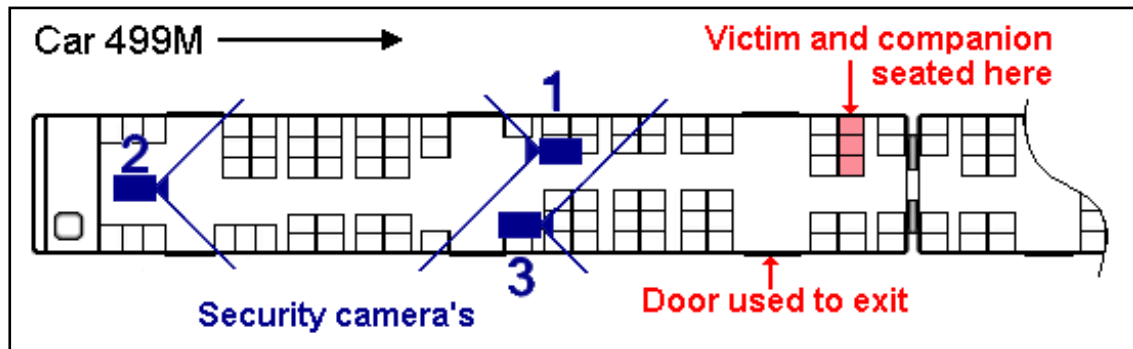
Figure 2 – Car floor plan

The six-car Comeng EMU⁶ comprised cars 383M⁷, 1042T⁸, 365M, attached to 534M, 1100T, and 499M. Car № 499M was equipped with three CCTV cameras as illustrated above. A six-car train occupies almost the full length of MURL platforms.

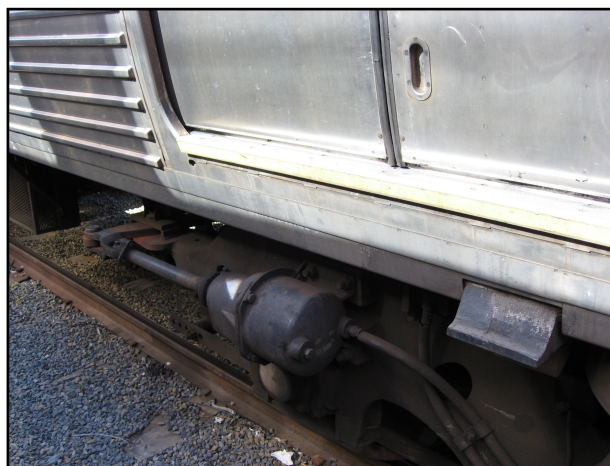
Figure 3 – Comeng motor car, showing door used by victim and proximate car brake cylinder (see photo below).

Two seconds after the train commenced to move, the male passenger was observed to force open the leading right-hand (in direction of travel) passenger saloon doors of the last car and attempt to alight. His companion followed and fell over him and onto the platform, but the man's left leg dropped between the platform and the train and was trapped as the train gathered speed. The door closed and the man was left in a seated position on the platform edge (coping strip) with his body against the side of the car. He was dragged along the platform edge with his right leg extended in front, and holding a bottle in his right hand. He slid on his buttocks in this position for the remaining length of the platform until striking a safety-handrail post at the top of the access stairway at the platform extremity, then to the ground (the track structure) and beneath the train. The speed of the train at this point would have been in excess of 50 km/h.
