Office of the Chief Investigator  
Transport Safety

**Rail Safety Investigation  
Report No 2011 / 05**

**Derailment  
Tram 3515  
Melbourne University Terminus  
20 April 2011**

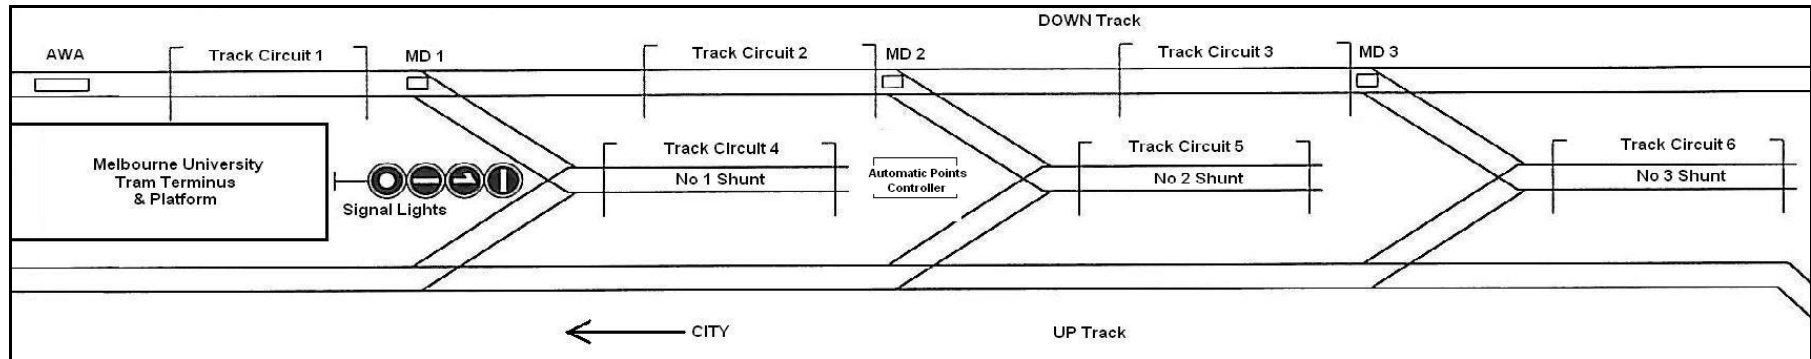
Figure 1 – Diagram of Melbourne University shunts with track components (not to scale)

Trams arriving from the city on the Down track and terminating at Melbourne University use one of the three shunts situated on the Down side of the platform to change to the Up track and return to the city (see Figure 1). No 1 Shunt is 34 metres in length and No 2 and No 3 Shunts are 30 metres in length.

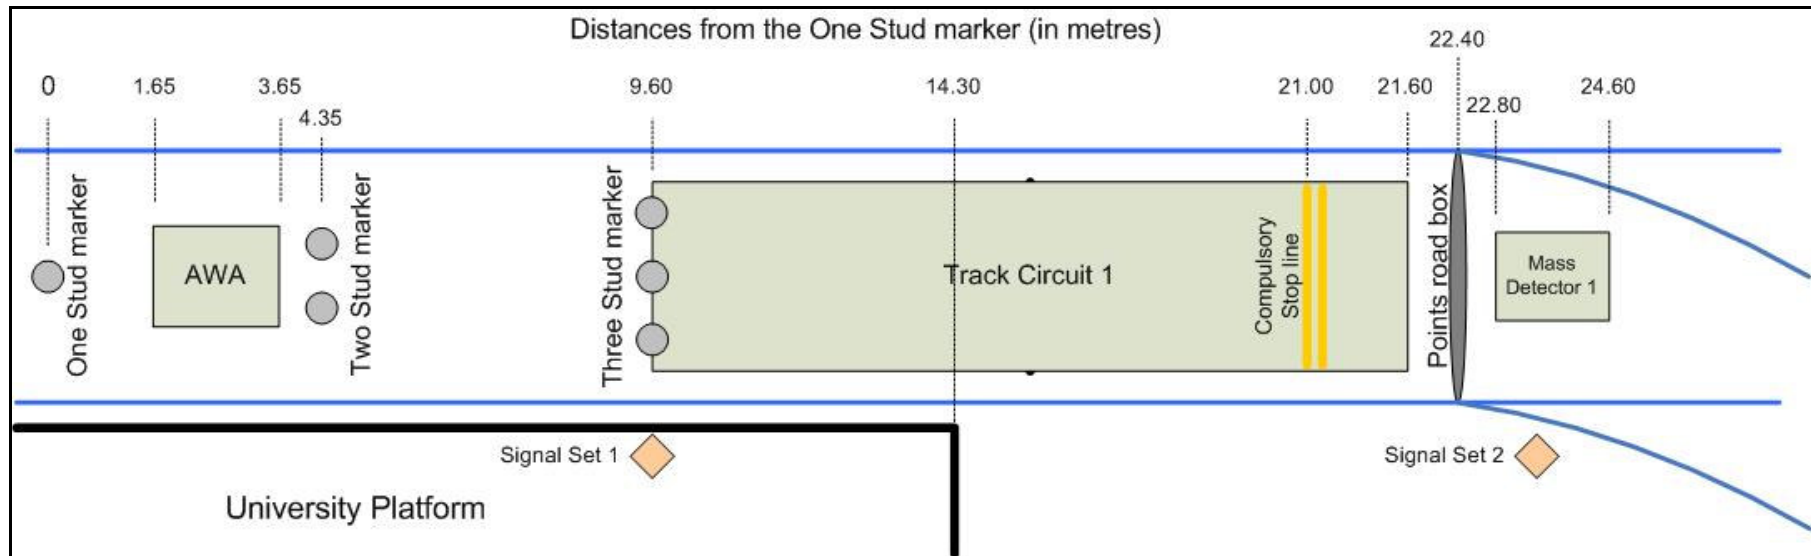
Figure 2 – Track components at Melbourne University platform leading into No 1 Shunt (not to scale)

Figure 2 provides an overview of the in-track equipment at the platform and leading into No 1 Shunt. The track circuitry leads to the automatic Points Controller which is located between No 1 & No 2 Shunts.

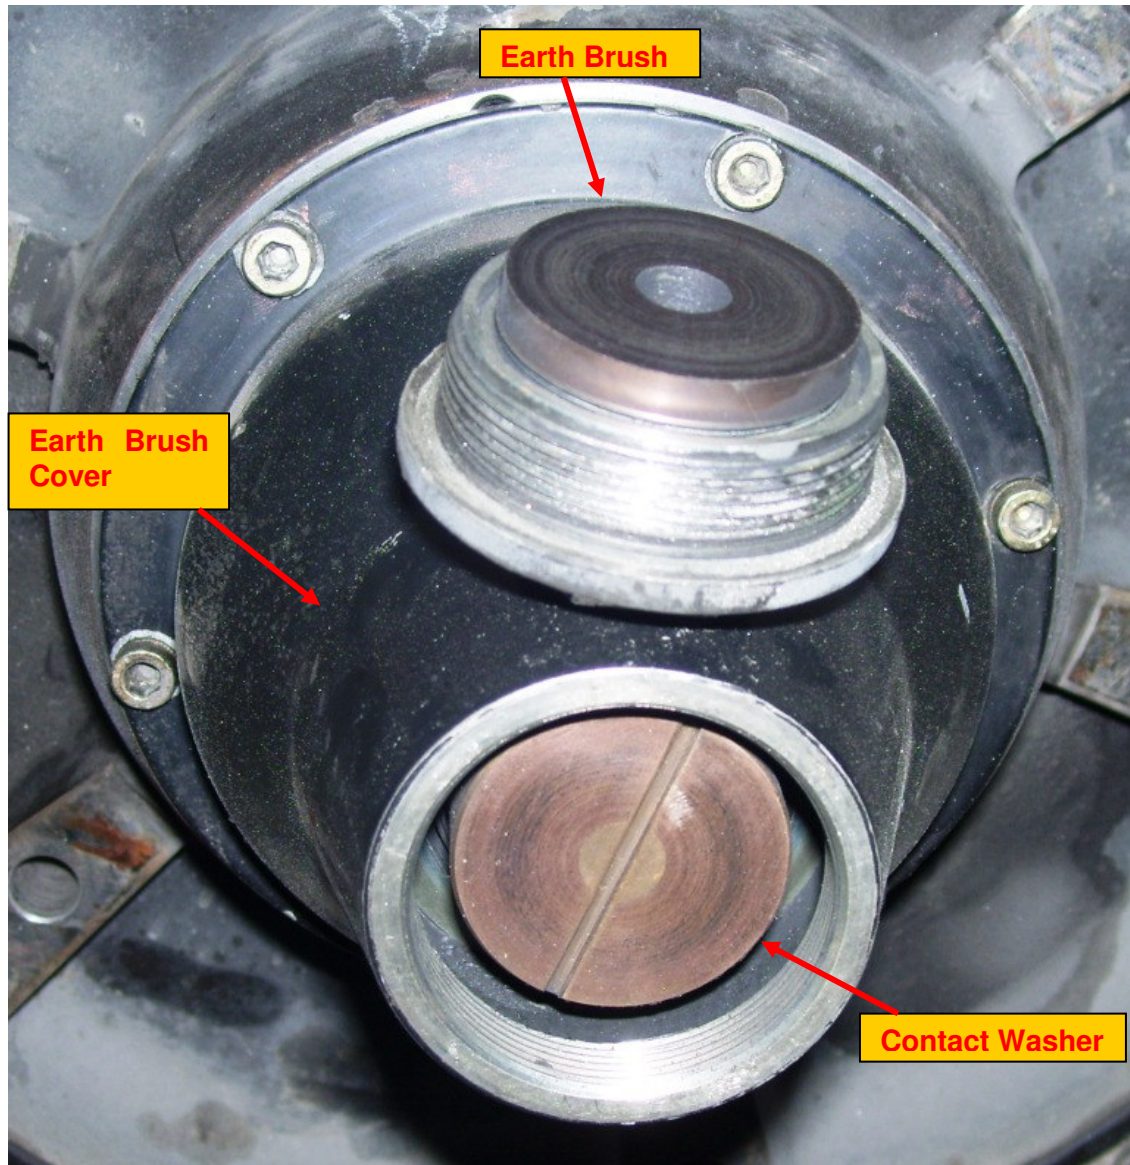
Figure 5 – Earth brush unit, external view

The EBU comprises a copper earth brush that screws into the earth brush cover to make contact with the copper contact washer. The contact washer is spring loaded so that it maintains continuous contact with the earth brush.

Connectivity between the contact washer and the tram wheel is through three earth shunt braids. As long as one earth shunt braid is intact and the earth brush makes contact with the contact washer, the circuit is closed and resistance measurement that is within limits is obtainable. However, the condition of the parts cannot be determined unless the unit is stripped and inspected.

The latest version (May 2008) currently installed<sup>9</sup> has a reduced mass contact washer and stronger spring within its fitting to overcome the chatter. It is also fitted with an improved rubber seal. This modification eliminated the longitudinal pins which were fitted (see Figure 5) to prevent rotational movement of the contact washer that occurred in prior versions. However, this version has not proved to be completely successful.
