Office of the Chief Investigator
Transport Safety

**Rail Safety Investigation
Report No 2018/01**

**Derailment of Tram No.190
At Moonee Ponds, Victoria
27 March 2018**

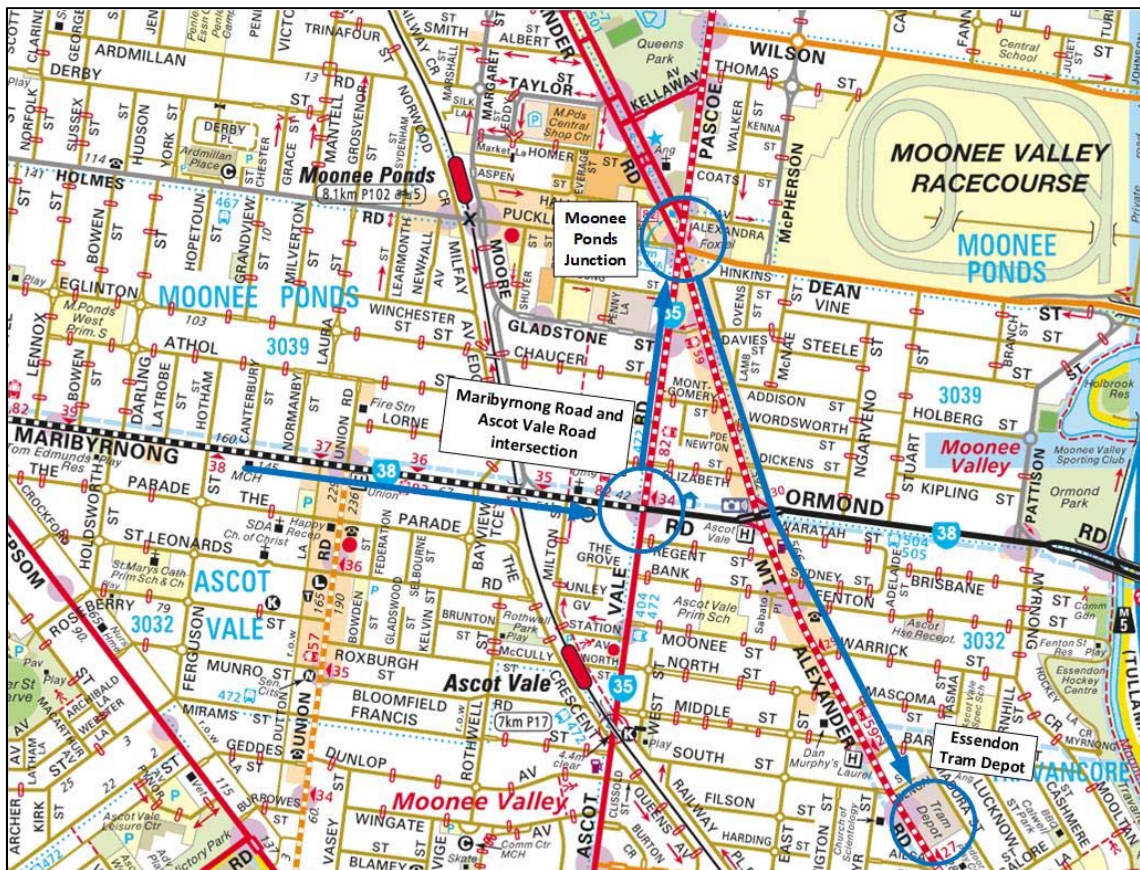
Figure 1: Maribyrnong Road and Ascot Vale Road intersection (route shown in blue)

The driver was then to drive the tram on route 57d, a shortened service finishing at Moonee Ponds Junction. He would then take the tram back to the Essendon Depot to complete his shift (Figure 1).

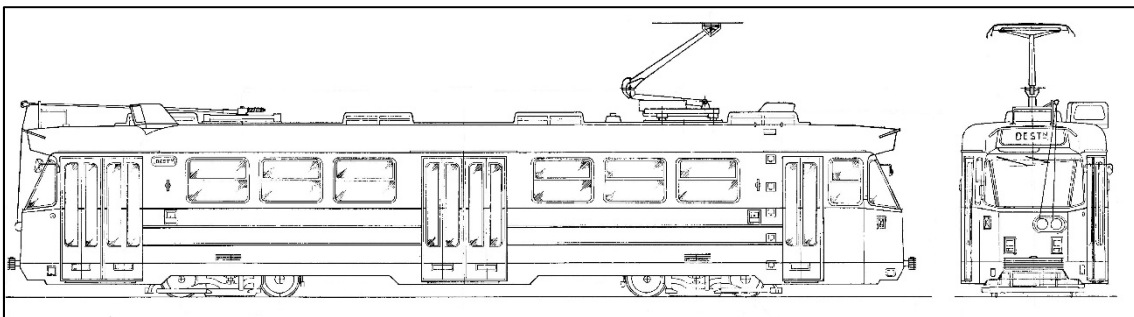
Figure 5: The Z3 Class tram

Tram 190 is a Z3 Class tram (Figure 5) built by Commonwealth Engineering (Comeng) in Dandenong and came into service in 1980. It is a pantograph equipped, double-ended non-articulated double bogie (four axle) tram, driven by two 195 kW AEG motors. The vehicle has driver consoles at both ends and has a 42-passenger seating capacity and a 125-passenger total capacity. It has a length of 16.6 m, a tare weight of 21.8 t and a maximum service speed of 70 km/h.

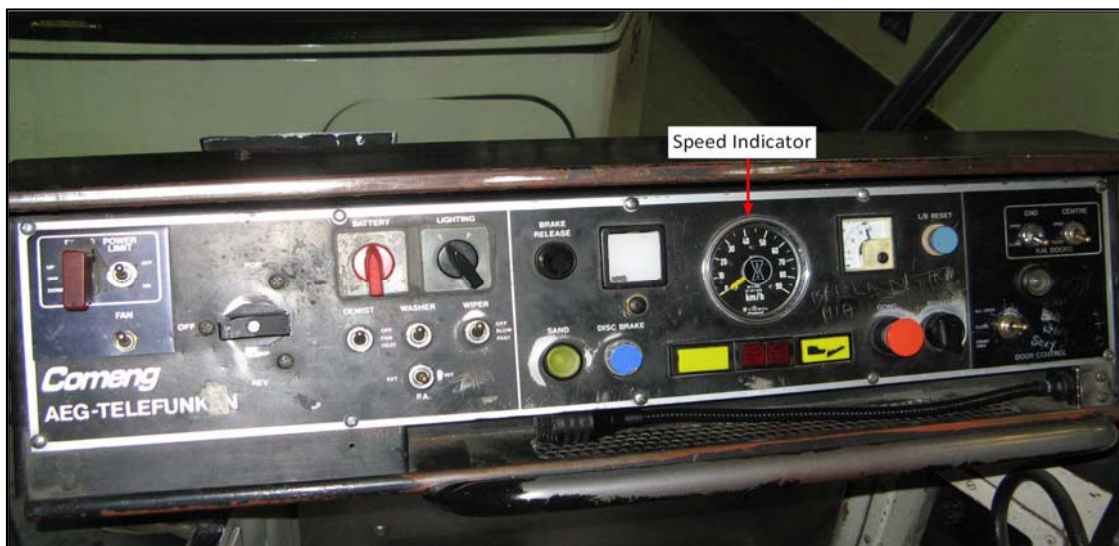
Figure 7: Z3 Class tram driver console

In front of the driver is a console that includes a range of auxiliary controls and a speed indicator (Figure 7).
