# Derailment of freight train 6BM9

Creighton, Victoria on 21 January 2019

**ATSB Transport Safety Report**

RO-2019-003

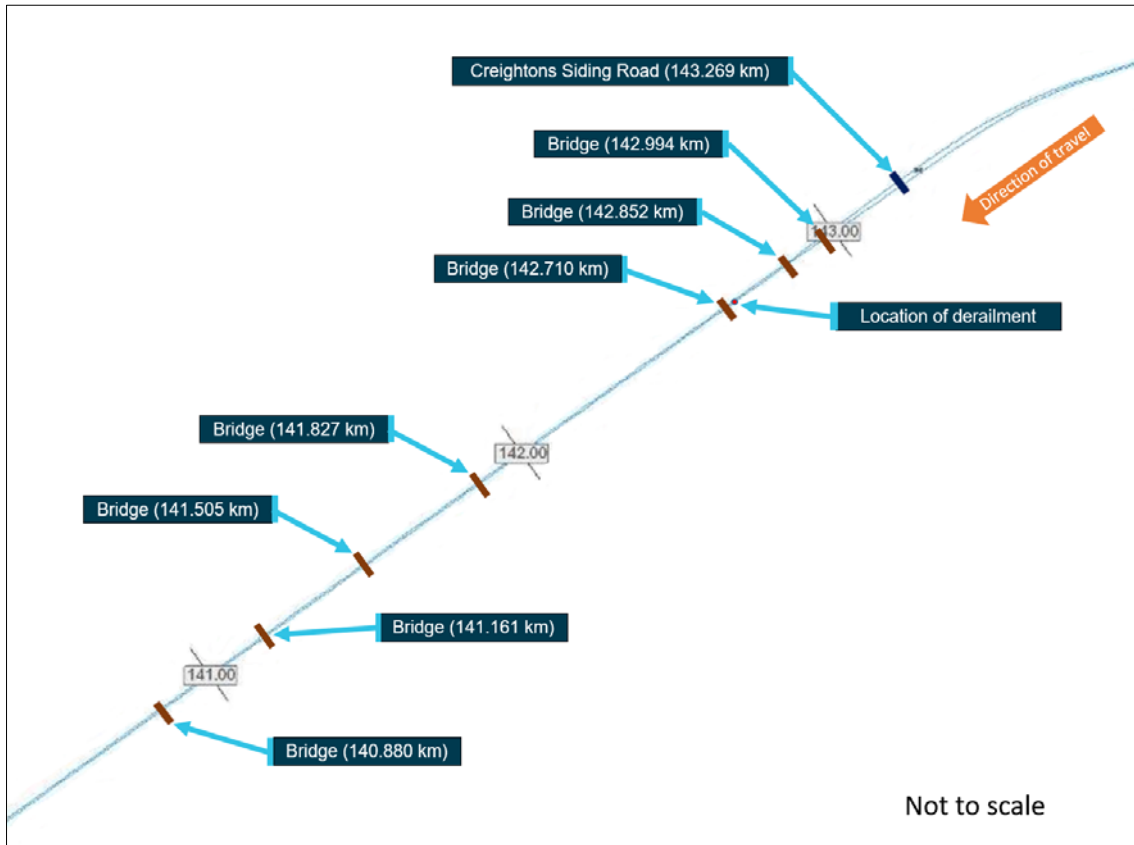
**Figure 6: Incident track section**

Creighton Siding Road is located 143.276 rail-km from Melbourne.<sup>12</sup> Travelling towards Melbourne, there were seven rail bridges over a relatively short distance. They were located at 142.944 km, 142.852 km, 142.710 km, 141.827 km, 141.505 km, 141.161 km and 140.880 km (Figure 6). The derailment occurred a short distance before the bridge at 142.710 km, and the train came to a stop just prior to the bridge at 140.880 km.

The point of derailment was between the short rail bridges at 142.852 km and at 142.710 km. Both bridges were transom bridges, with timber sleepers fixed to I-beam girders supported at each end by concrete abutments. Rails were secured to sleepers with Trak-Lok type fastenings that had a design toe load of approximately 9 kN for each fitting. The rail bridge at 142.710 km was about 7.4 m long and in good condition (Figure 7).

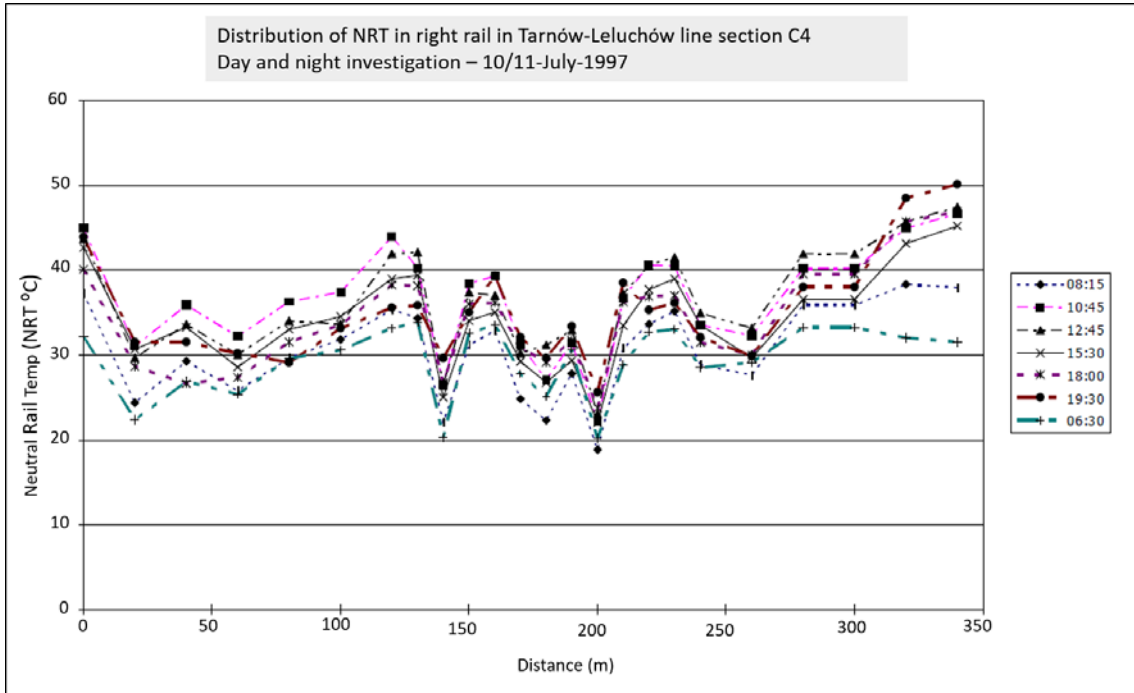
**Figure 13: Typical short-term track response on the straight section of CWR track when the lateral movements reach a few millimetres.**

Figure 42 from this research (reproduced as Figure 13) shows the longitudinal distribution of stresses (shown as Neutral Rail Temperature (NRT) or SFT as used in this report) measured simultaneously across a 350 m section of tangent track through a complete day-night cycle. Esveld showed that for the rail section studied, the average SFT was approximately 33°C but the actual SFT varied along the length of rail due to two effects. Firstly a variation of about 7°C with a change in actual rail temperature as rail cools and heats during a 24 hour period and secondly, a variation from 27 to 40°C along the length of the rail during the hottest part of the day (in each case disregarding the readings at the extremities of the test section). Therefore, understanding the distribution of stress as well as the variation with ambient temperature is important to understand the risk of buckling.

The ARTC standard for installing CWR on concrete sleepers specified an SFT of  $38 \pm 5 \text{ }^\circ\text{C}$ . Following this incident, the rails were unfastened, straightened and the SFT of each rail estimated using VERSE testing. The measurements were taken approximately midway between the bridges bounding the section of track in which the derailment occurred. There was not a large difference between the two rails, with their estimated SFT being  $35 \pm 1 \text{ }^\circ\text{C}$ .

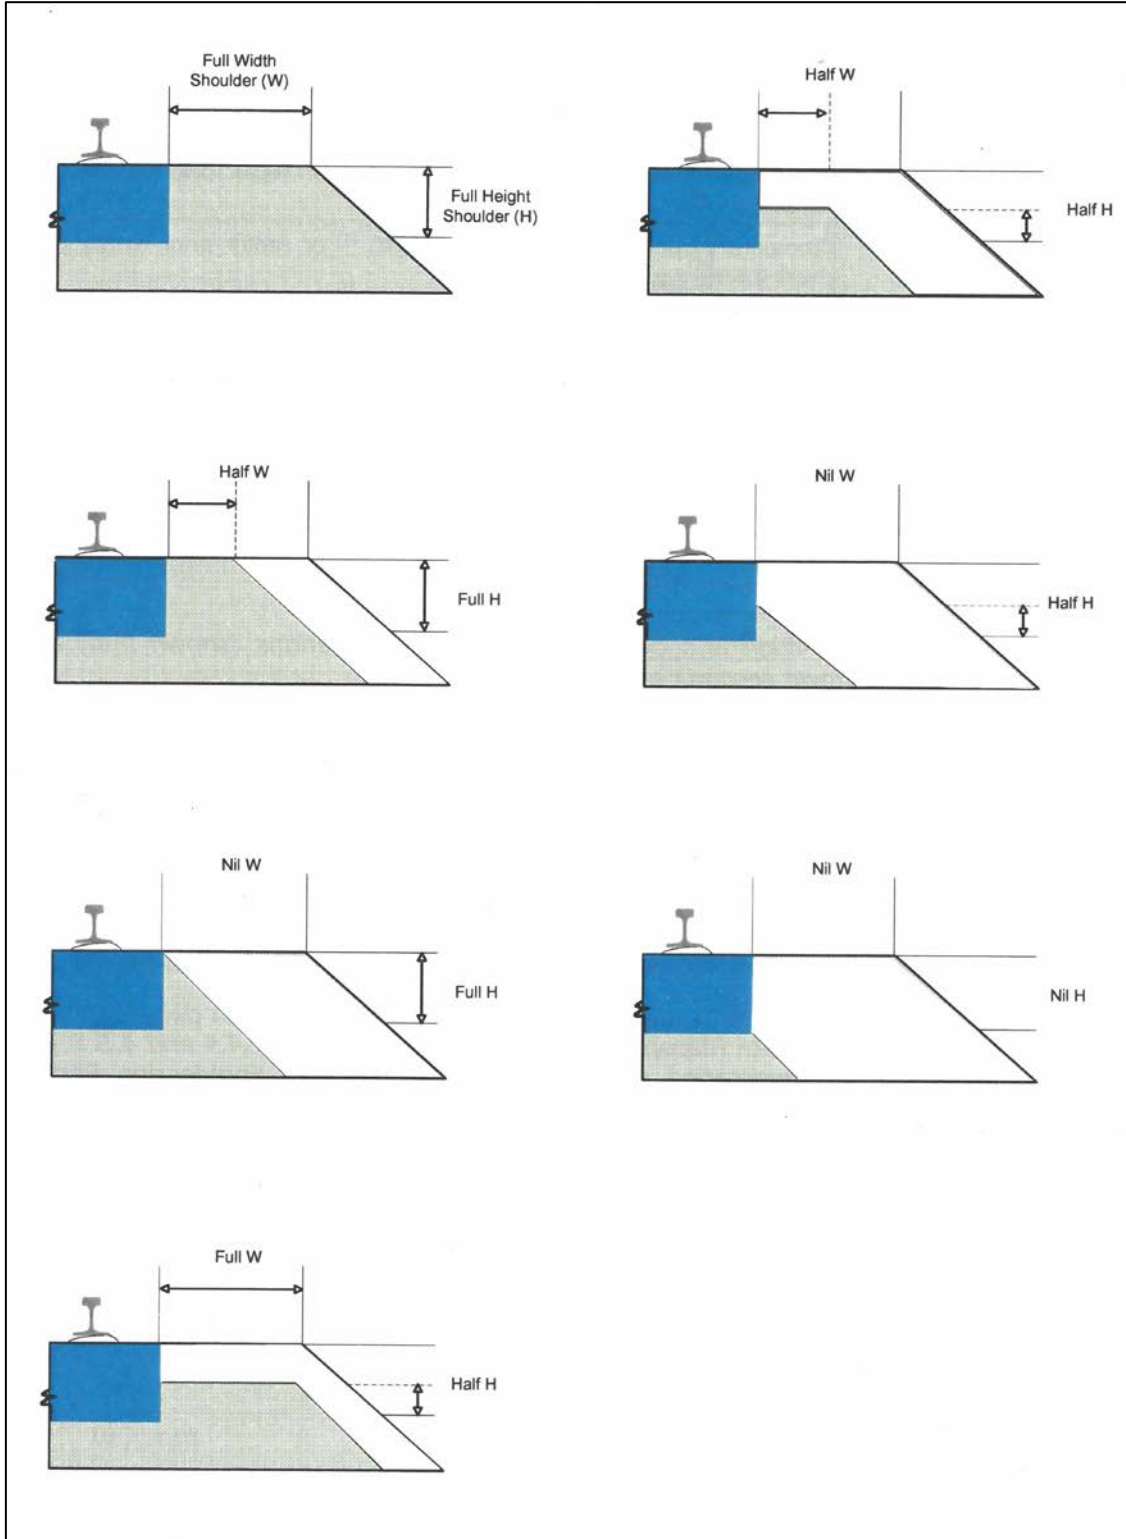
## Appendix A – ARTC pictorial definitions of reduced ballast profile

The response code table notes<sup>30</sup> state that ‘in concrete sleepers the responses apply where height and width deficiencies occur over 10 m or greater.
