Parting of Metro Trains Melbourne passenger train TD 3817

Croydon, Victoria, 9 November 2018

Rail Occurrence Investigation

RO-2018-019

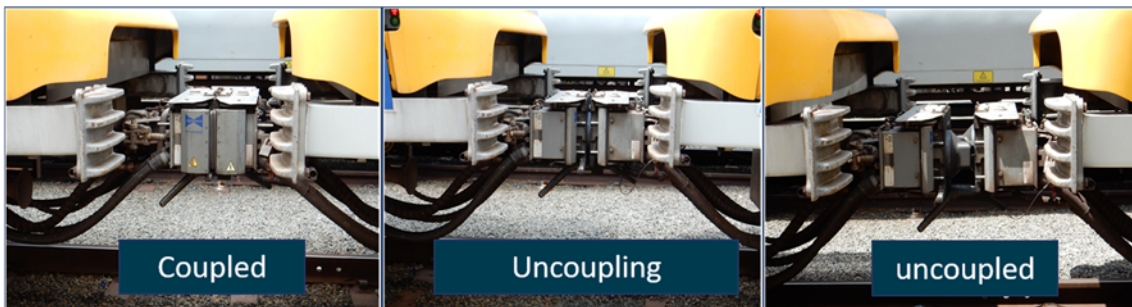
Figure 6: Scharfenberg coupler between cars shown uncoupling

Each end of the 3-car units were equipped with an automatic Scharfenberg coupler that enabled mechanical, pneumatic and electrical coupling of two 3-car units (Figures 5 and 6).

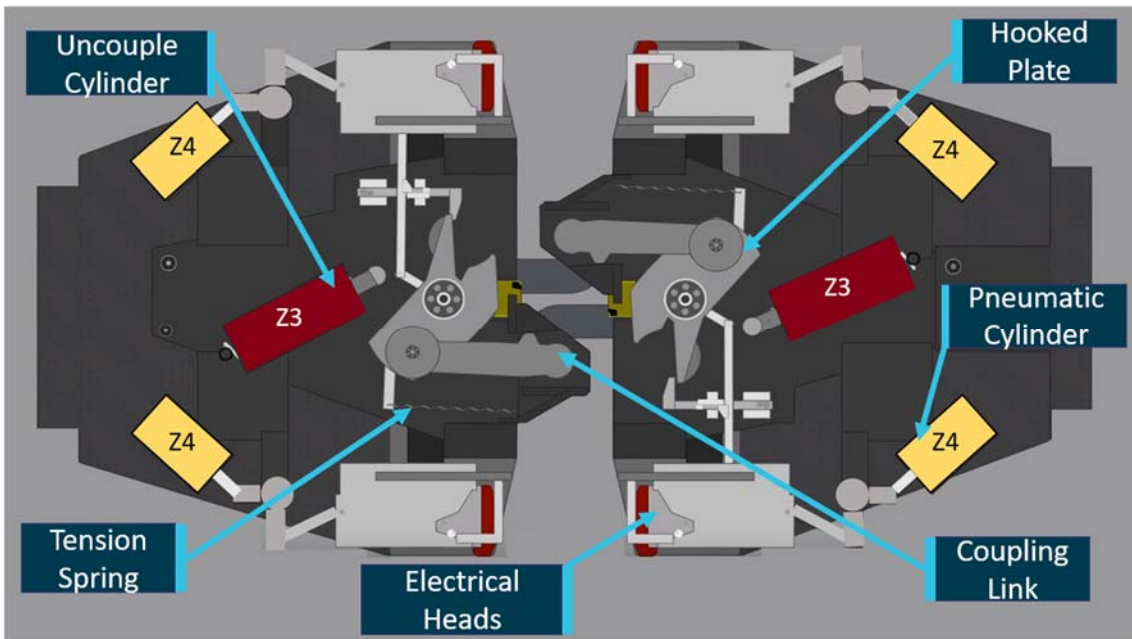
Figure 7: Illustration of uncoupled Scharfenberg coupler

The Scharfenberg coupler has a coupler lock that consists of a rotating hooked plate, a coupling link and tension springs (Figure 7). During coupling, the coupling link of one coupler engages the hooked plate of the mating coupling and locks in the indentations on the hooked plates. The cone and funnel shape design of the coupler front plates establishes a rigid and slack-free connection. During the coupling, the electric heads and the air pipe connections engage to ensure connectivity between the two car units. The coupler has a flexible buffer assembly that allows movement of the cars when negotiating vertical and horizontal curves.

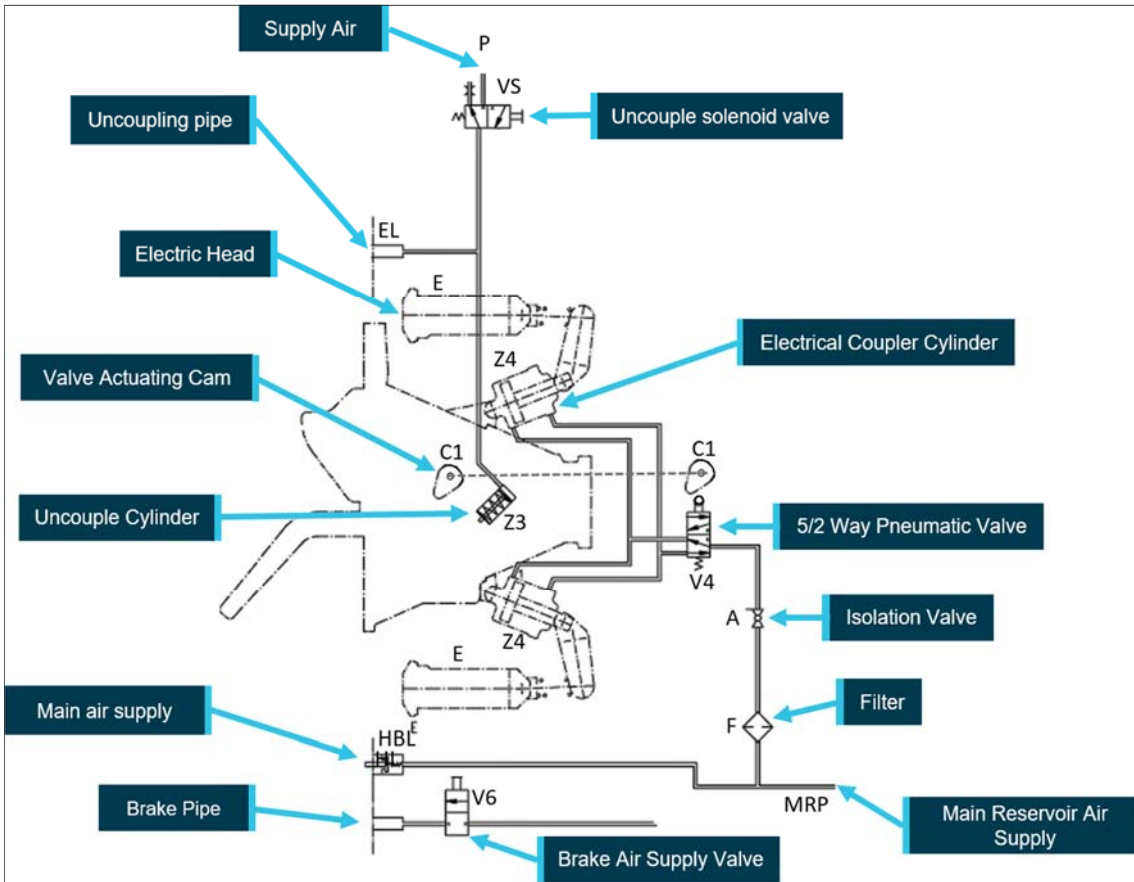
Figure 9: Pneumatic schematic for uncoupling of Scharfenberg coupler

The uncouple cylinder (Z3) actuating piston rotates the hooked plates of the coupler against the force of the tension springs (Figure 7 and 9). The coupling links slip out of the indentations on the hooked plates and the couplers can then be separated. The uncouple cylinder actuating piston also rotates the cam (C1) that actuates the 5/2 way pneumatic valve (V4). Actuation of the 5/2 way pneumatic valve allows air to be directed to the pneumatic cylinders (Z4) that retract the electrical heads (E).
