Impact with wharf by MV Lady Cutler

Docklands, Victoria on 14 January 2023

CITS Transport Safety Investigation Report

MO-01-2023

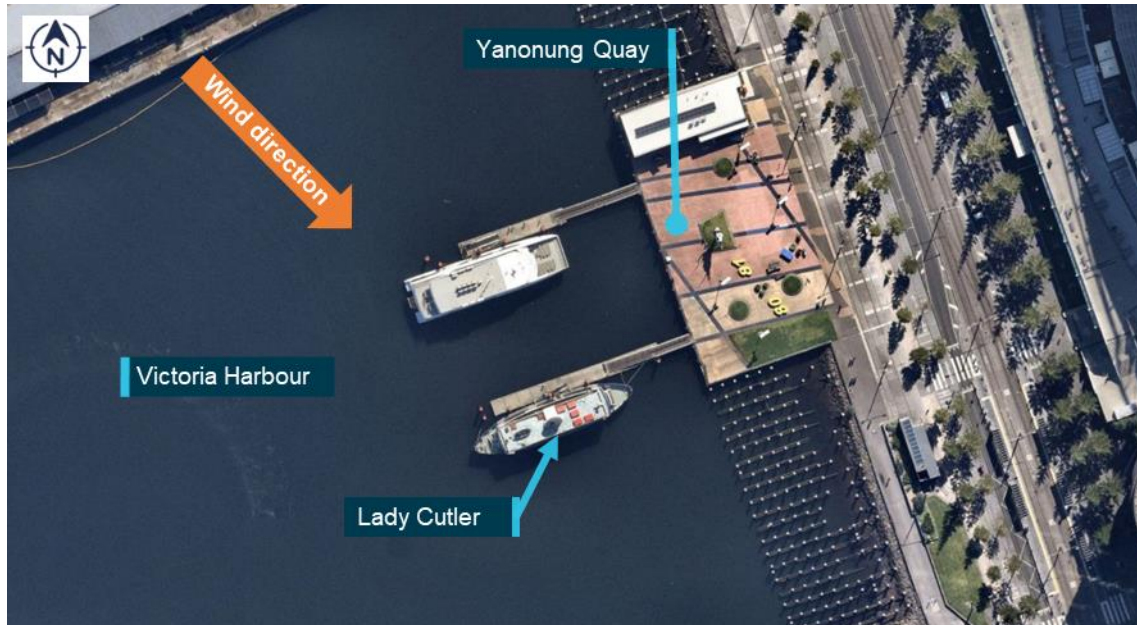
Figure 4: Lady Cutler berthed at Yanonung Quay

The normal berthing position of the Lady Cutler was port side to its designated floating jetty that projected perpendicular to the Yanonung Quay wharf within Victoria Harbour. The jetty was about 48 m in length. In its normal berthed position, the bow of the Lady Cutler would be about 16 m from the wharf ahead and its stern about 6 m past the end of the jetty (Figure 4).

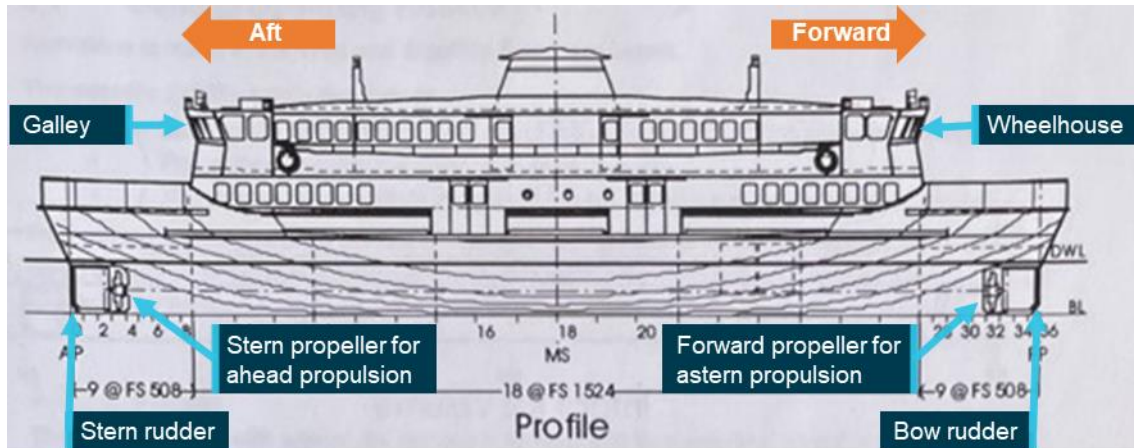
Figure 5: Profile drawing of Lady Cutler

The vessel was decommissioned in 1991 and subsequently brought to Melbourne in 1998. In 2007, the vessel underwent extensive modifications which included converting one of the wheelhouses into a galley for onboard catering. In January 2008, it commenced operating as a passenger cruise vessel on Port Phillip. The vessel was controlled from the wheelhouse at one end that was designated the forward end (Figure 5).

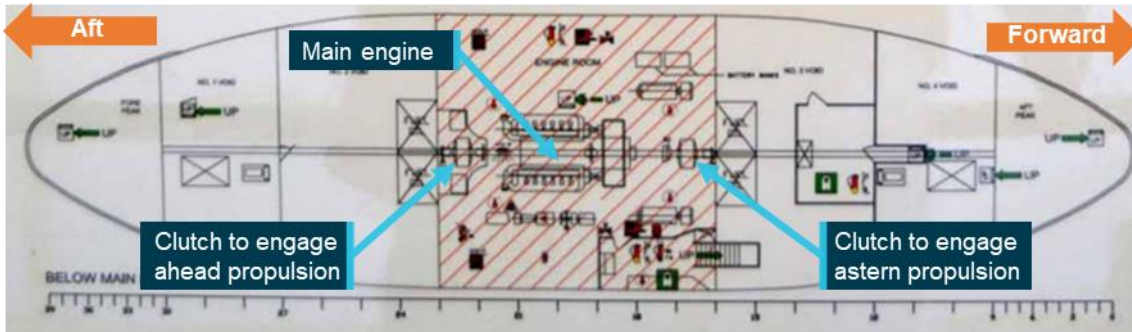
Figure 6: Lady Cutler schematic of propulsion unit

Ahead or astern propulsion was achieved by the movement of an engine control lever. For forward propulsion, the aft clutch was engaged to drive the aft propeller shaft. Conversely, to operate astern propulsion, the forward clutch was engaged to drive the forward propeller shaft. Prior to the driving clutch engaging the required propeller shaft, a stopping clutch would bring the disengaged freewheeling shaft to a stop. The change-over in propulsion direction was reported to take several seconds, both to slow and stop the propelling shaft and then to engage the new shaft.

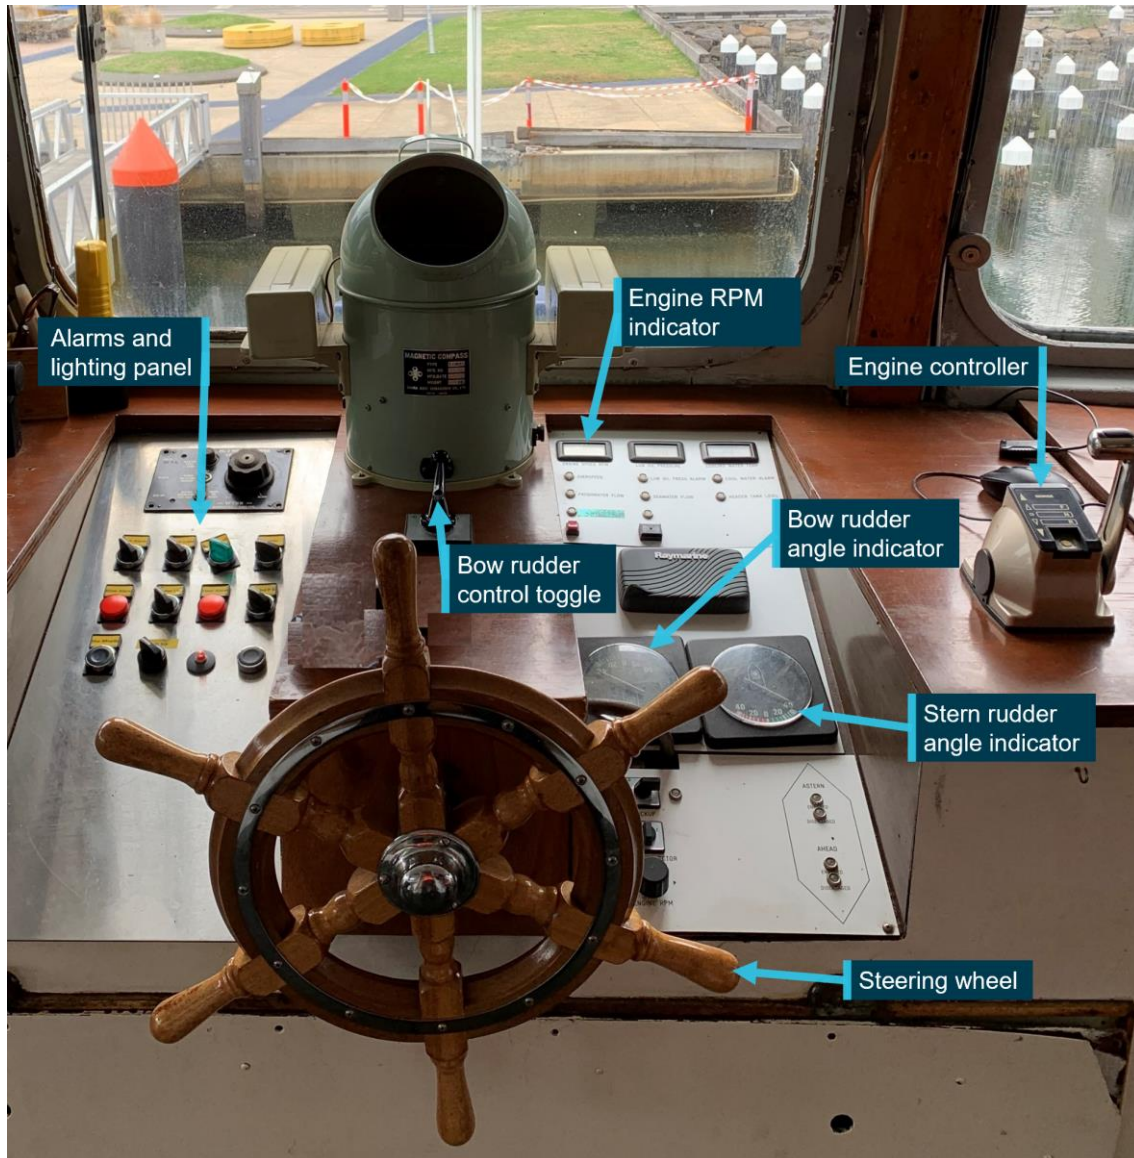
Figure 7: Wheelhouse central navigation console

Indicators and available information differed between the central console and the two side consoles (Figures 7 and 8). Engine RPM information was available at the central console only, and a speed indicator fitted centrally on the wheelhouse deckhead could be viewed from the central position. The controls and indicators that were available at all stations included:

The position of the controller handle at a particular control station did not necessarily indicate the direction of propulsion as this was dependent on which conning position was active.
